APPLICATION FOR CERTIFICATE OF APPROPRIATENESS

Location of Proposed Work (Address): 424 NW 17th Street

FIELD INSPECTION REPORT

Project Name 427 NW 27th, Block 13 Lot 19 of
Jefferson Park Addition Project Number 5681
Date 12-21-2023 Type of Work Property condition assessment
Report Number 1 Reported By: Tim Meltabarger, RCI

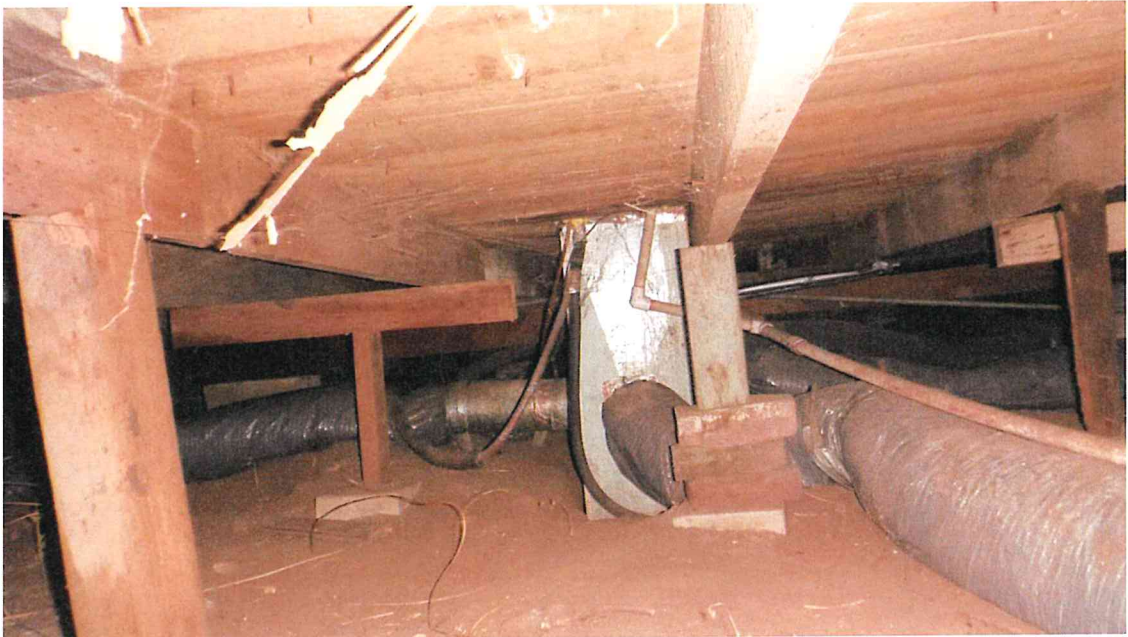
Center of house at furnace below kitchen

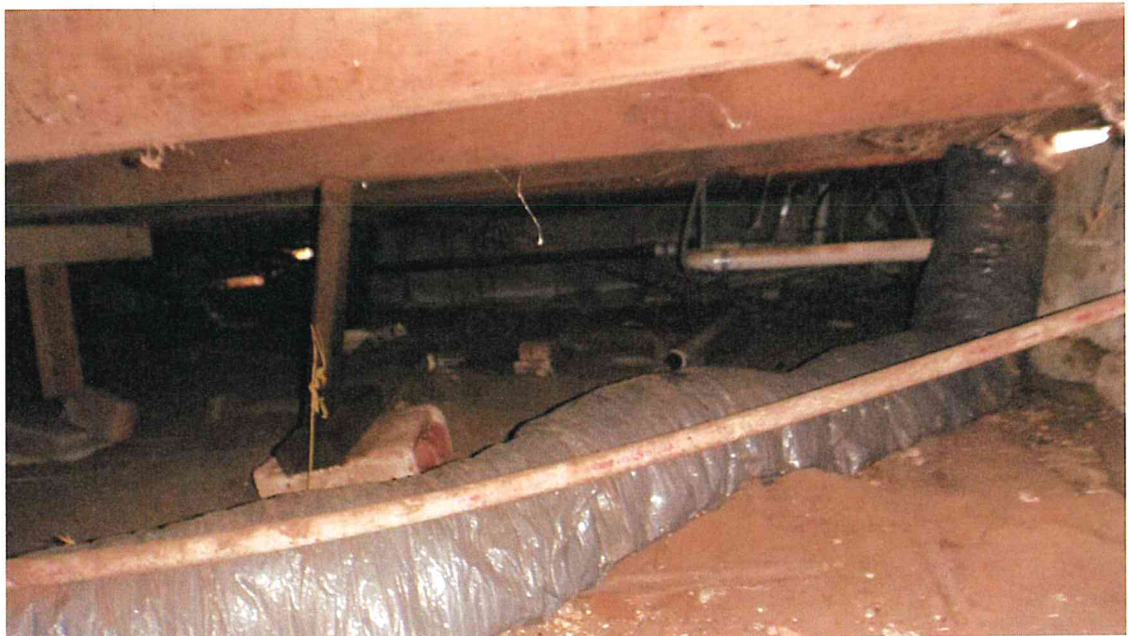
West side of house under kitchen.

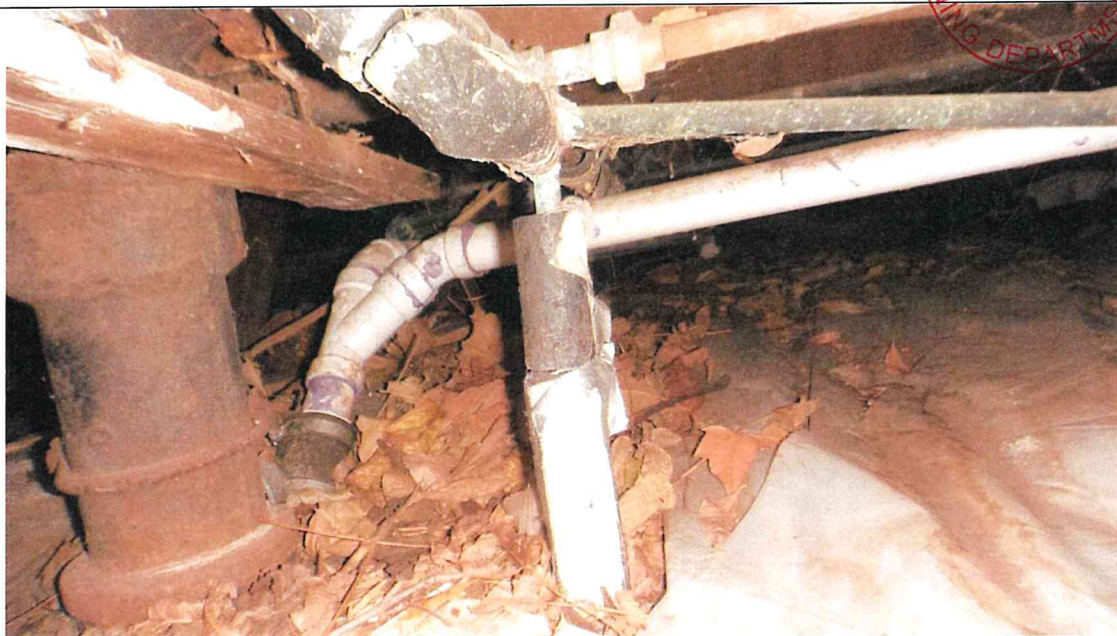
View of crawlspace at south access hatch.

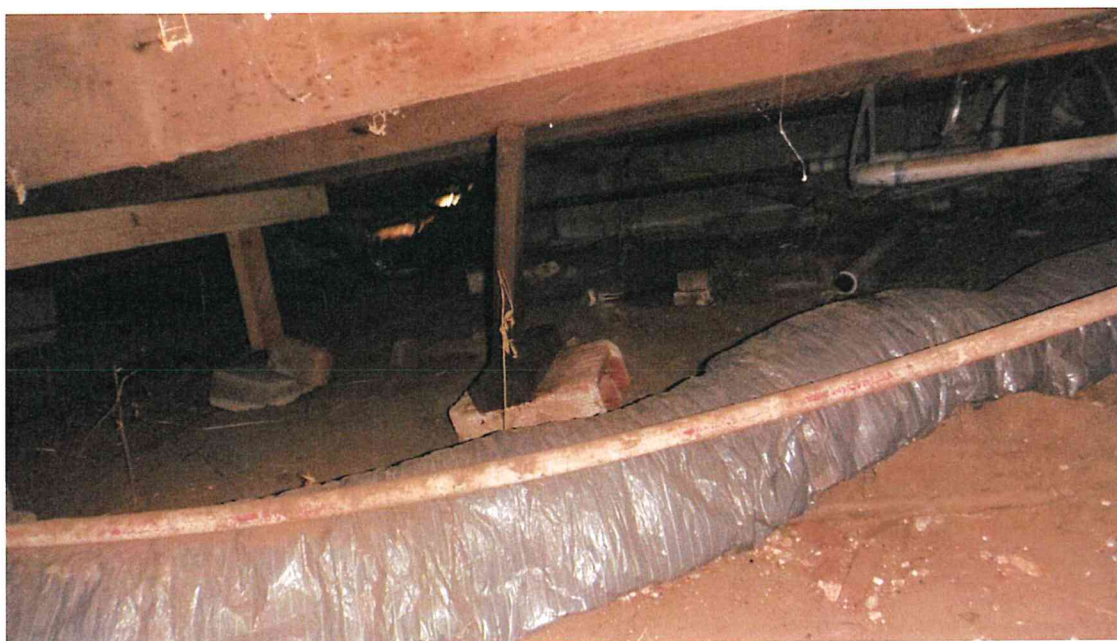
Center of house looking south.

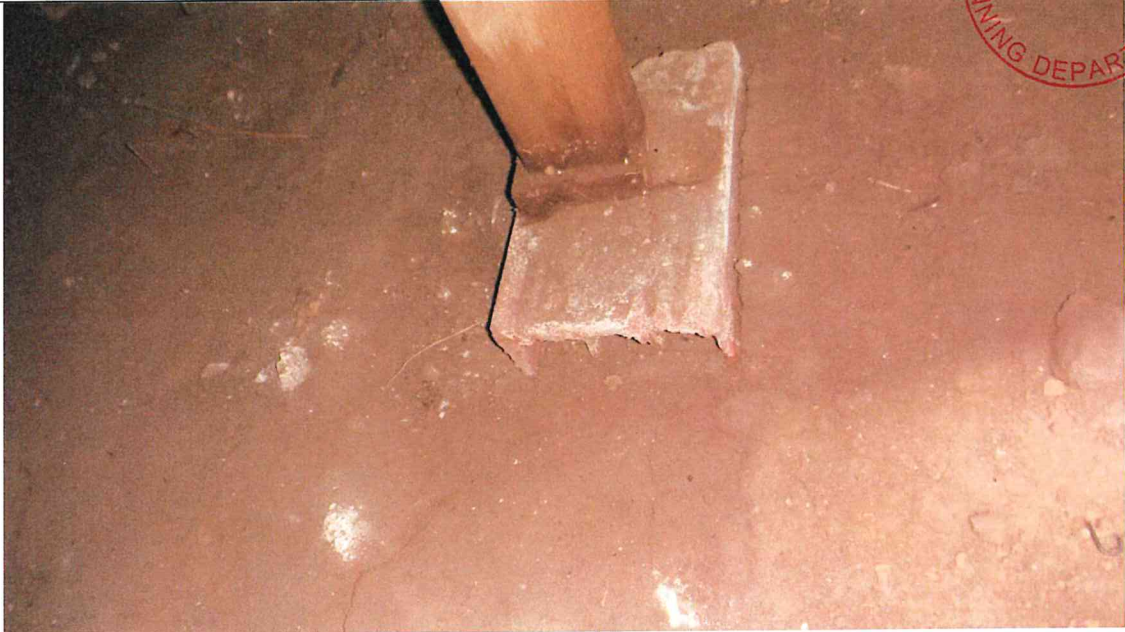
The floor of the house deflects significantly under foot load. An inspection below the house in the crawlspace indicates that the post and beam bracing for the floor are partially sunken or not in contact with the blocks that are to support the loads. In a few locations, there are stacks bricks that are leaning or fallen over. The perimeter foundation wall consists of stone that have shifted significantly and are no longer bonded together. Foundation shifting is noted in several locations within the house. Doors do not stay closed, and others are difficult to close. Rub marks from misalignment of frames is common in several locations. There are two significant trees growing next to the house that are in such proximity, that they appear to be causing the foundation to heave. One tree is at the back door and the other at the NE corner of the house. These trees are both 16 inches to 24 inches in diameter. There are several others between the subject house and the house to the east that may pose a hazard with falling limbs.

Clay brick support for post and beam. Partially sunken.

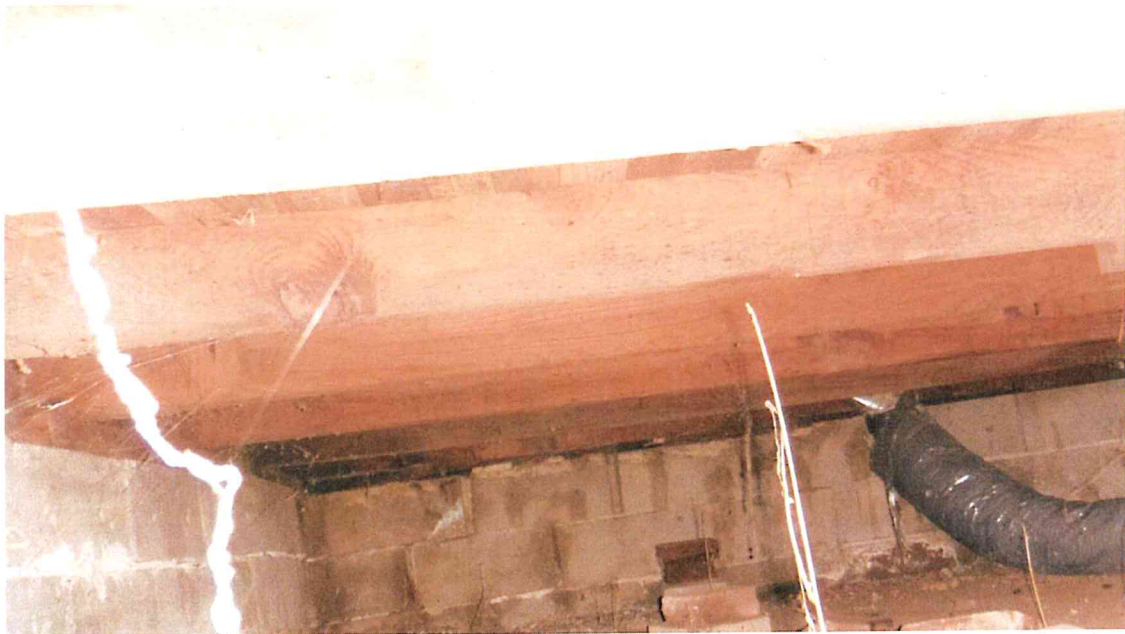
West foundation wall from crawlspace. Block knocked out of alignment or broken bond.

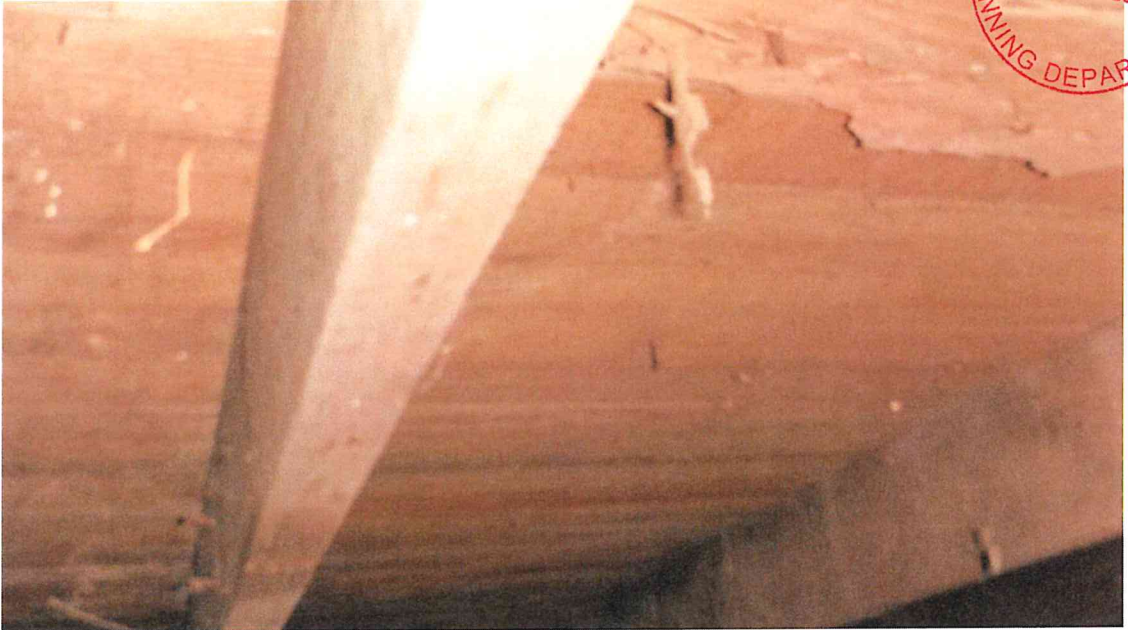
Split sub-floorboards and termite damage evident.

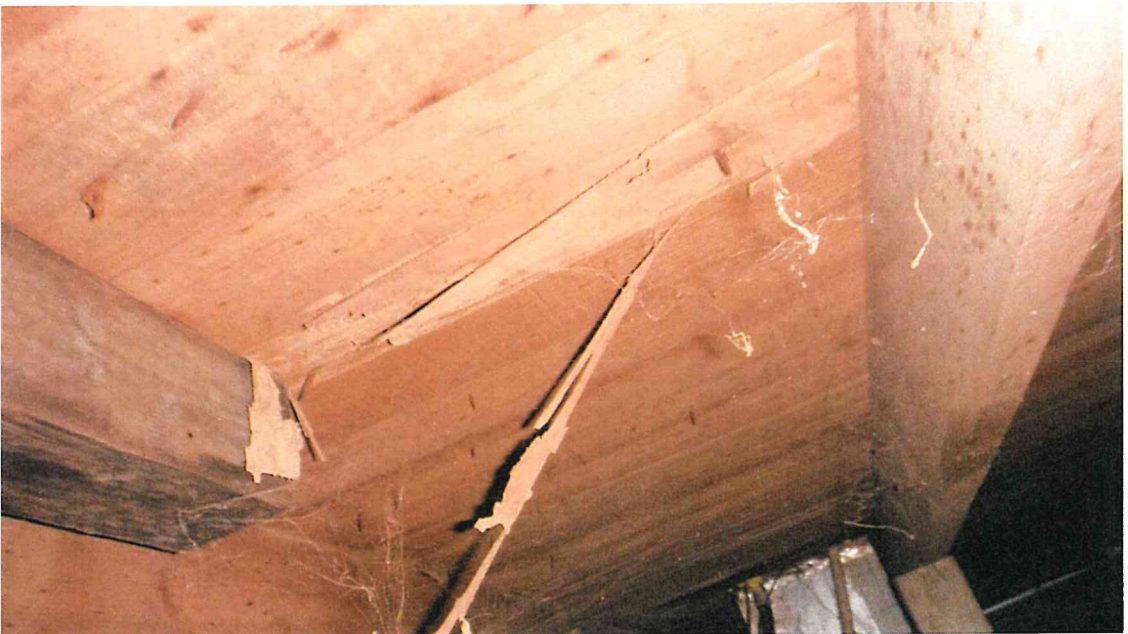
Split sub-floorboards and termite damage.

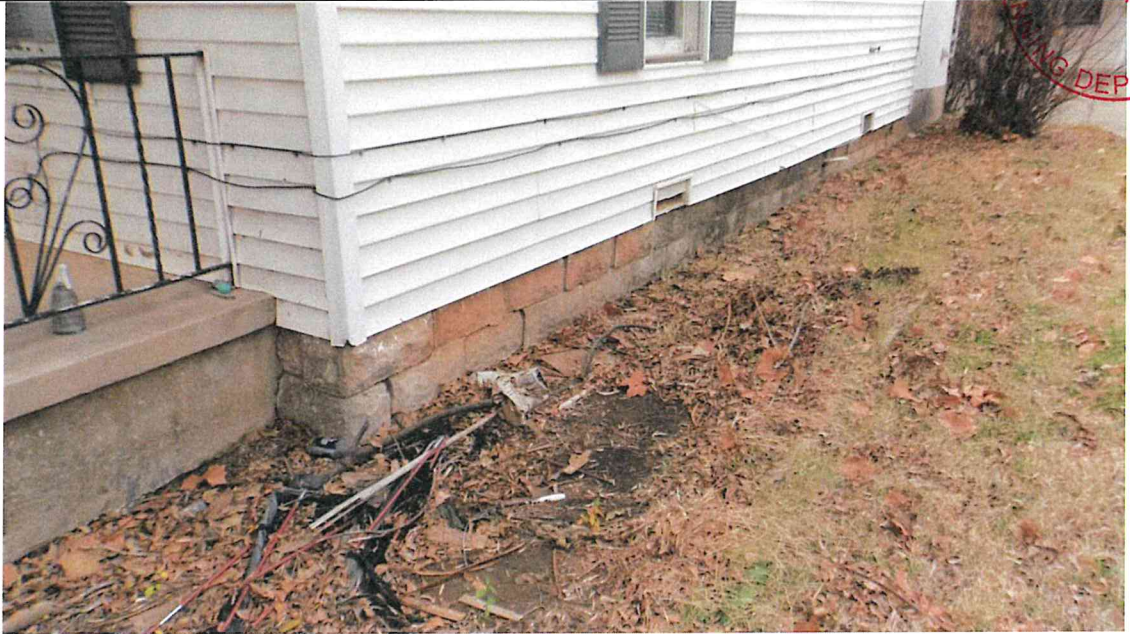
NW Corner of house foundation blocks

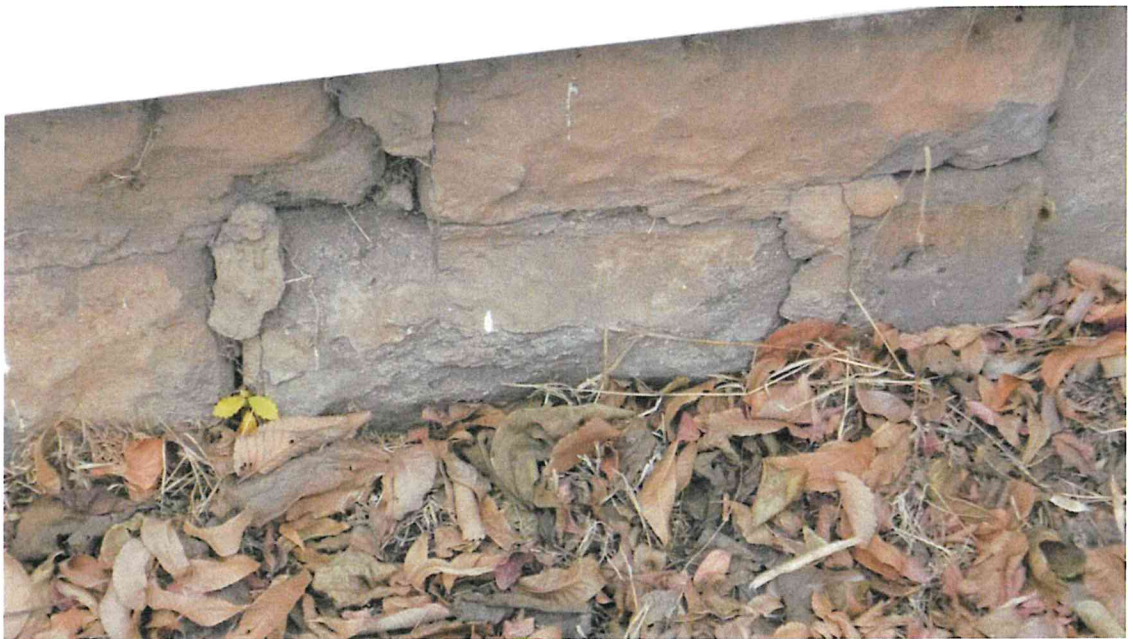
West foundation wall.

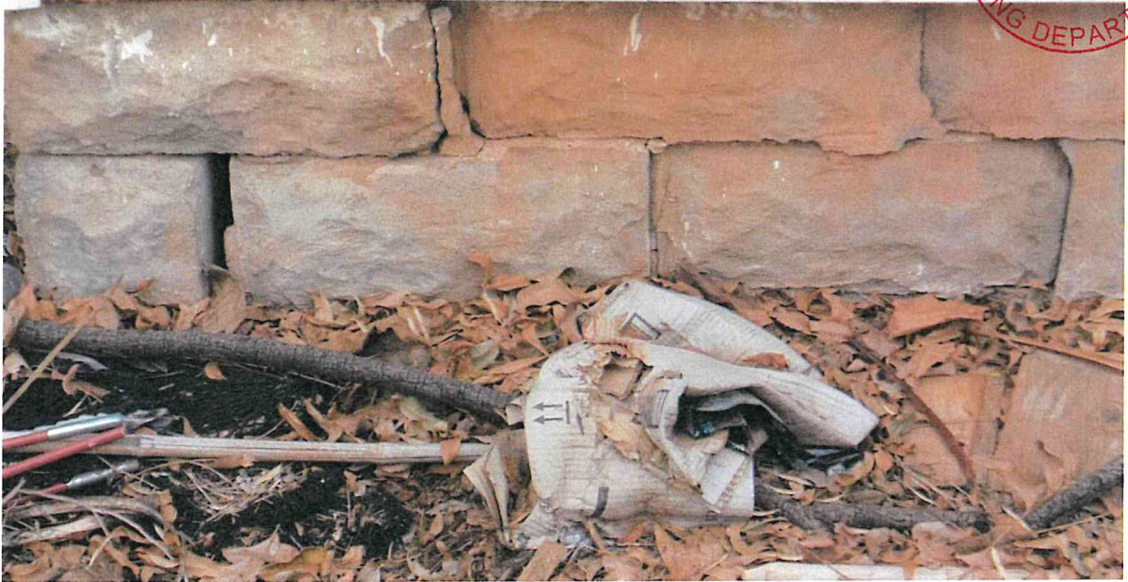
West foundation wall blocks out of alignment and movement evident.

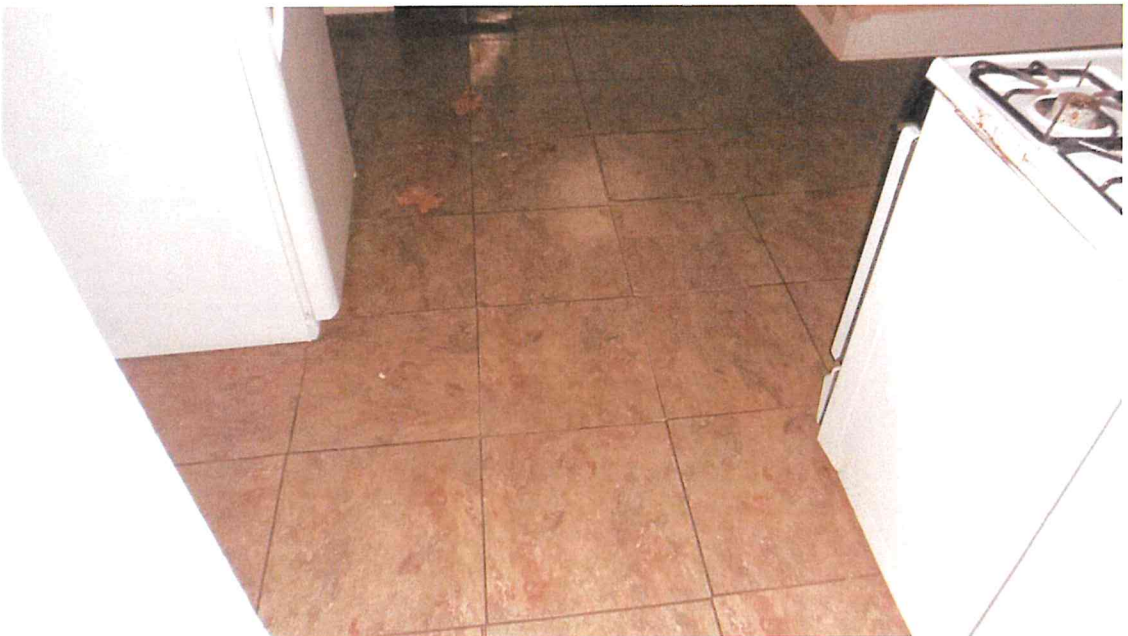
Floor in kitchen deflects under foot load.

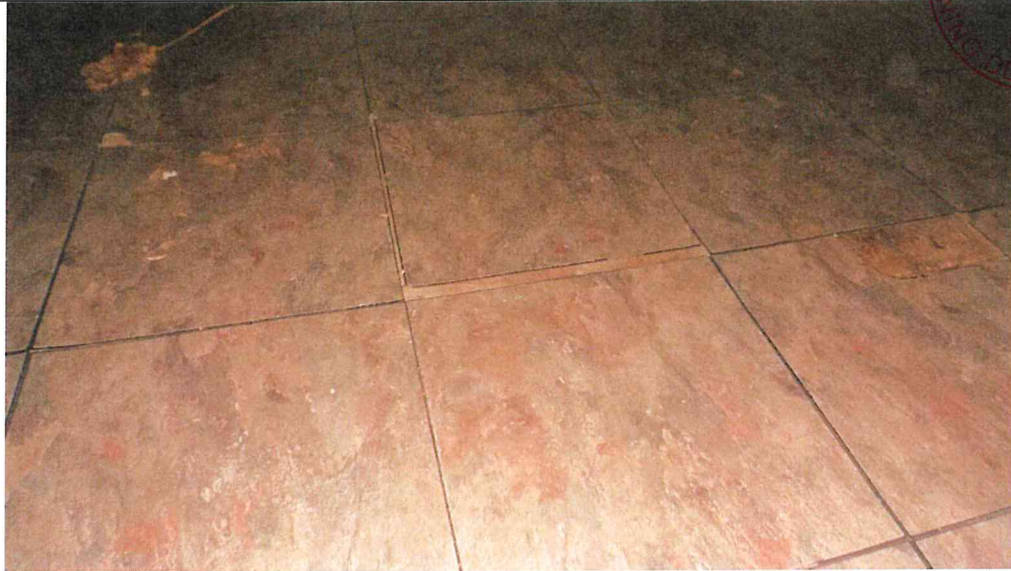
Tiles unbonded and loose.

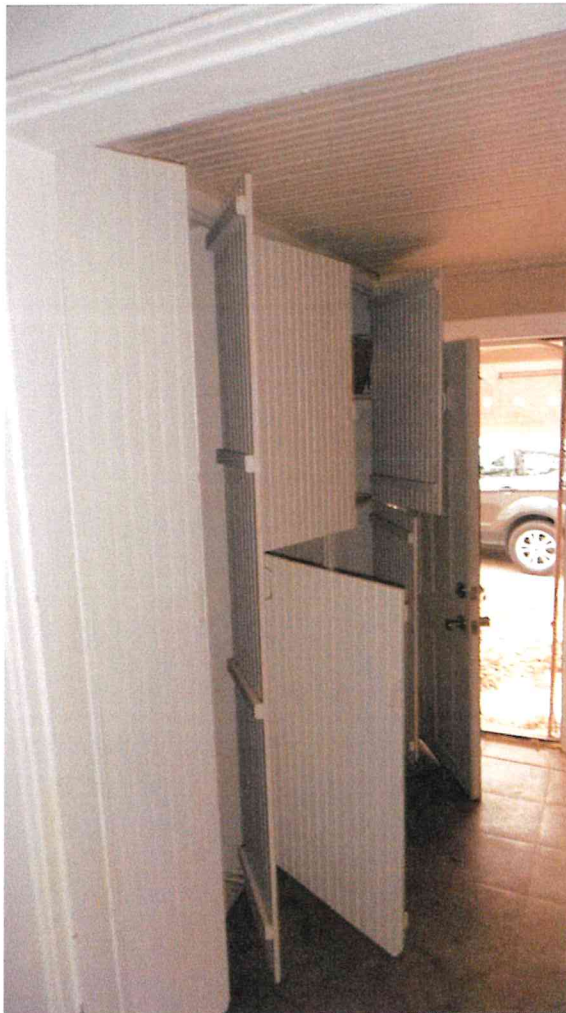
Doors in utility room cabinets swing open due to non-level floor.

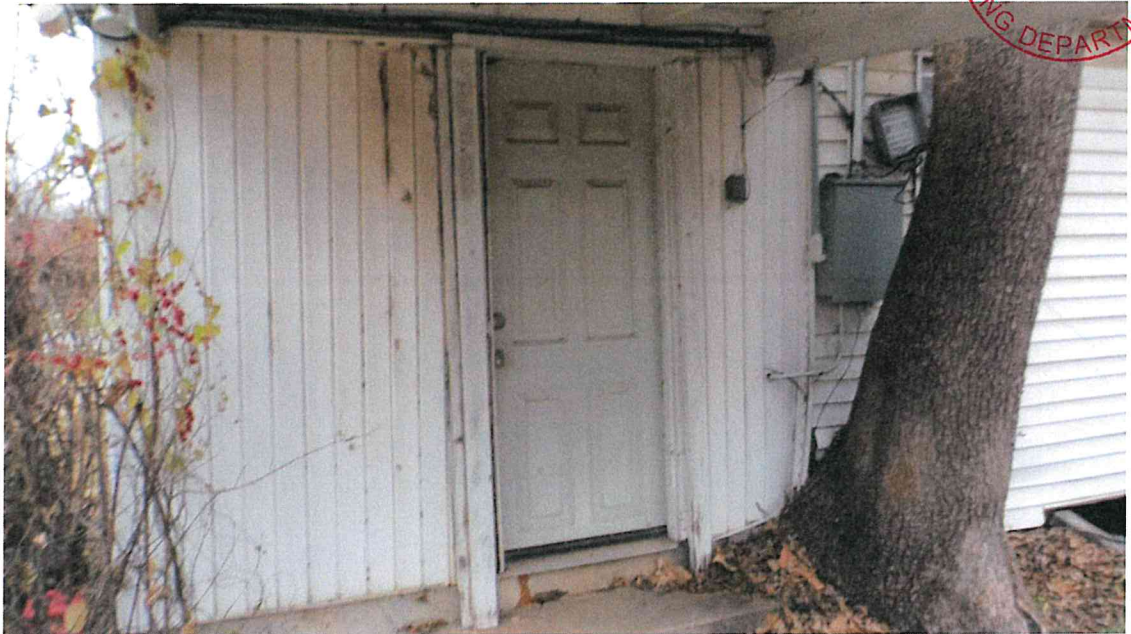
Tree growing out of base of foundation and causing floors to heave.

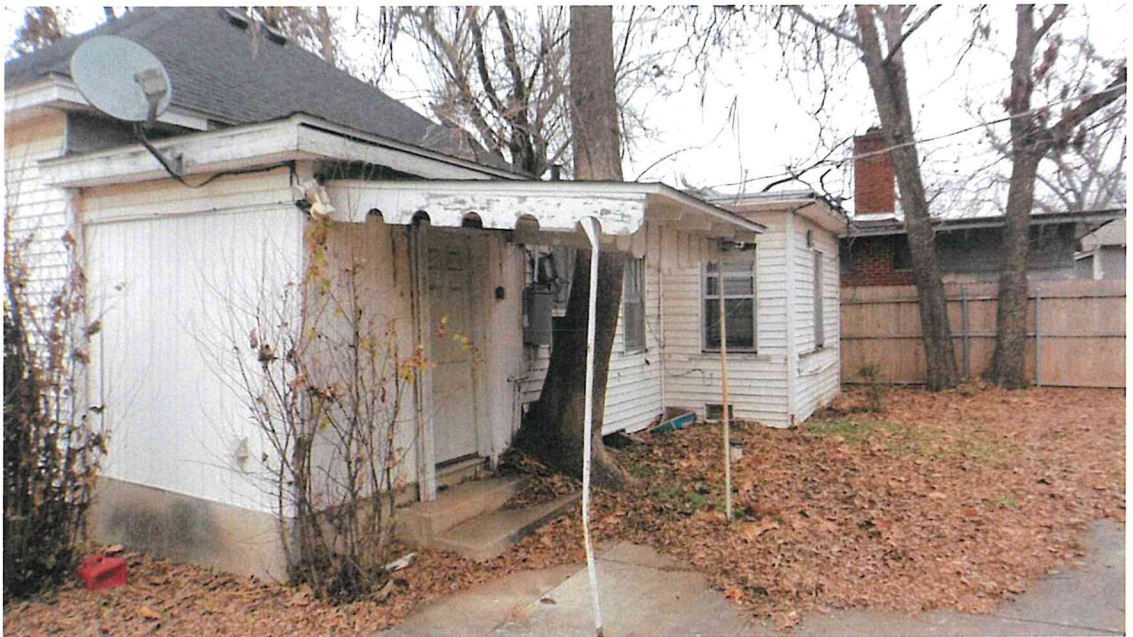
Back porch utility room located at back door.

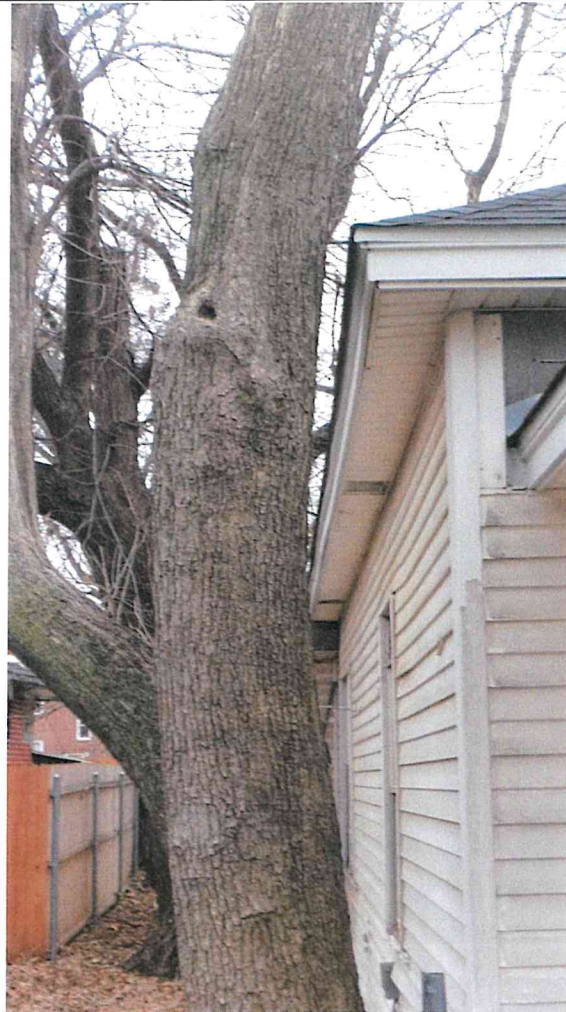
Tree at NE corner of house growing out of foundation base.

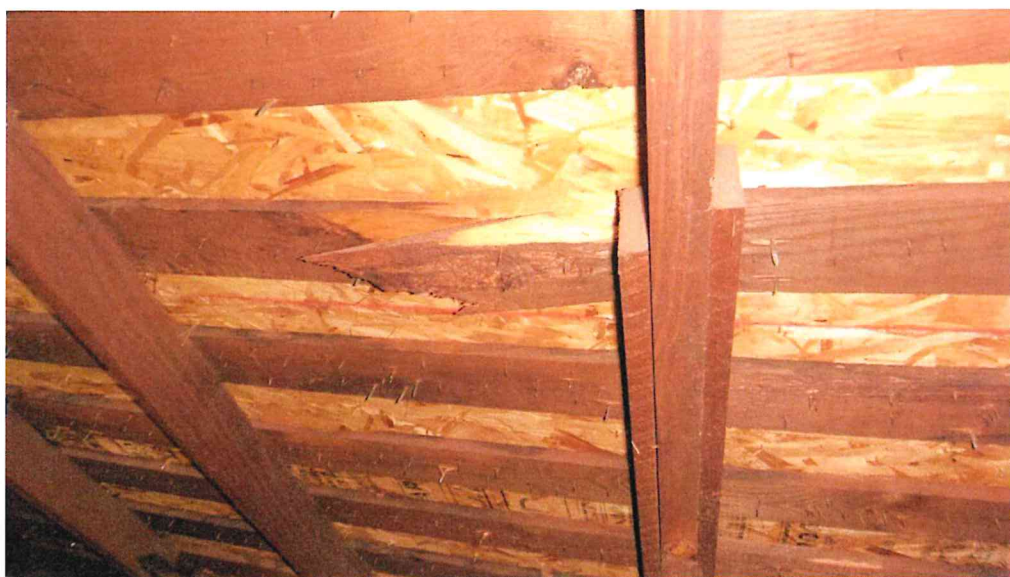
OSB sheathing applied over existing 1 X 6 spaced sheathing boards.

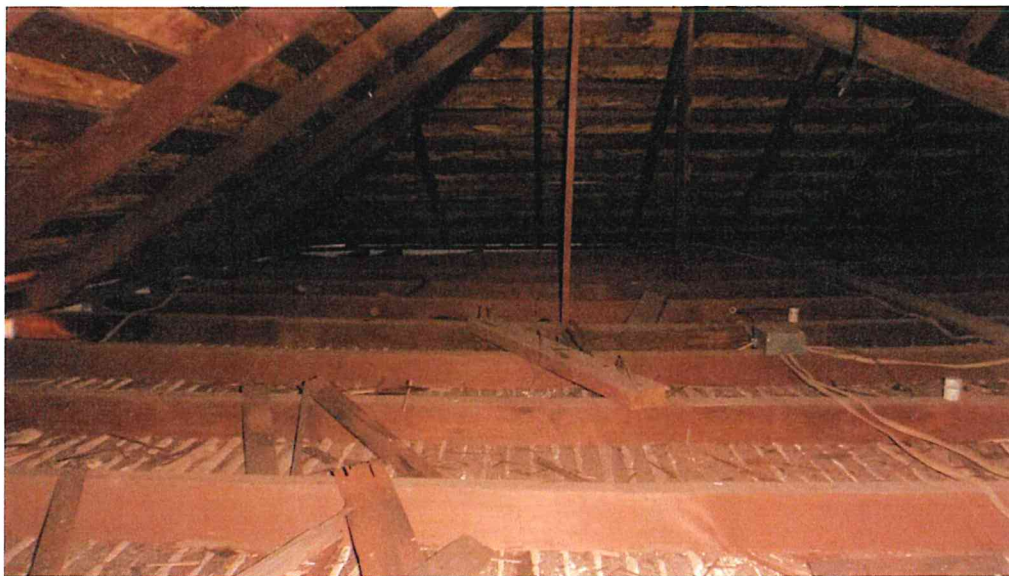
Signs of previous fire in attic. No insulation in attic.

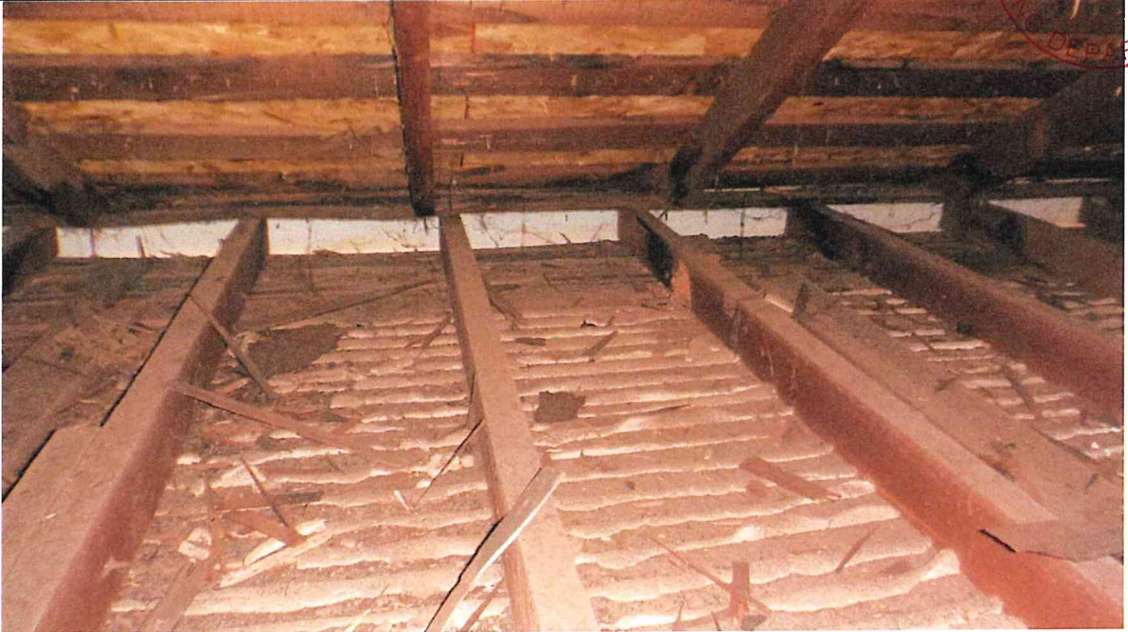
Construction debris left from previous sheathing replacement.

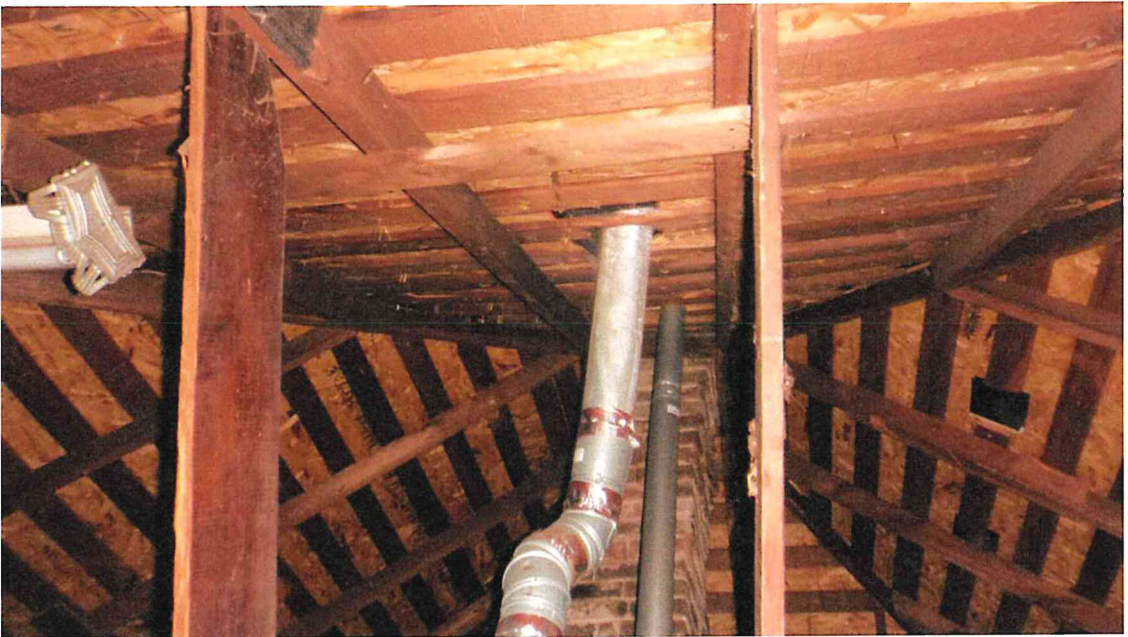
Charred framing in attic. Significant sagging of roof.

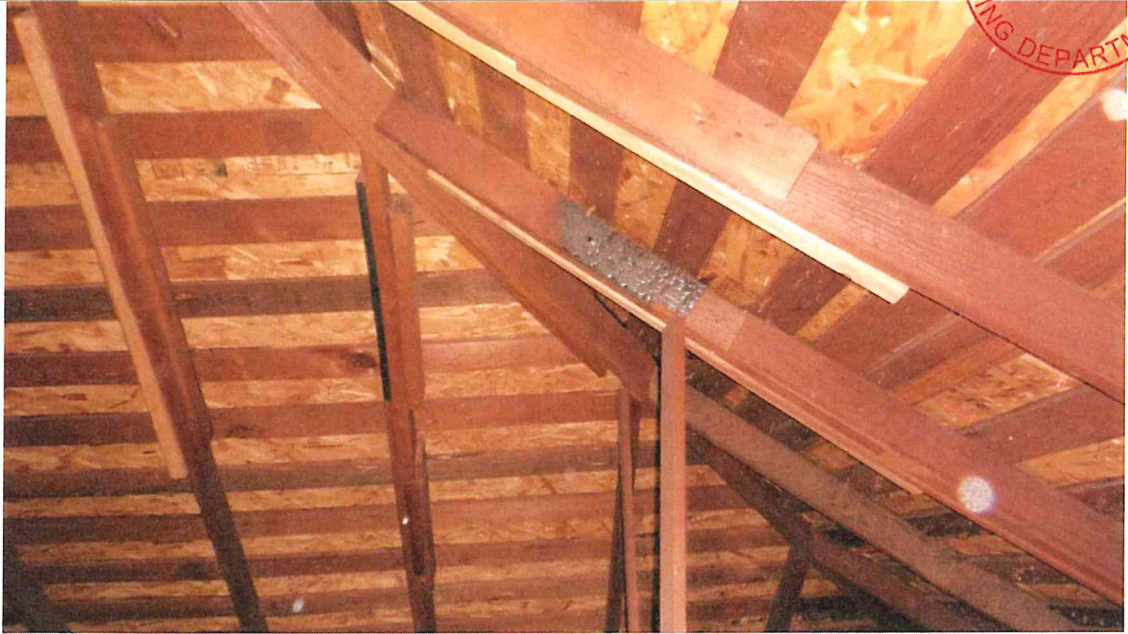
Previous repairs to rafters and recent addition of wind bracing.

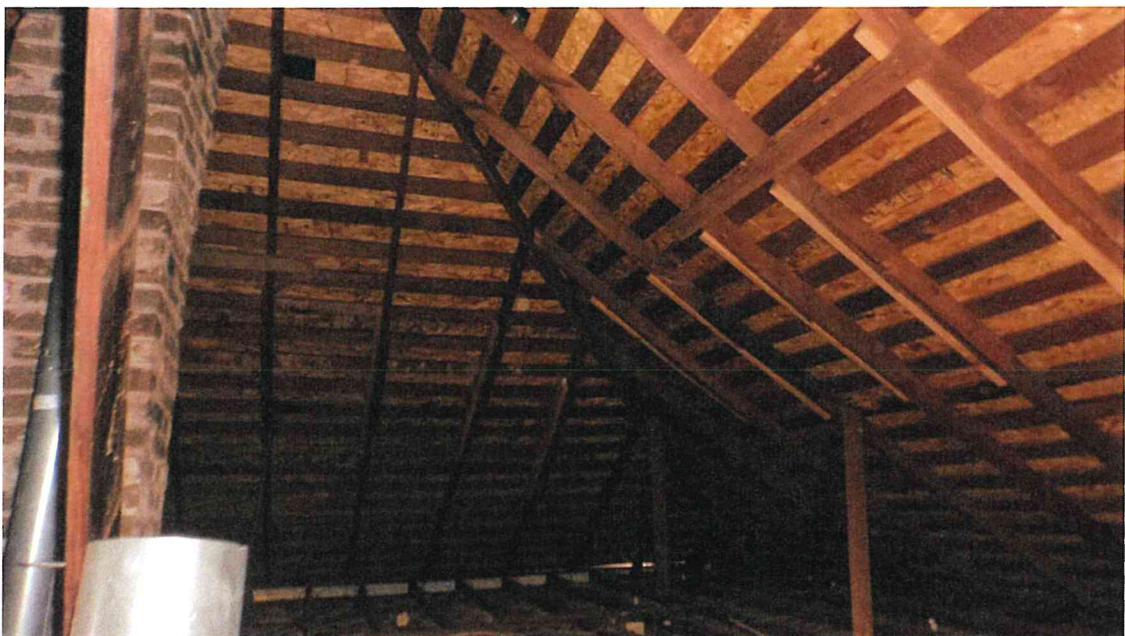
Sway of roof deck evident in attic.

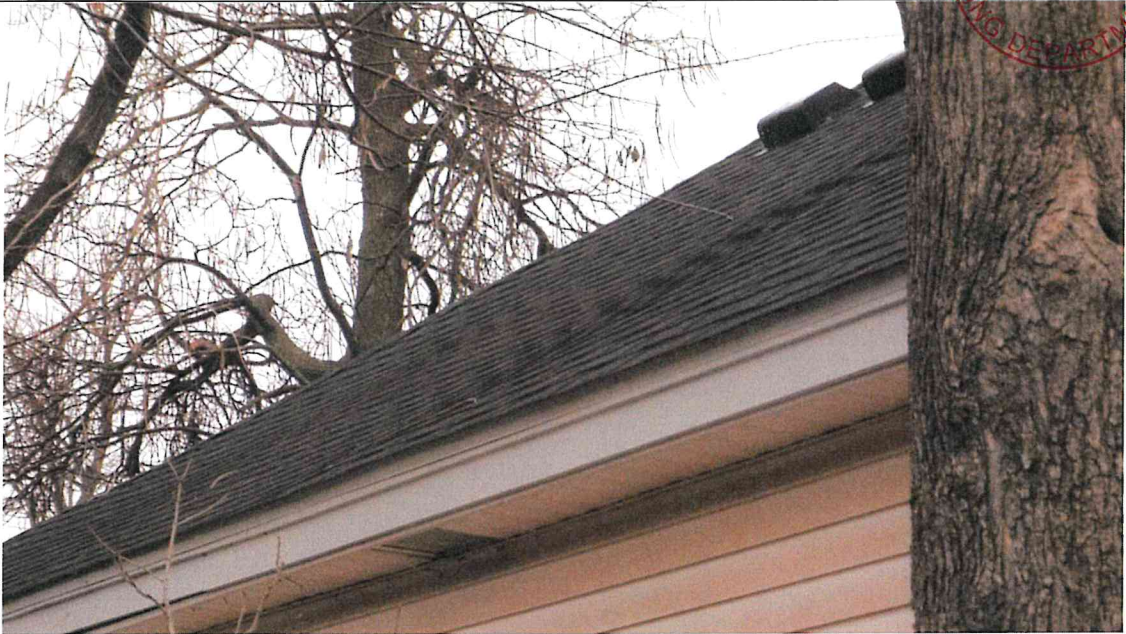
The roof framing consists of the original rafters with spaced sheathing of 1" X 4" boards. Each of the hip roof faces is sagging toward the center of each face. Inspection of the attic revealed the OSB

Roof sagging on all four faces of hip roof.

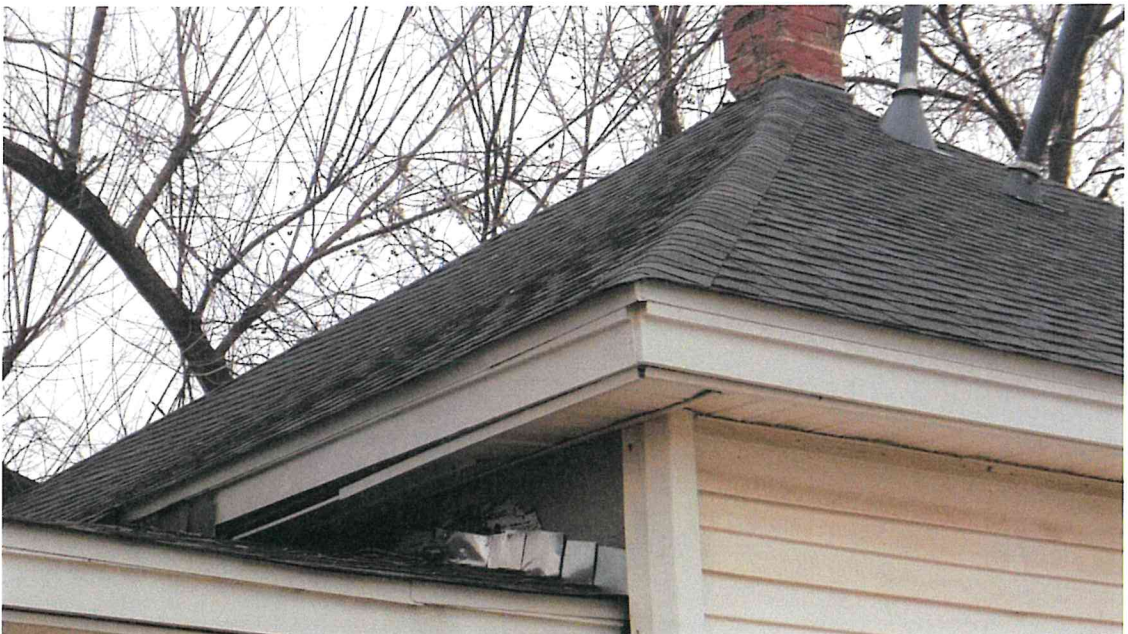
Roof sagging evident.

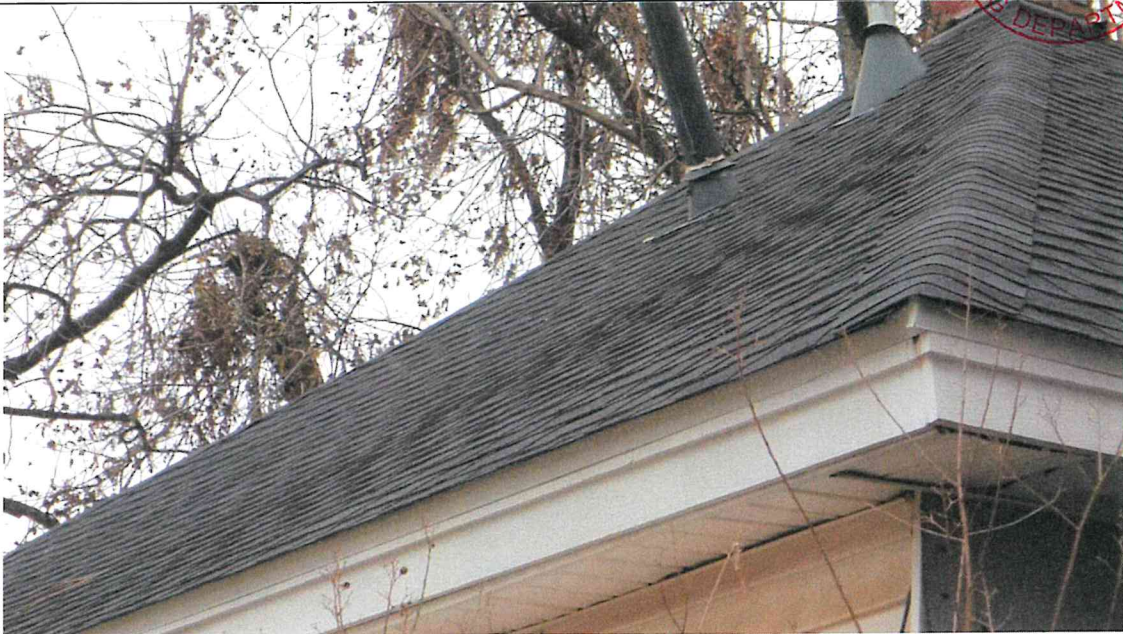
Roof sagging evident.

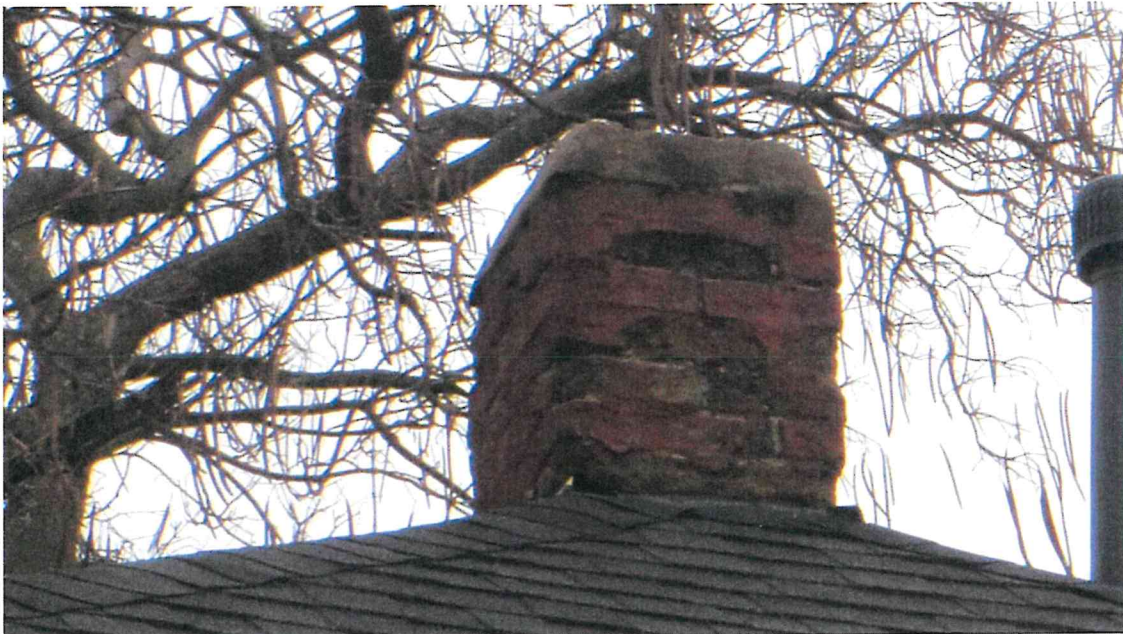
Decomposing brick and mortar of chimney at center of house.

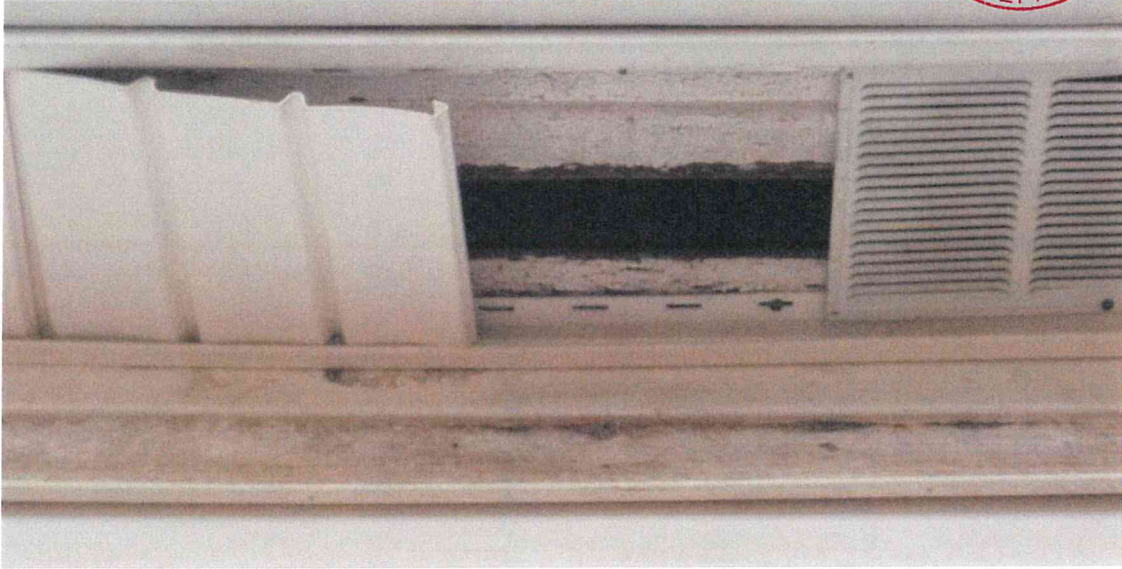
Rotting and decomposing wood at soffits.

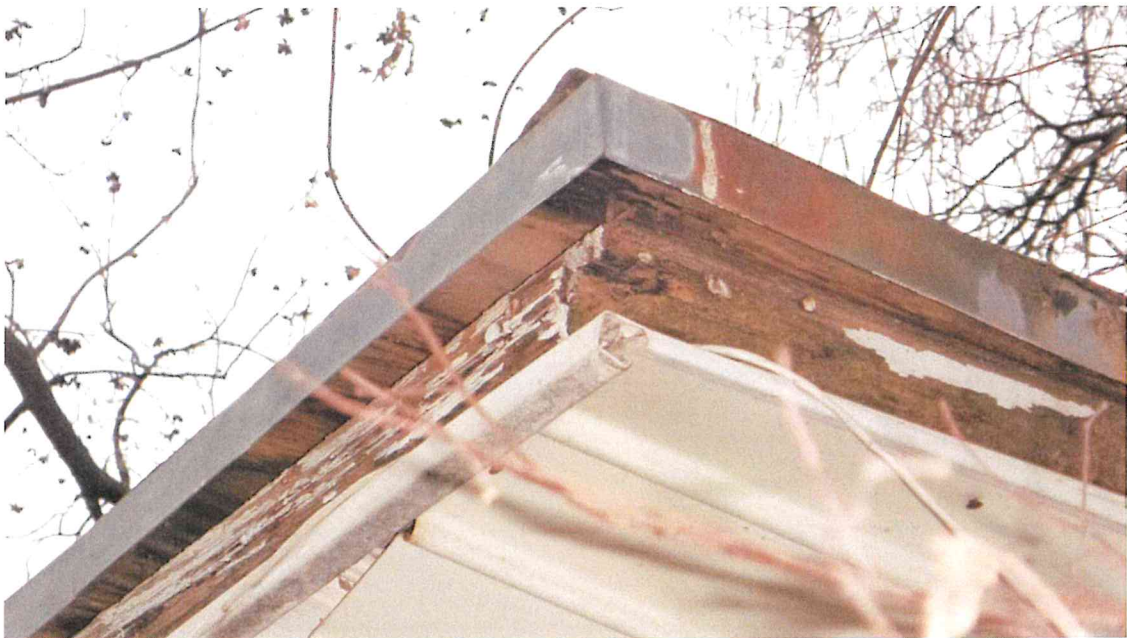
Actively rotting wood exposed at roof edges.

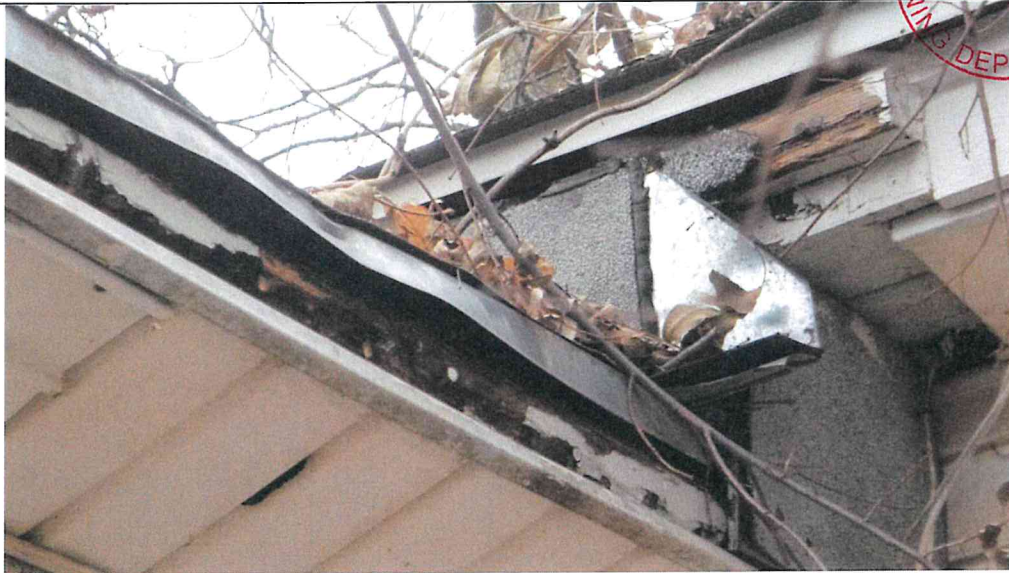
Damaged flashing and rotting wood at roof edges.

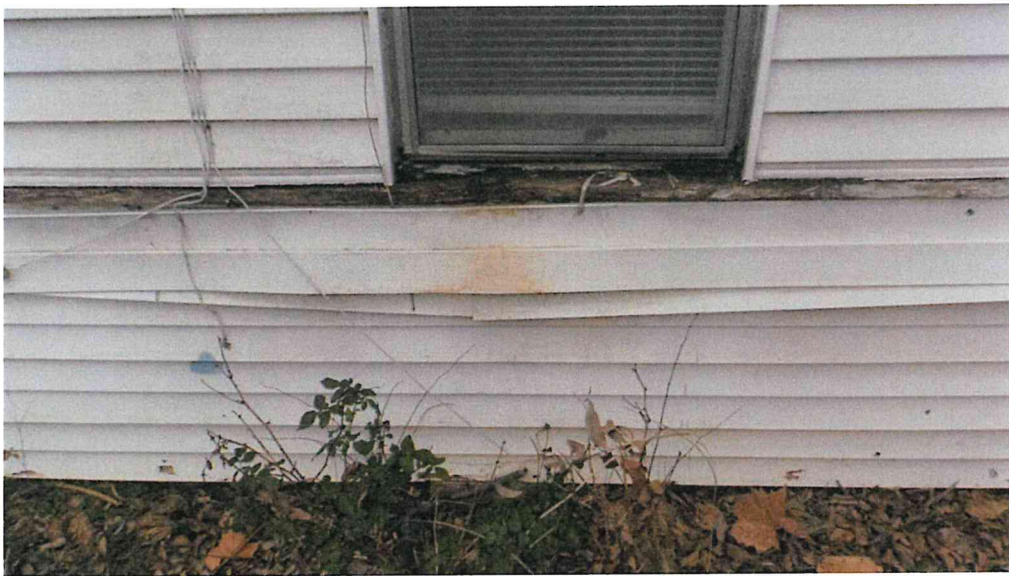
Rotting wood at windowsills all around the house.

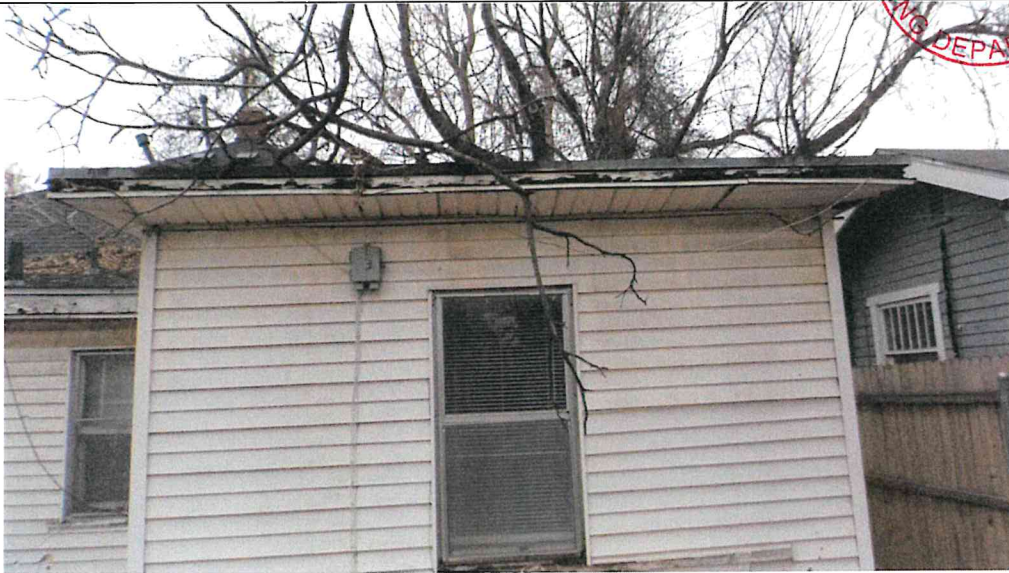
Damage from falling tree branches on back room.

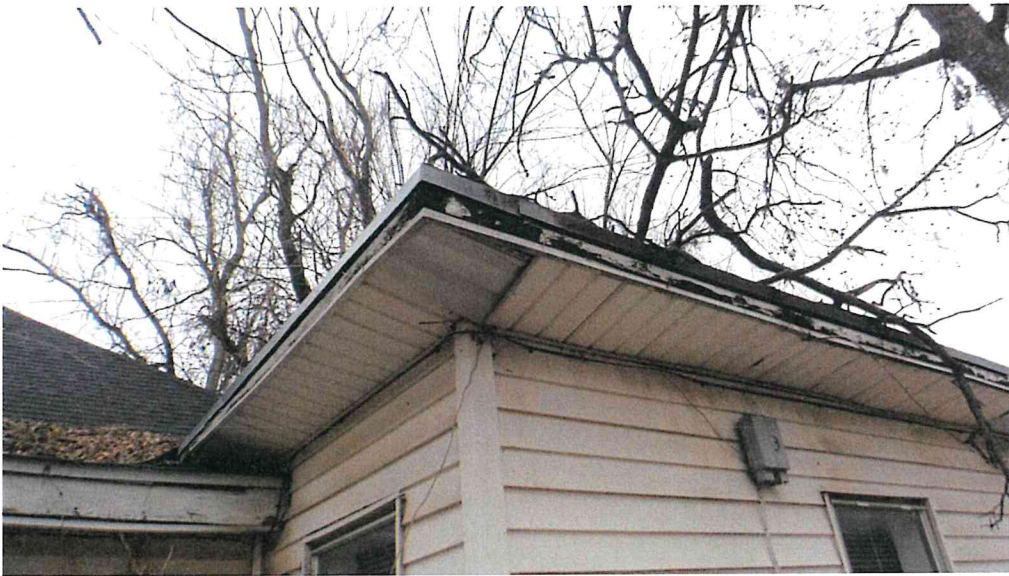
Roof damage from falling tree branches.
