APPLICATION FOR CERTIFICATE OF APPROPRIATENESS

Location of Proposed Work (Address): 424 NW 17th Street

FIELD INSPECTION REPORT

Project Name 427 NW 27th, Block 13 Lot 19 of
Jefferson Park Addition Project Number 5681
Date 12-21-2023 Type of Work Property condition assessment
Report Number 1 Reported By: Tim Meltabarger, RCI

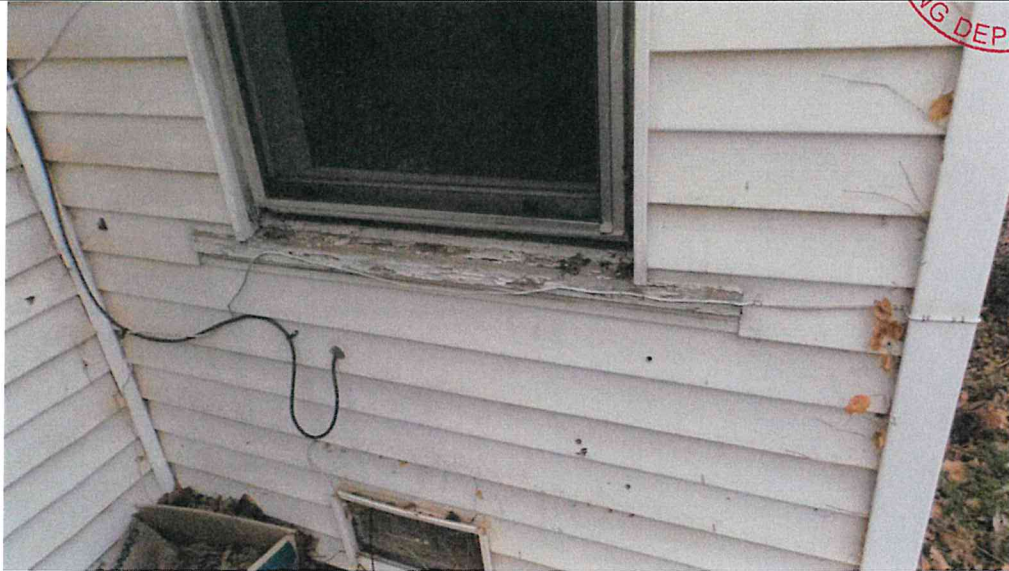
Rotting window sills.

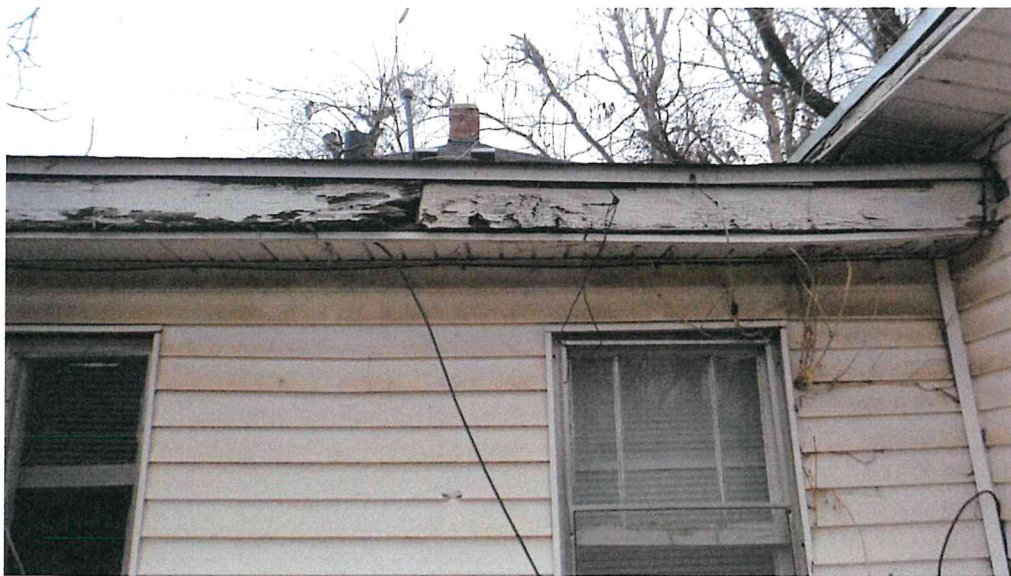
Rotting fascia. Plants growing out of siding.

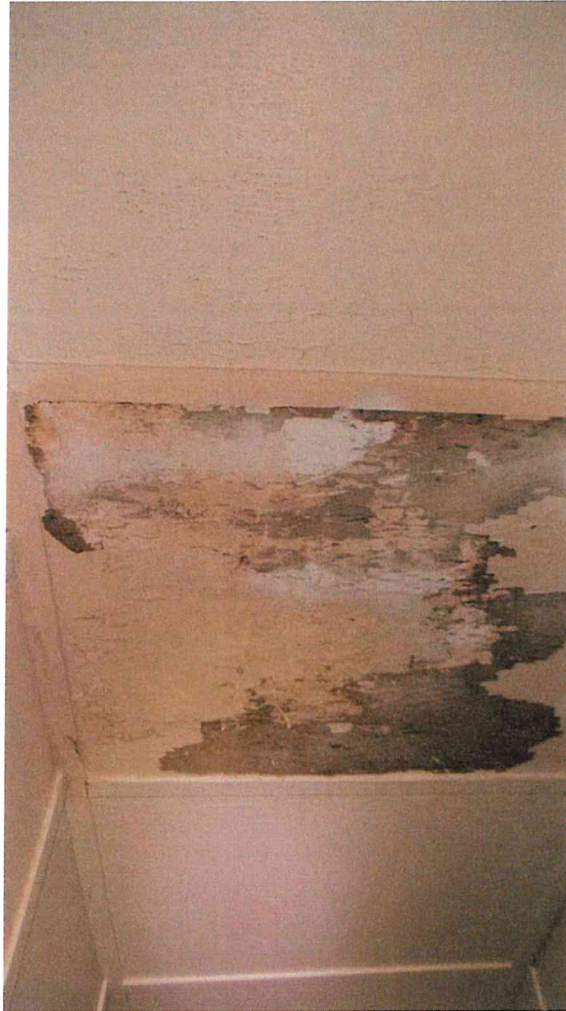
Ceiling panel in closet has water damage.

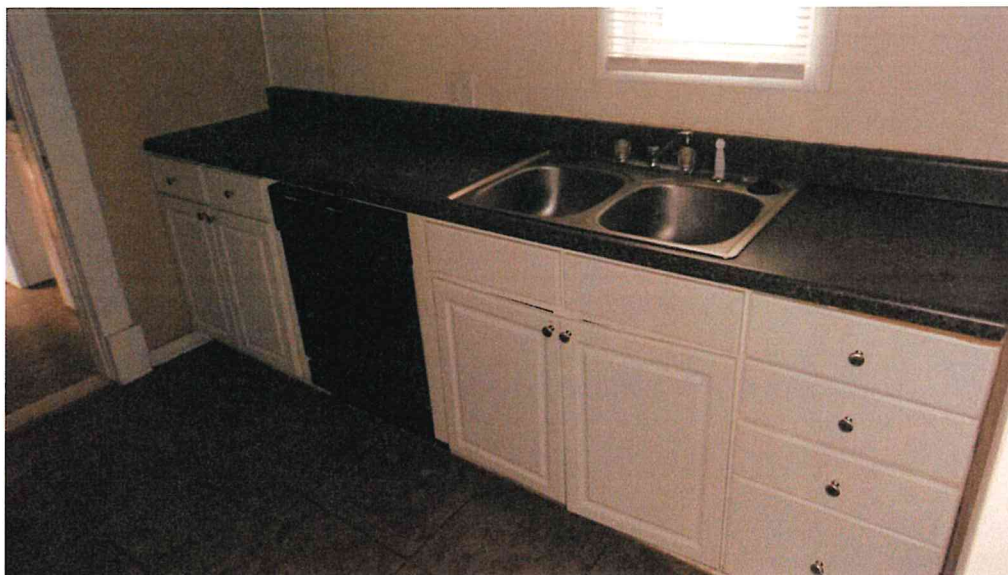
Newer cabinets installed over sagging floor.

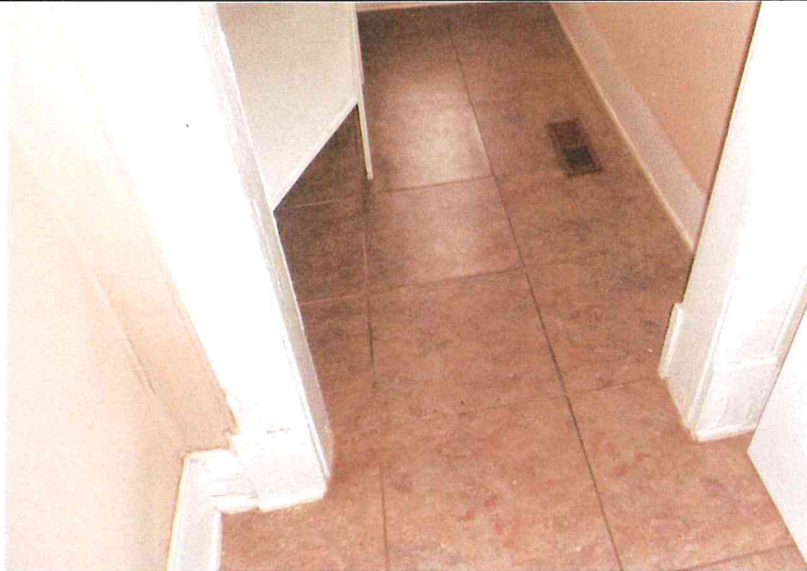
Loose tiles due to uneven floor.

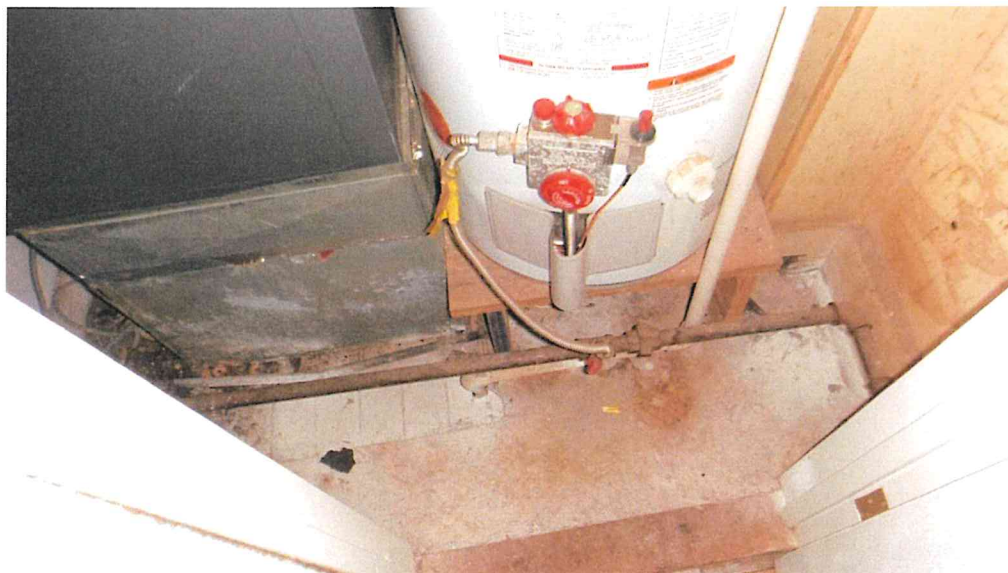
Water heater and furnace appear to be installed about the same time.

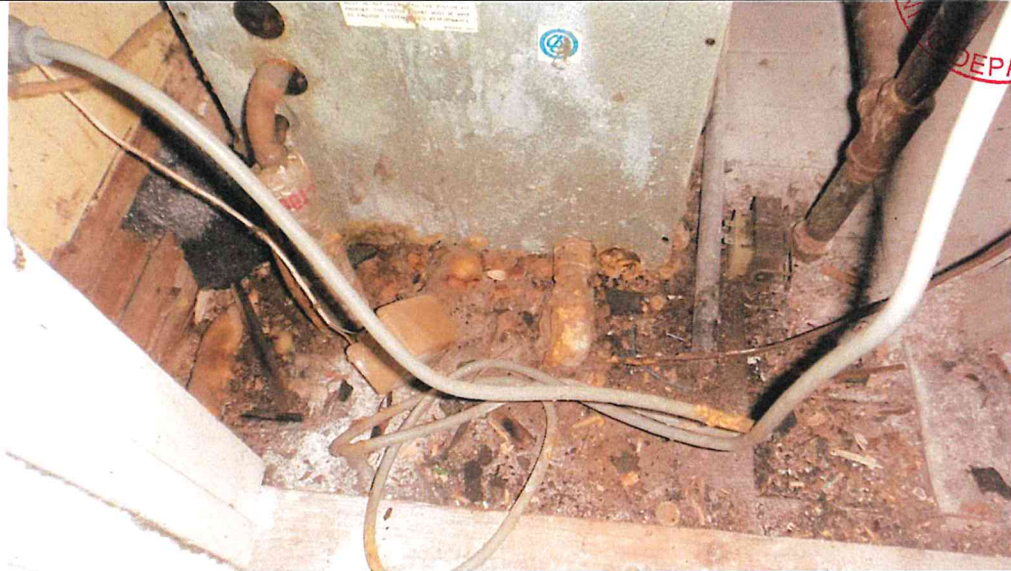
Evaporator unit for AC is badly corroded.

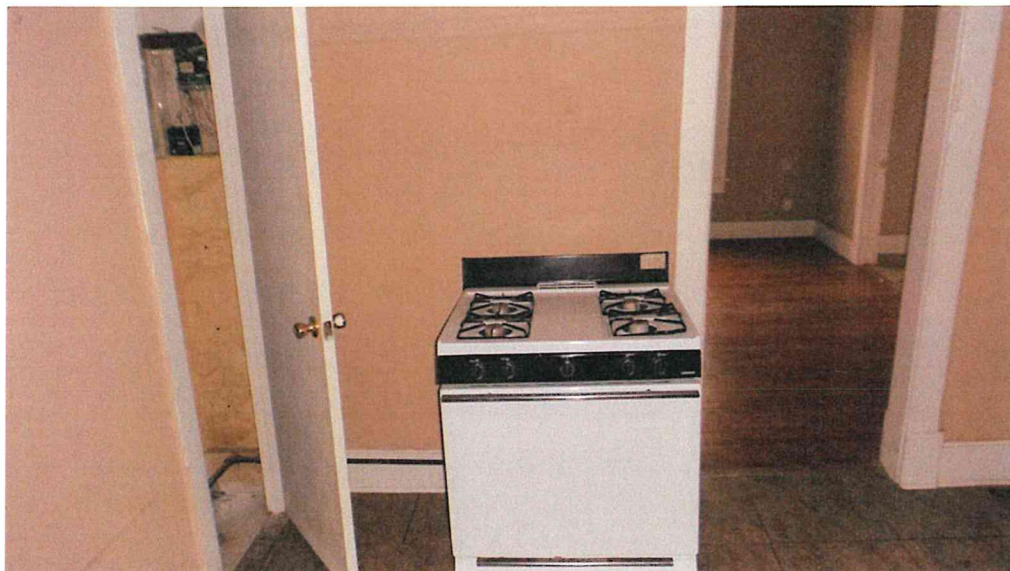
Gas range at kitchen next to water heater closet.

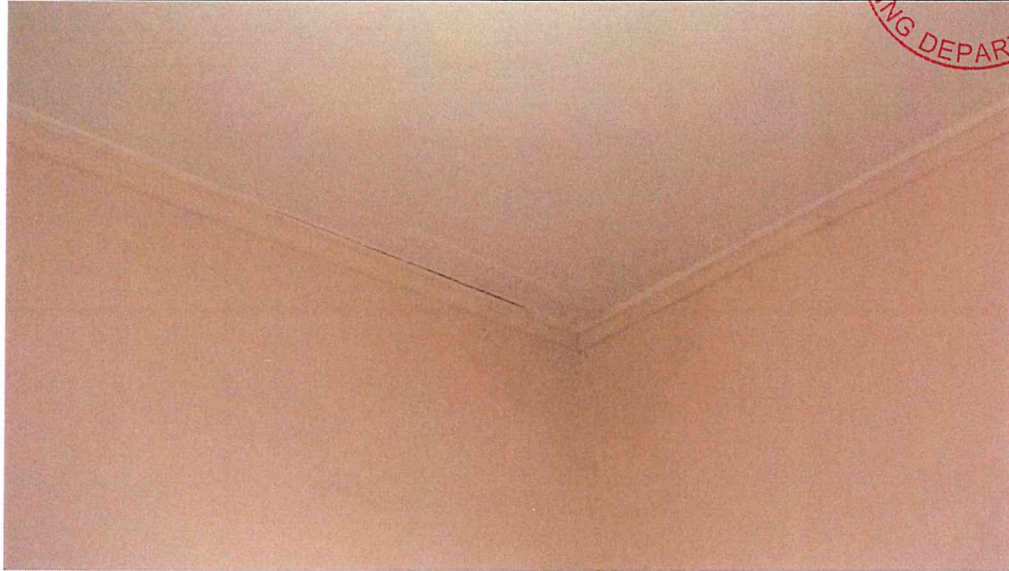
Water damaged ceiling

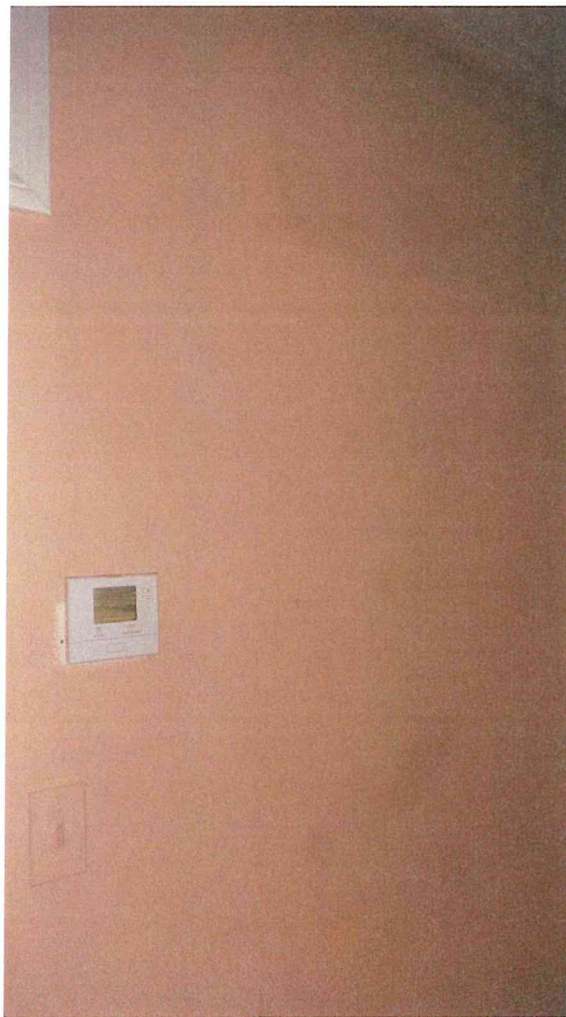
Water damaged walls

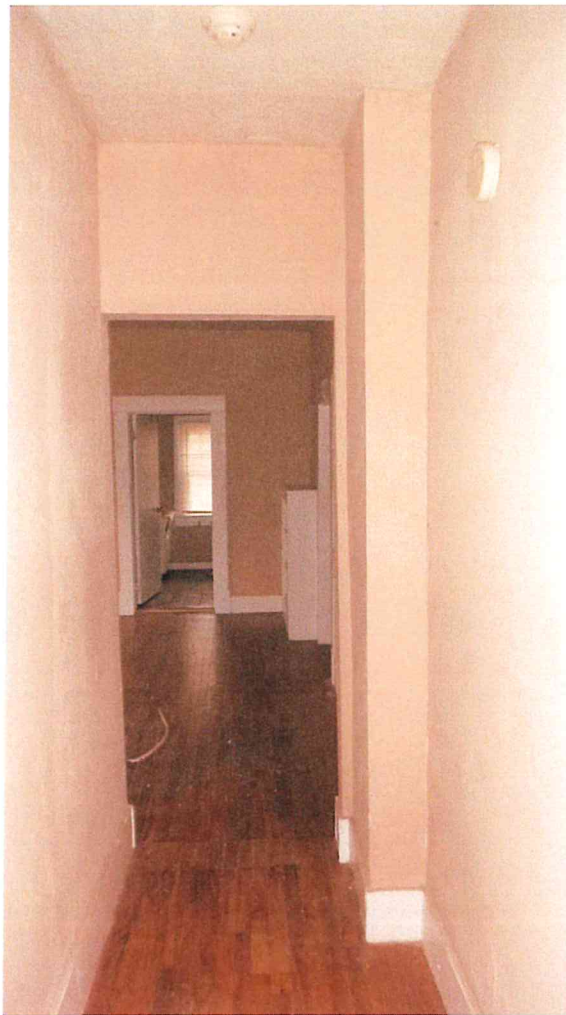
Uneven floor from front door to back bathroom

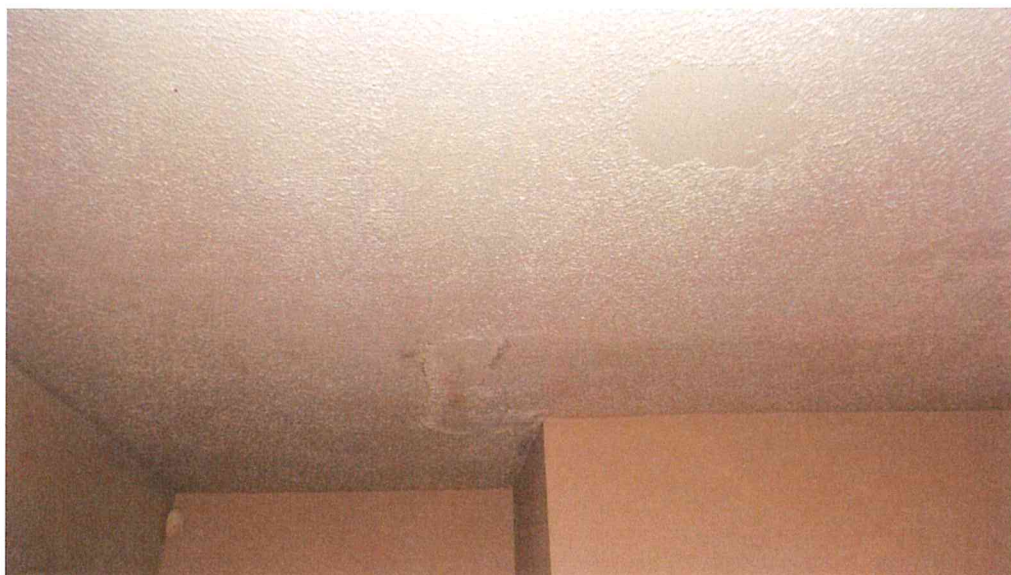
Water damaged ceilings.

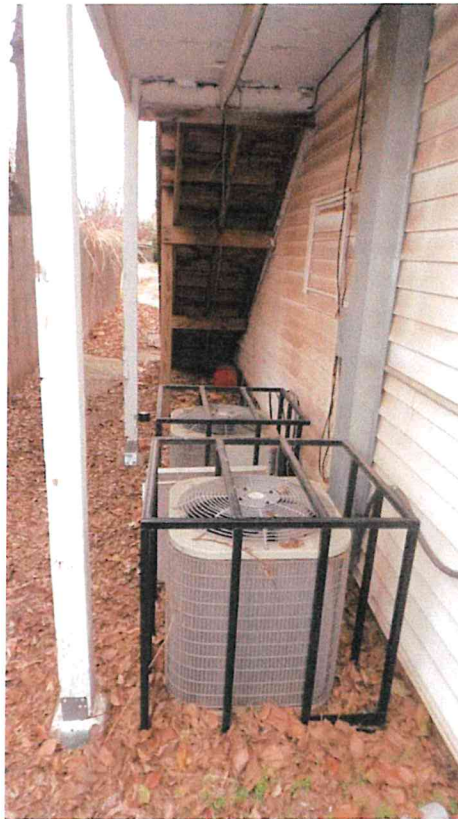
AC Compressor units under stairs in cages.

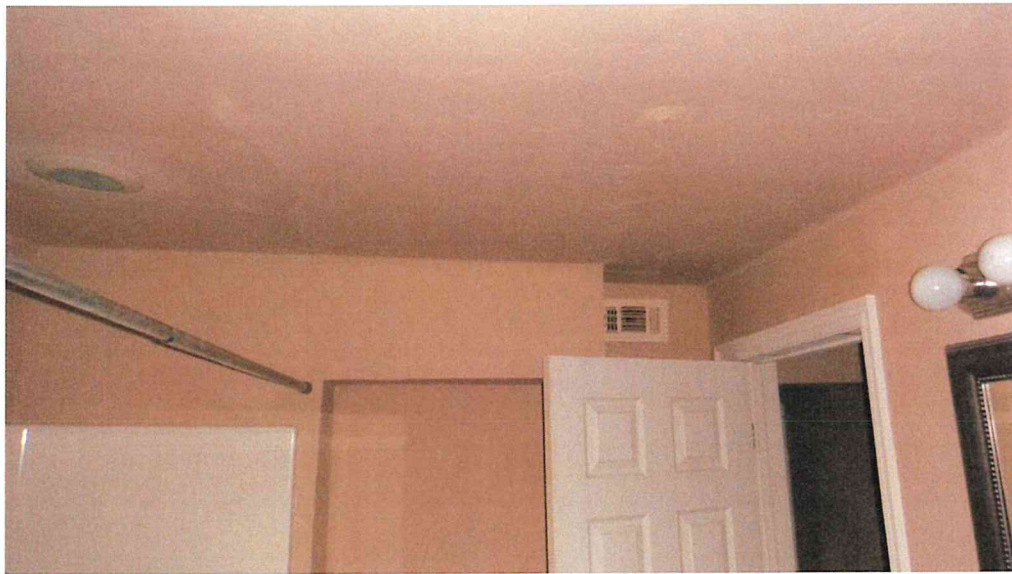
The ceiling shows warpage from water leakage in bathroom.

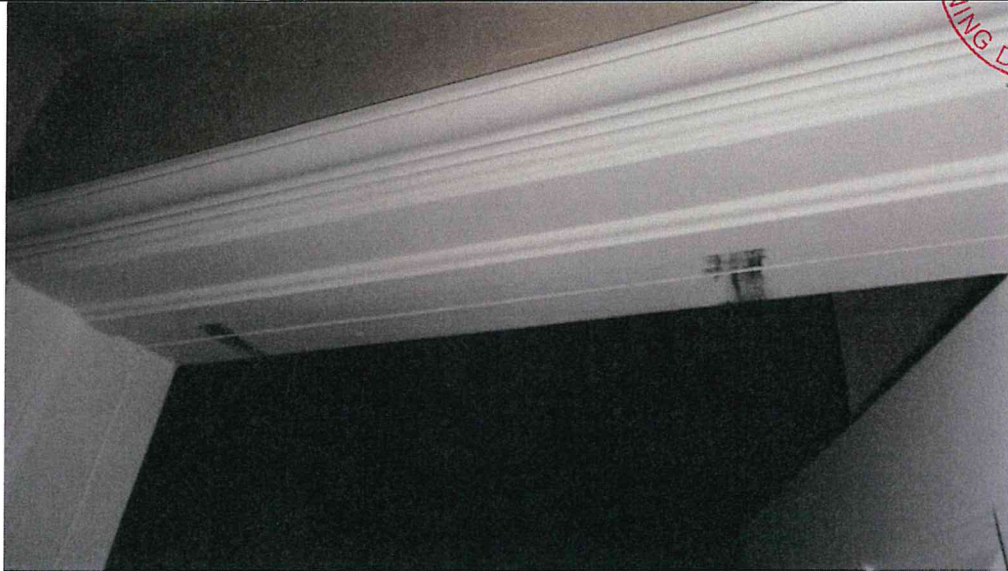
Door rub marks from building uneven settlement.

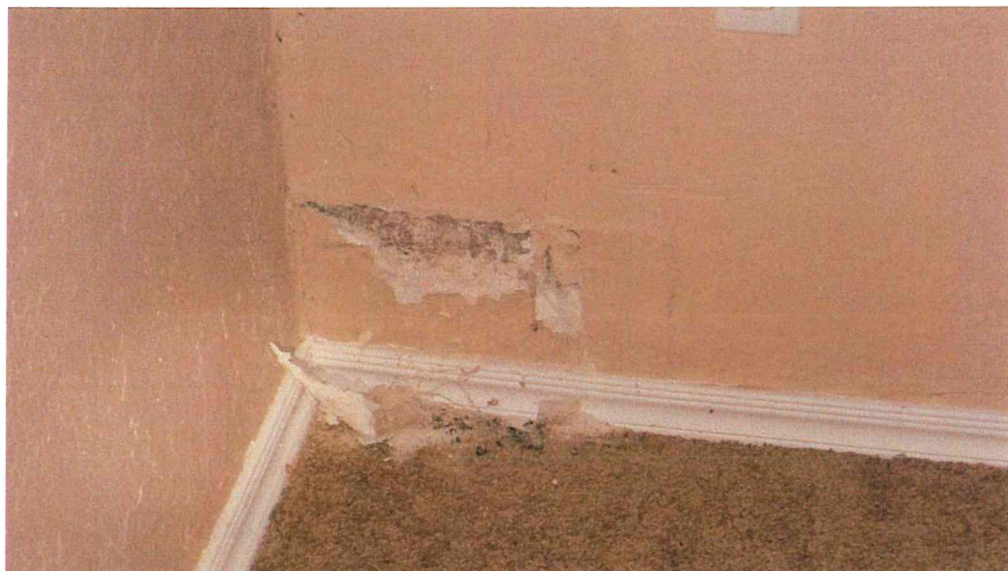
Water damage from floor up wall in front room.

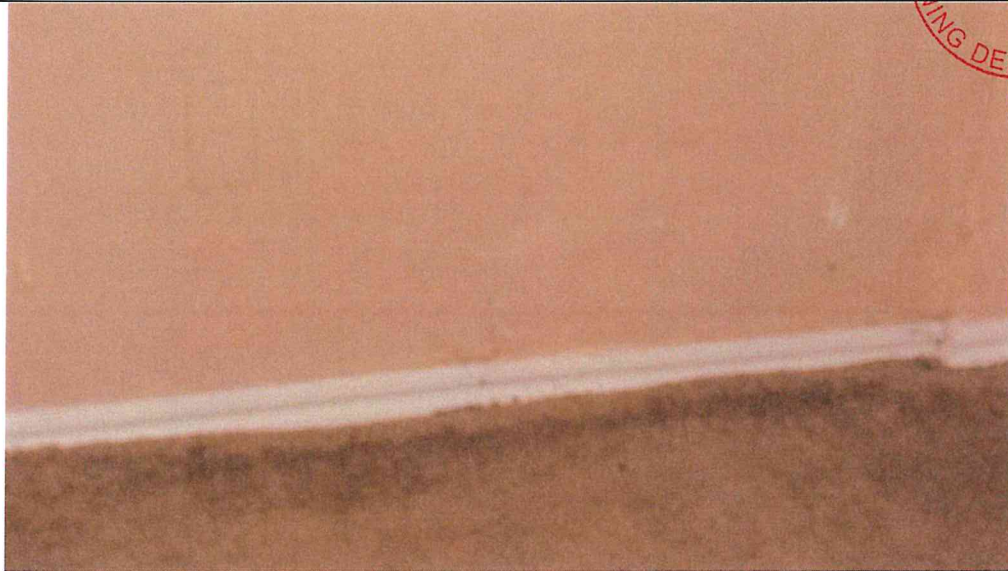
Water damage in front room

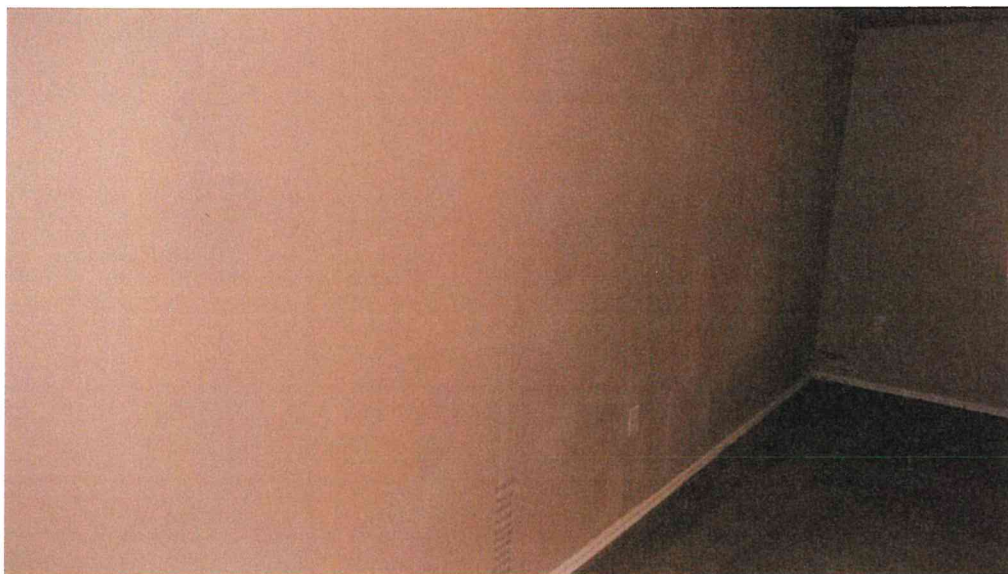
Front room west wall some water damage.

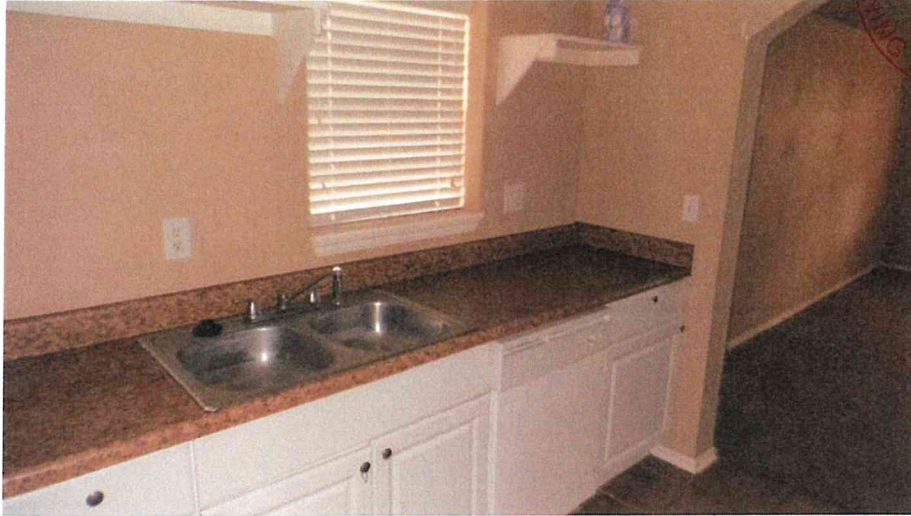
Kitchen on elevated platform from front of building.

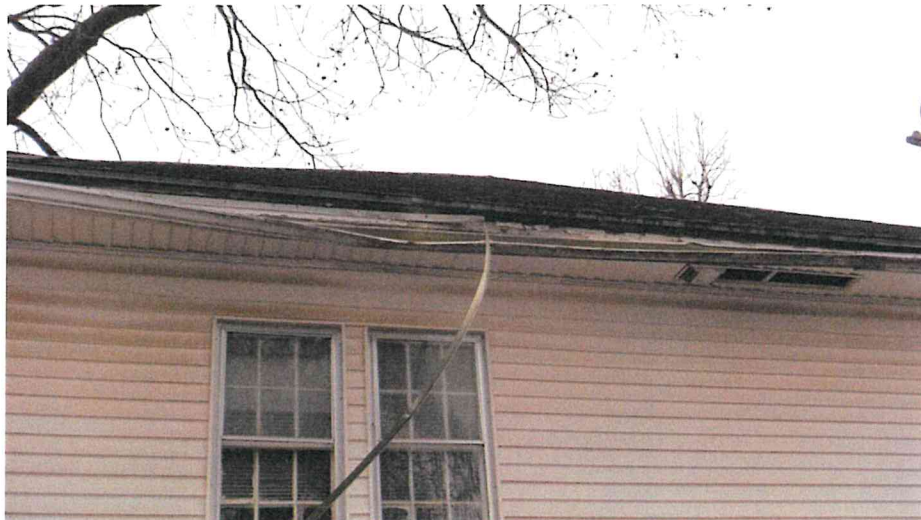
Roof damage at front of building from tree branches.

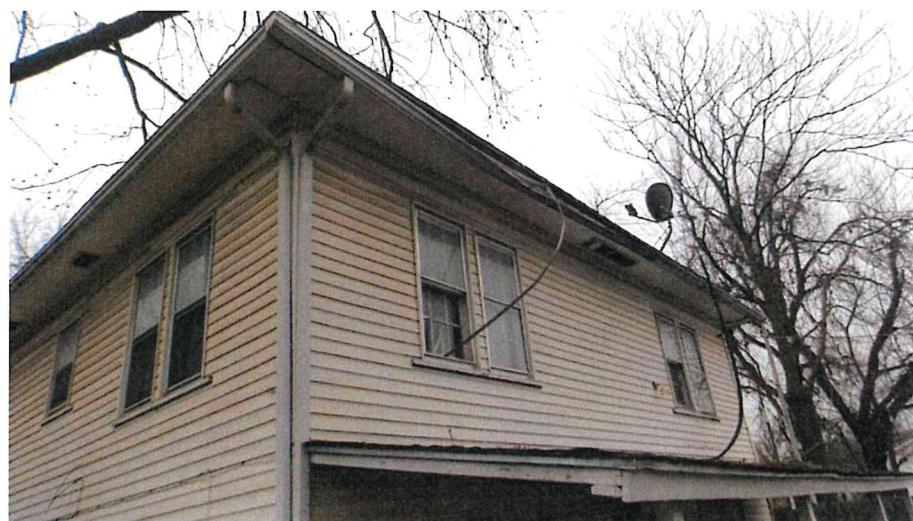
Roof damage

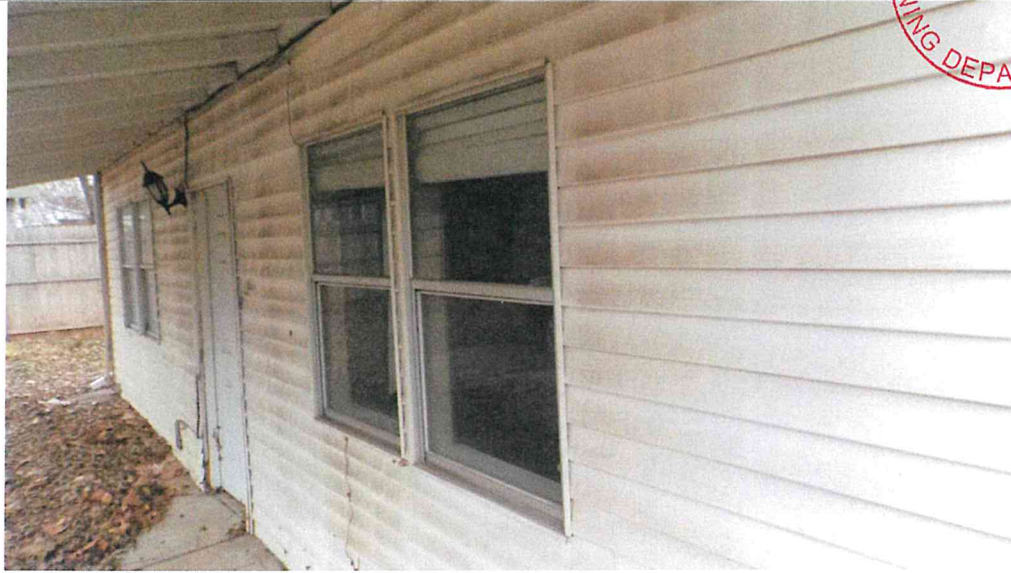
Front of lower apartment unit.

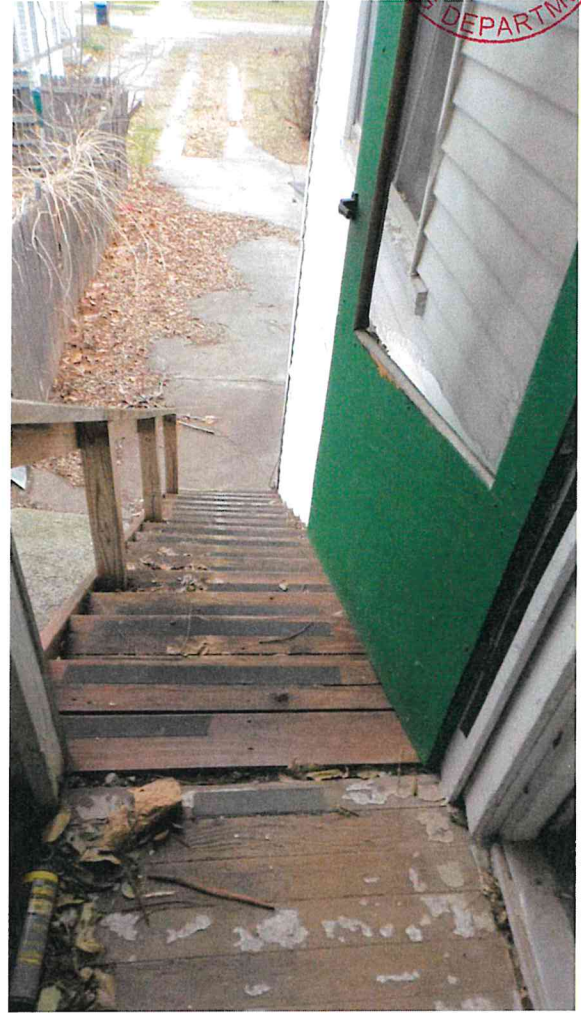
The stairs to upper apartment are functional but difficult to maneuver at the top and not very stable.

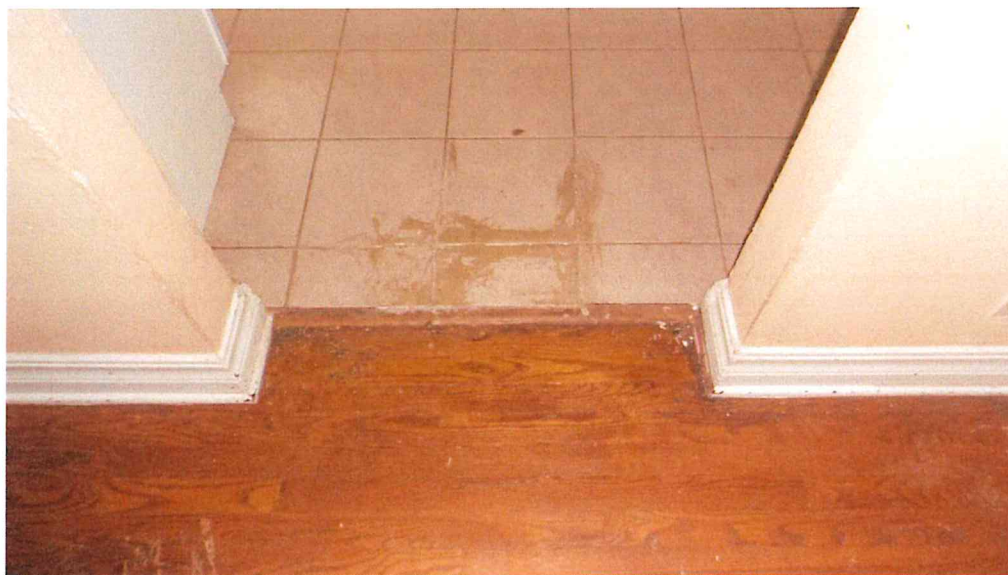
Loose bonding in tiles in kitchen.

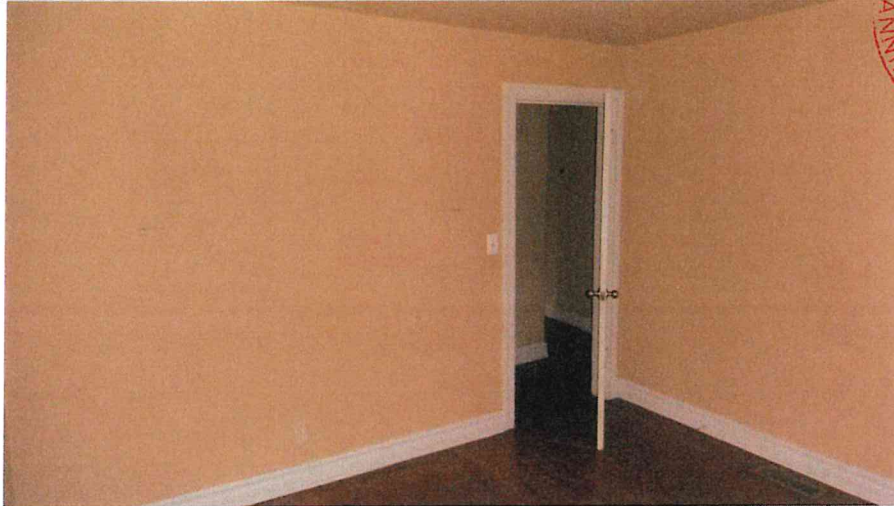
Foundation movement indicated by door alignment

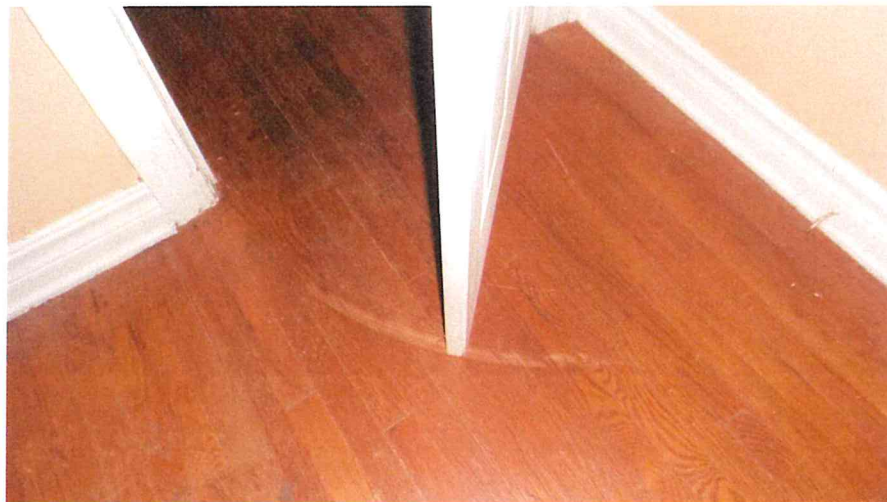
Floor rub marks due to settlement

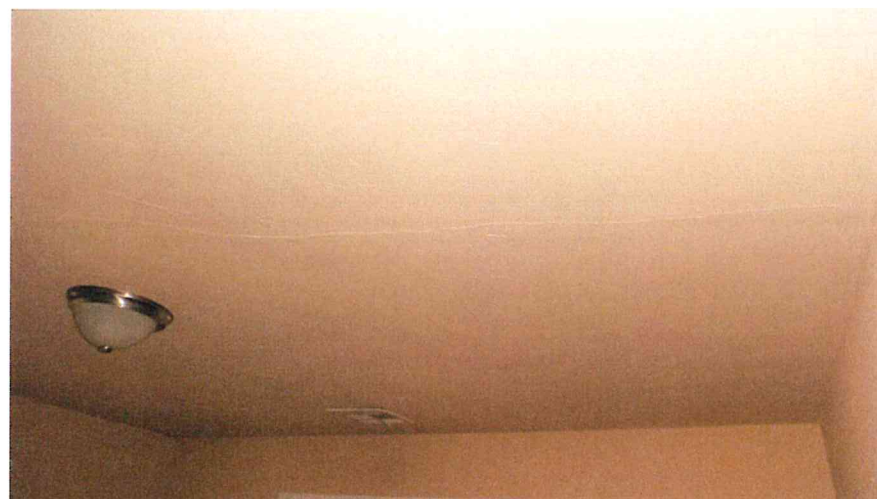
Water damage and ceiling cracking

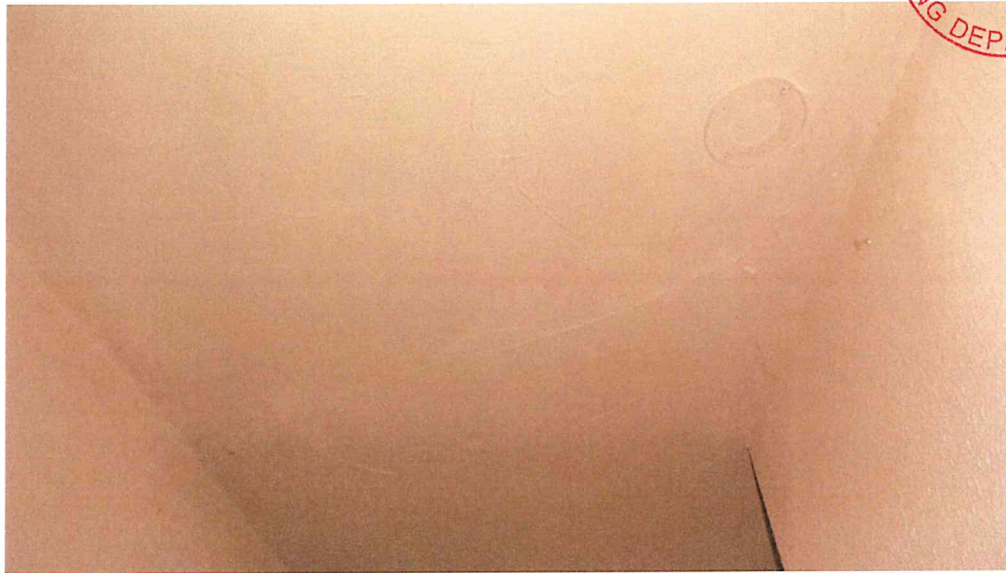
Ceiling damage from foundation movement.

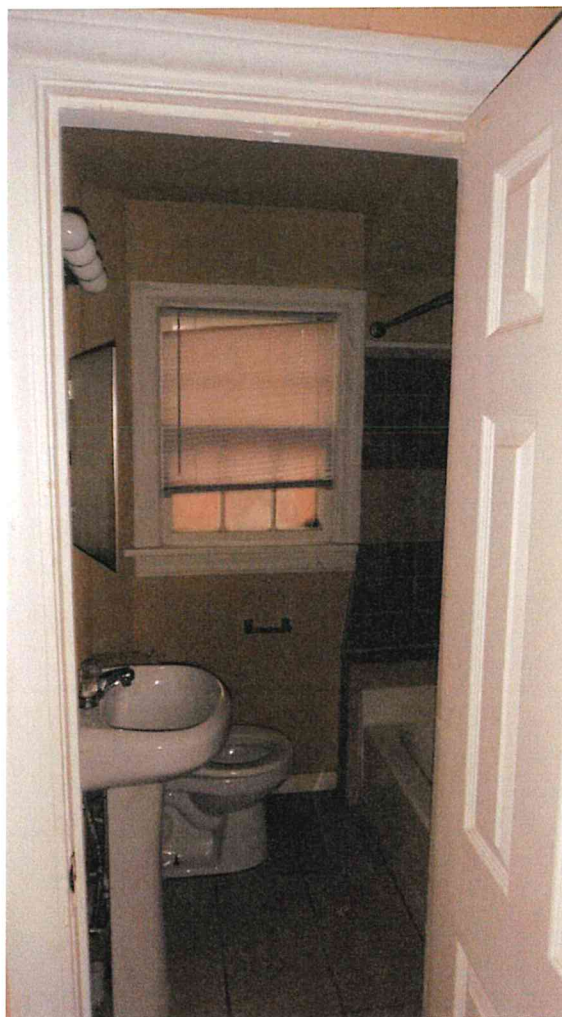
Door alignment out at bathroom.

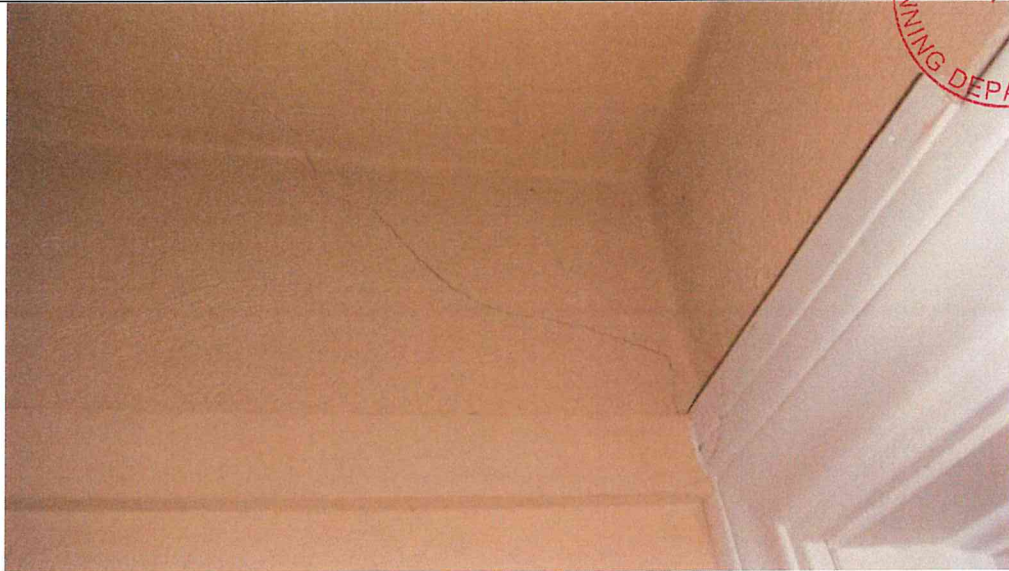
Wall cracking at corners

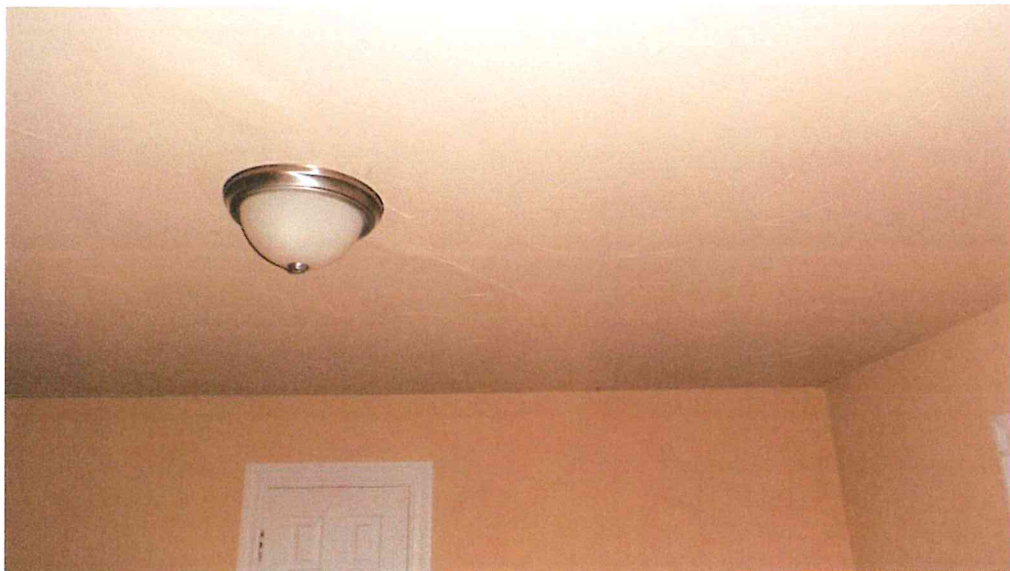
Ceiling cracking

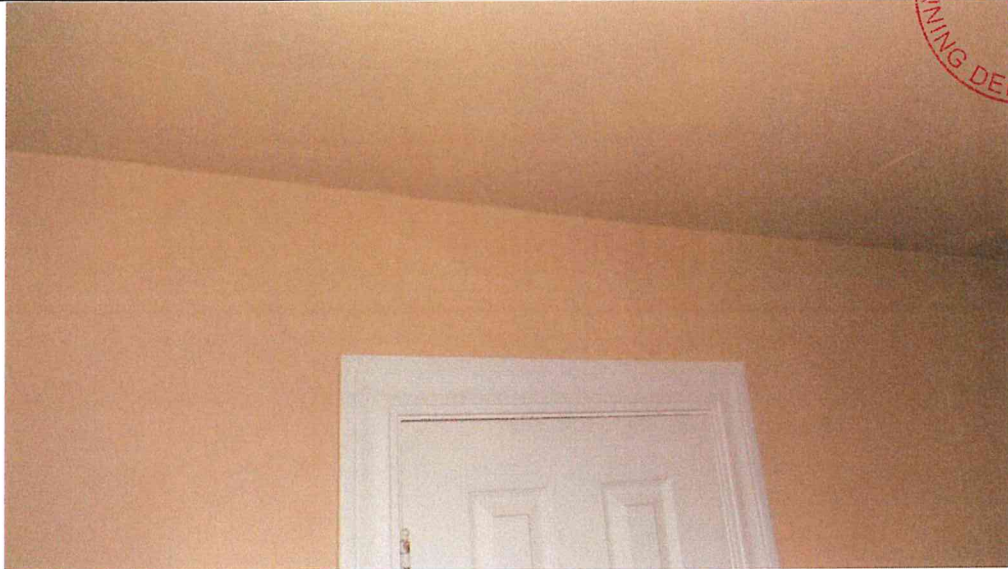
Cracking of wall above door

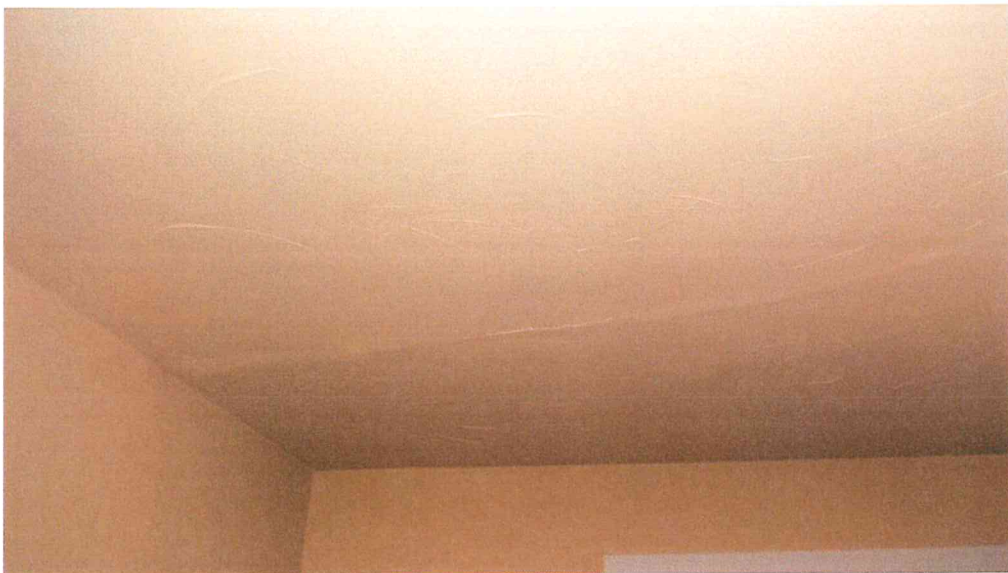
Ceiling cracking.

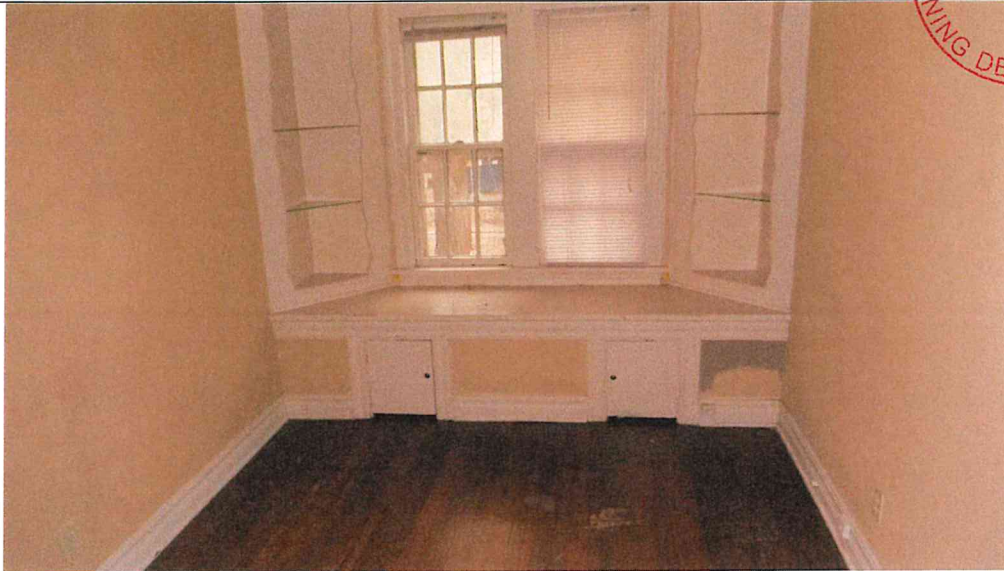
Window seat in south room.

Exposed exterior sheathing above bead board under window seat.
