WM-0342 & WM-0343 Lake Atoka Road Rehabilitation Preliminary Engineering Report

April 2023

OCWUT Project Nos. WM-0342 & WM-0343
Atoka Lake Road Rehabilitation
Lake Atoka

Poe and Associates, Inc.
Certificate of Authorization No. 541
1601 Northwest Expressway, Suite 400
Oklahoma City, OK 73118
Telephone: (405) 949-1962

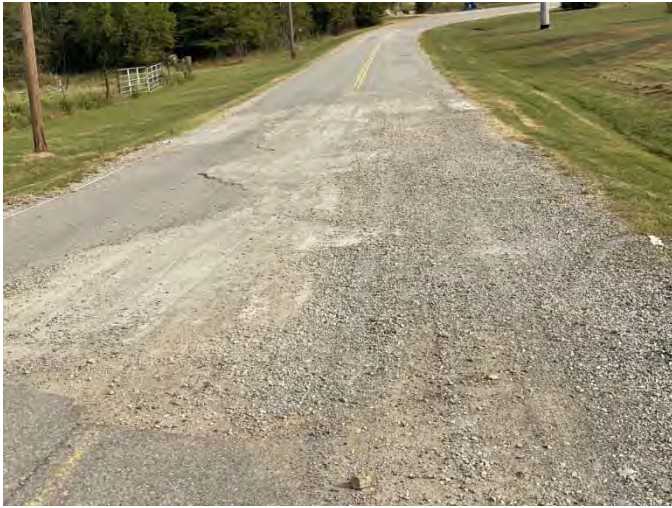
The 4 miles of pavement along these two projects has deteriorated extensively due to the poor base material on which the pavement was constructed and also due to the thin depth of asphalt pavement originally constructed. Intermittent patches of missing asphalt are evidence of the deterioration along project WM-0342. Extensive longitudinal cracking of the existing pavement is evidence of deterioration along project WM-0343. Photos of these deteriorated areas are included in the Appendix.

WM-0342 Pavement Deterioration

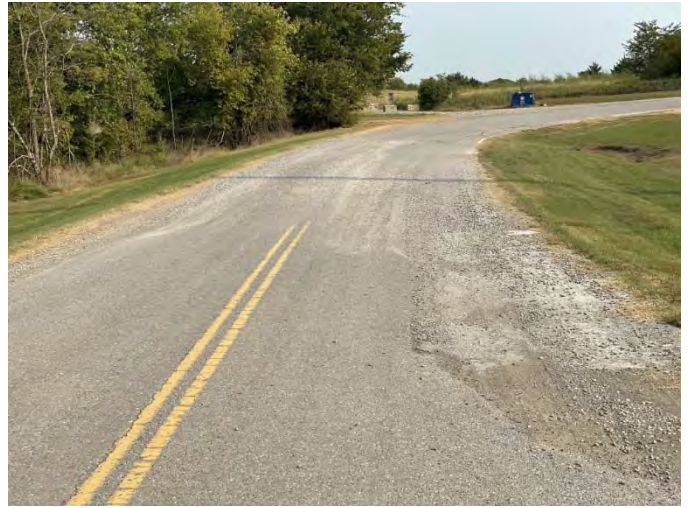
WM-0342 Pavement Deterioration

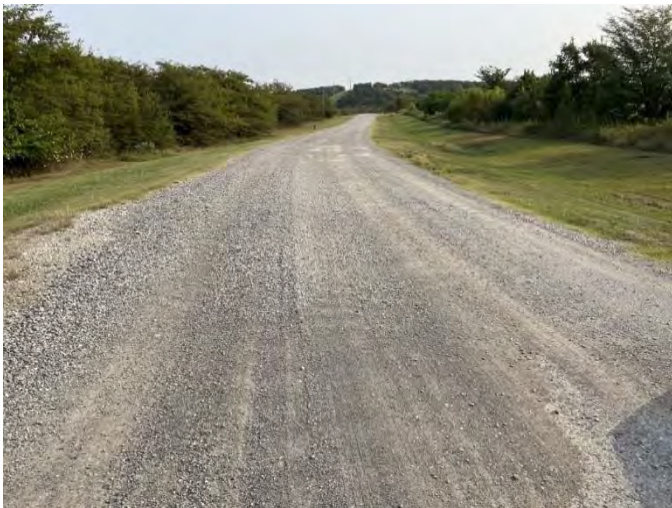
WM-0342 – Gravel Covered Roadway

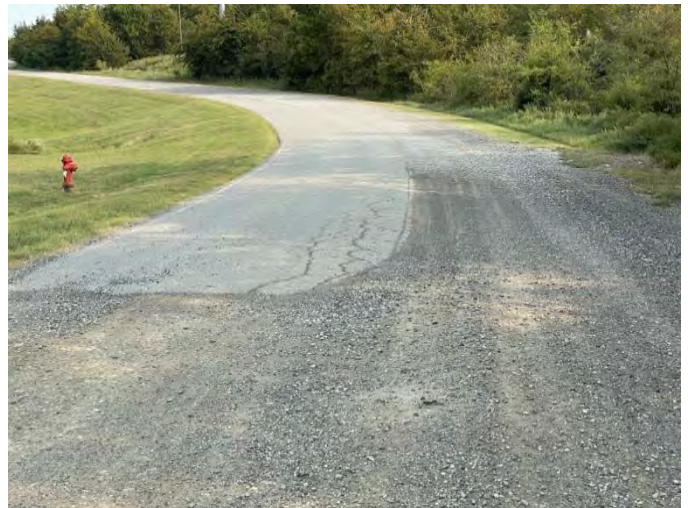
WM-0342 Pavement Deterioration

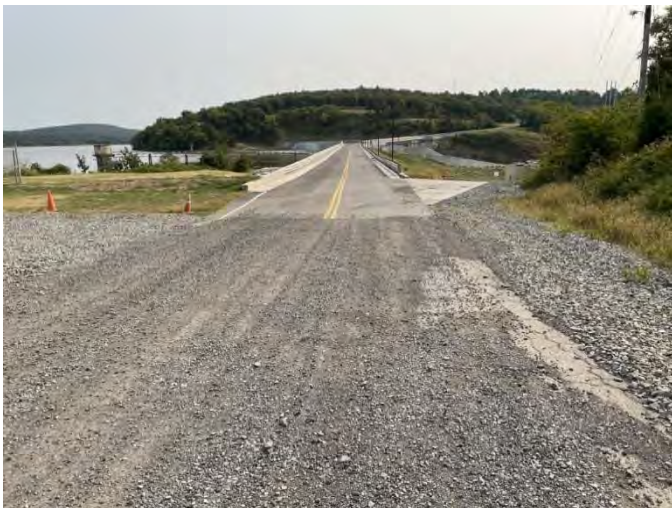
WM-0342 – Gravel Covered Roadway at Dam

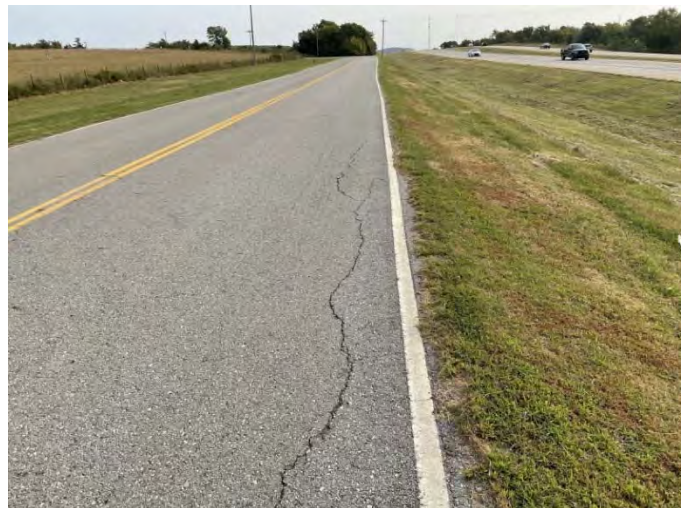
WM-0342 – Pavement w/ Longitudinal Cracking

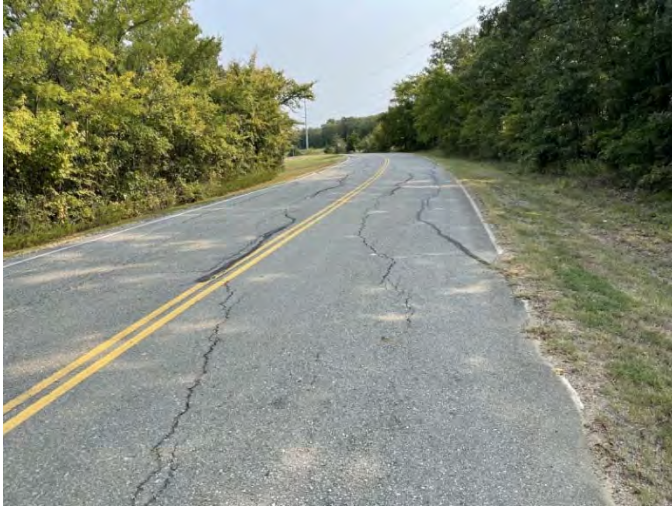
Borings accomplished during the preliminary engineering phase indicate that the existing pavement and base conditions along both projects consist of 2.5 to 7 inches of asphalt on top of either a 6-inch treated subgrade or 6-inch aggregate base. The existing pavement is experiencing significant deterioration. There are extensive patches of asphalt which have disintegrated into loose gravel along project WM-0342. Along much of project WM-0343, longitudinal cracking, several inches in width in some locations, is present.

WM-0343 – Longitudinal Cracking

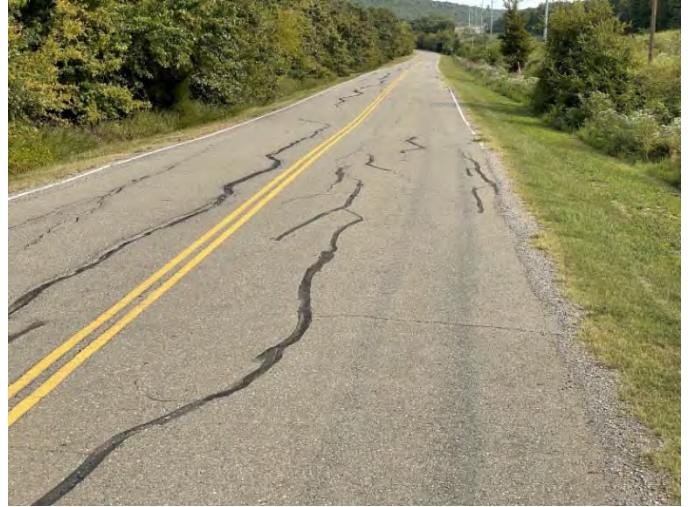
WM-0343 – Longitudinal Cracking

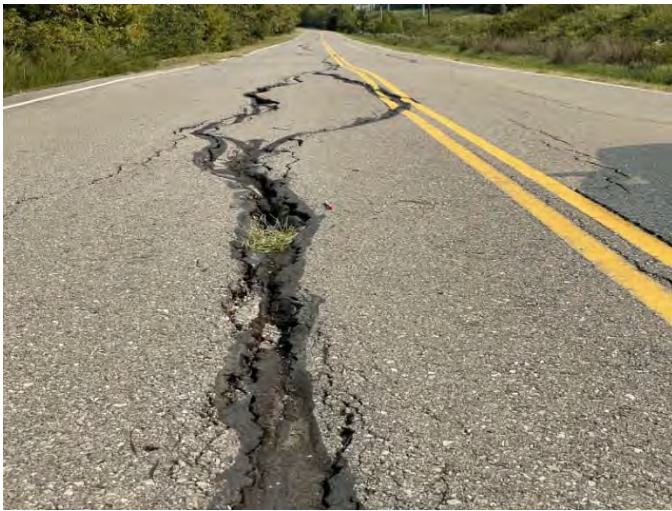
The area of widest longitudinal cracks present in project WM-0343 occurs where the roadway is closest to the lake. Supplemental geotechnical stability analysis performed in this area concluded there were no stability issues under the roadway or down the slope from the roadway. Geotechnical sampling and analysis determined that the base material for the existing pavement along both projects is generally comprised of soils having high plasticity. These high plasticity, expansive soils are prone to shrink and swell cycles corresponding to exposure to seasonal or prolonged dry and wet weather durations. This shrink/swell process coupled with the shallow existing pavement depths has been determined as the main cause for the deterioration of the roadways throughout both projects.

WM-0343 – Widest Longitudinal Cracking

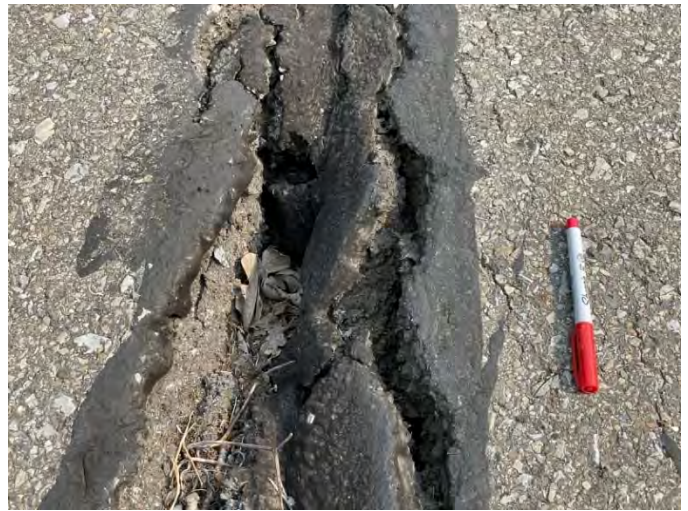
WM-0343 – Widest Longitudinal Cracking

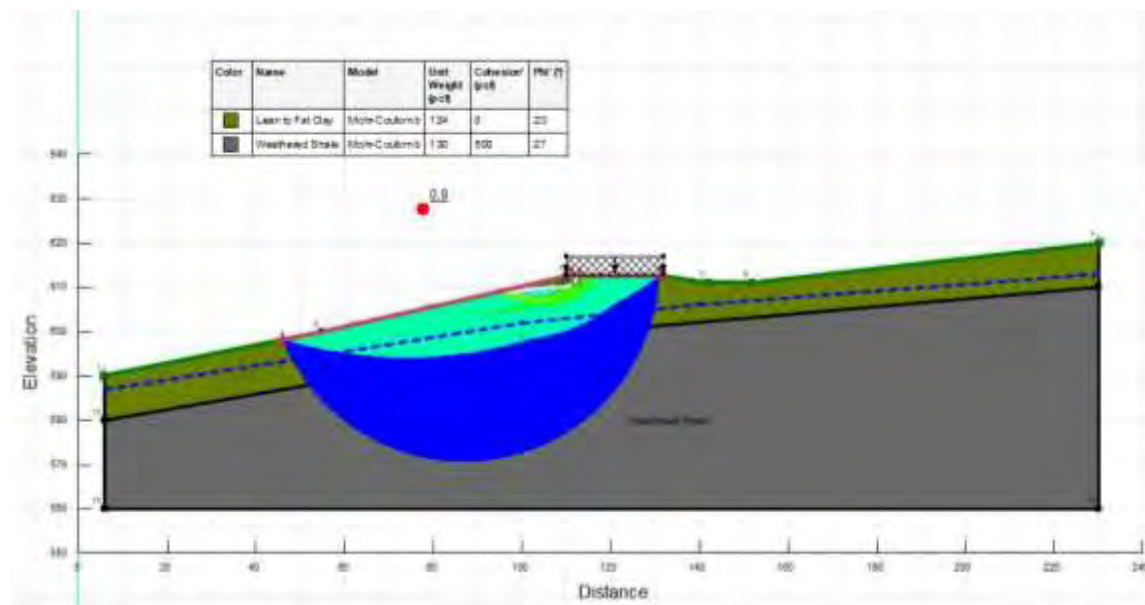
Figure 1 – Estimated Failure Plane of Slide near Borings B-5, B-5A, & B-5B.
Approximate Station 547+20

The back-calculation results displayed in Figures 1 and 2 provide our best estimate of the most likely location of the failure surfaces within the slope based upon the embankment soil parameters used and the slope geometry at each location. It should be noted that only one point on the failure surface (the tension crack in the pavement) is known. The actual location (depth and downslope extent) of the failure surface likely varies from the locus shown in each figure due to variations in material property, weathering and other variables not accounted for in the

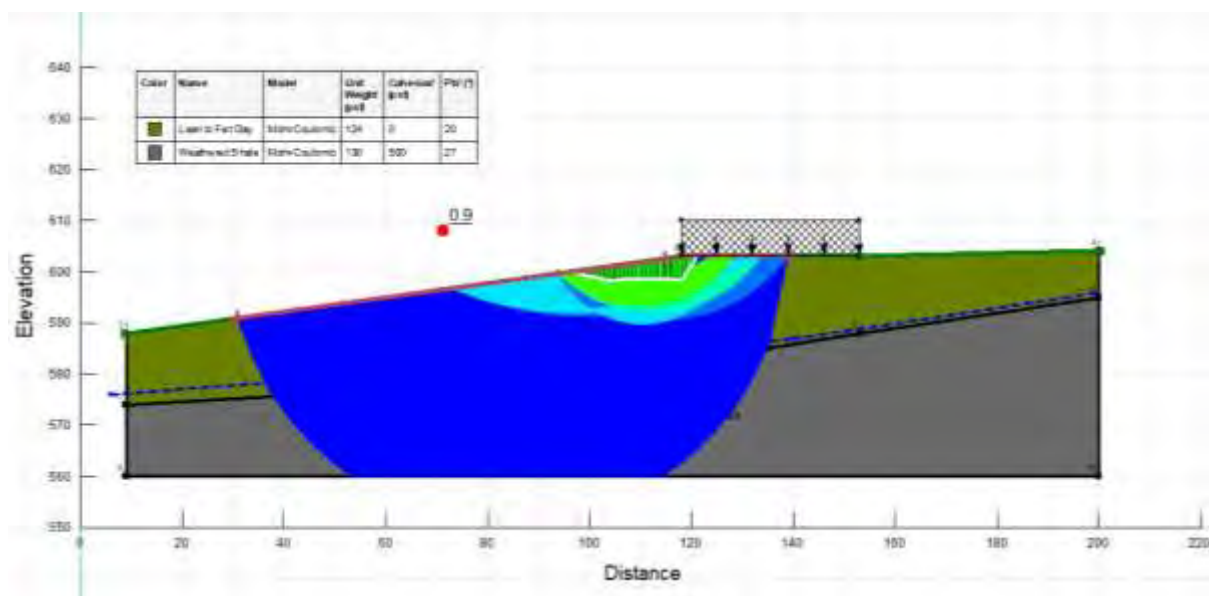
Figure 2 – Estimated Failure Plane of Slide near Borings B-6, B-7A, & B-7B.
Approximate Station 556+20

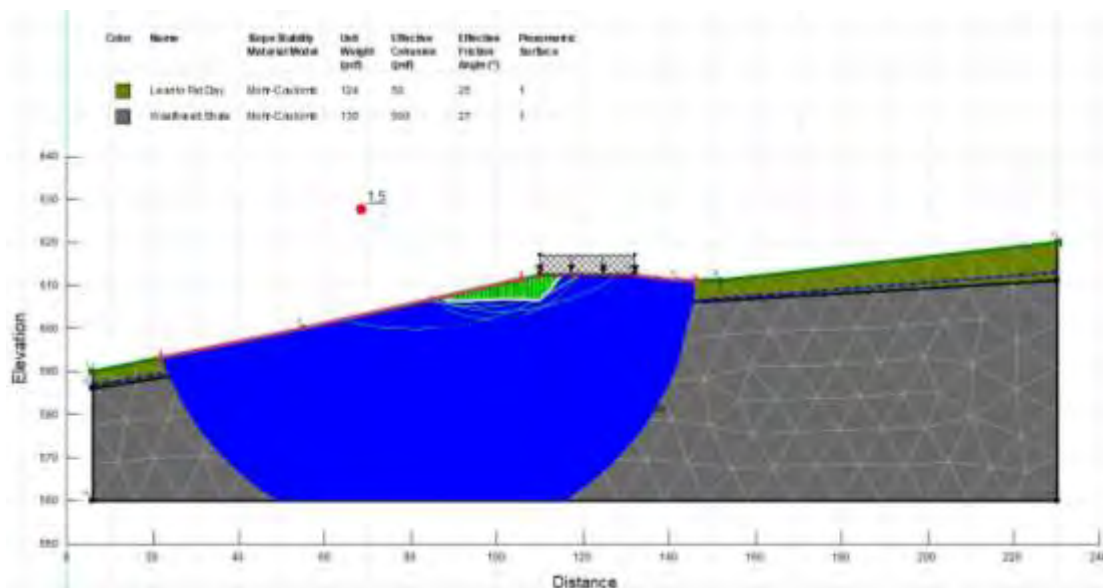
Figure 1 – Estimated Failure Plane of Slide near Borings B-5, B-5A, B-5B and B-5C.
Approximate Station 547+20

The slope stability results displayed in Figures 1 and 2 are reasonable and appear to be more in line with what should be expected along these shallow slopes. Additionally, observations made during the August 2022 site visit found no indication of a scarp or slippage plane development along any of the slopes. We recommend monitoring these areas for the development of any

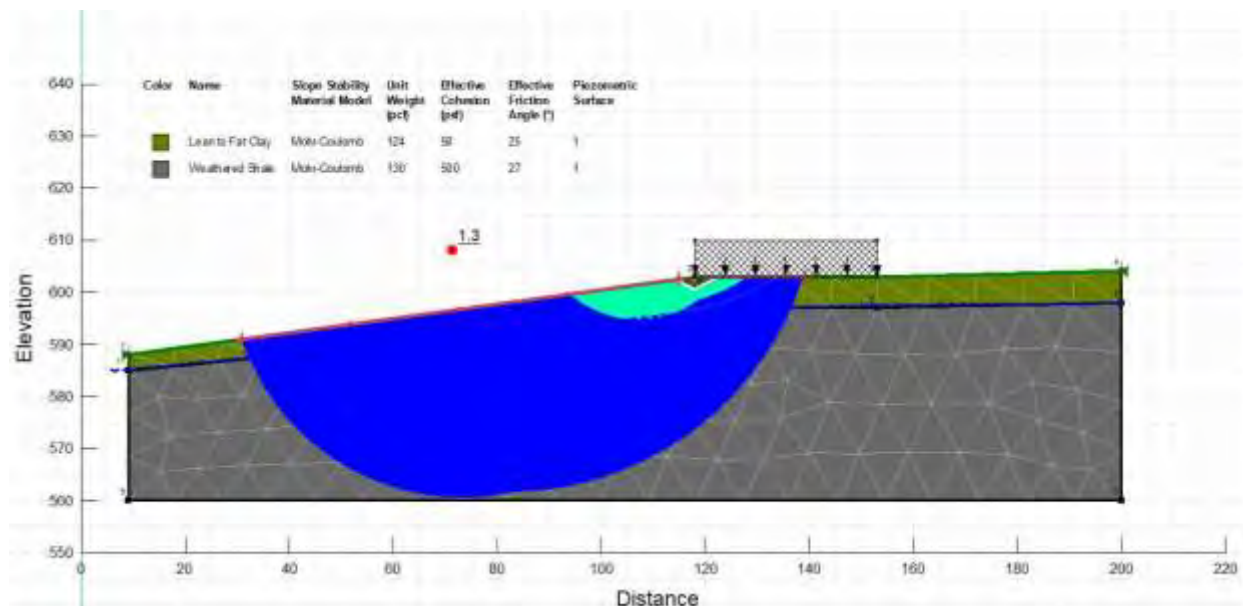
Figure 2 – Estimated Failure Plane of Slide near Borings B-8, B-7A, B-7B and B-7C.
Approximate Station 556+20

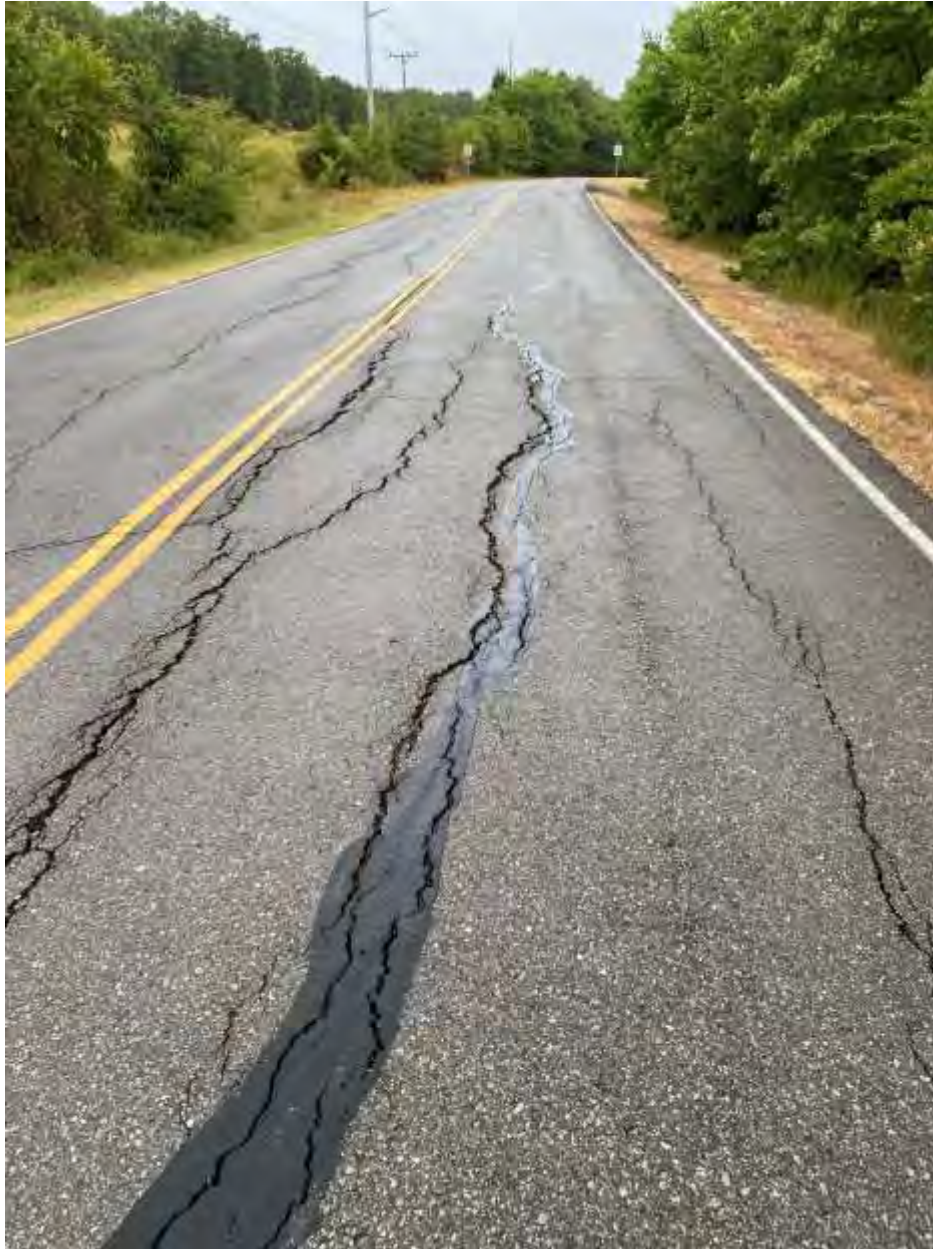
Photo 1 – Pavement condition near approximate location of boring B-4A

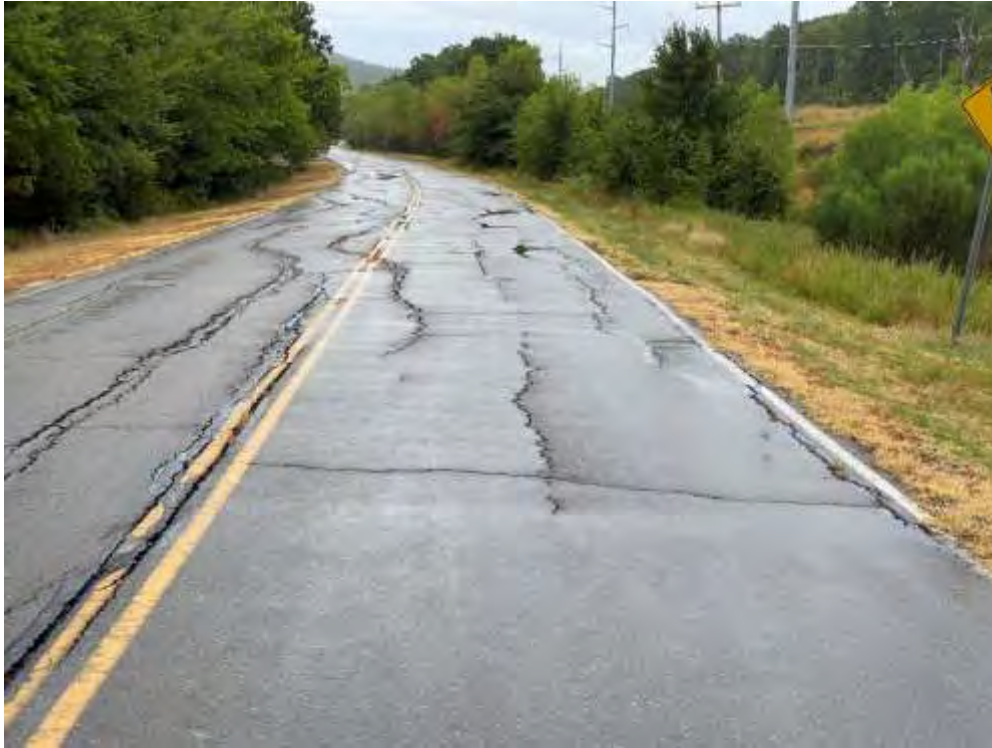
Photo 2 – Pavement condition between borings B-7D & B-8A

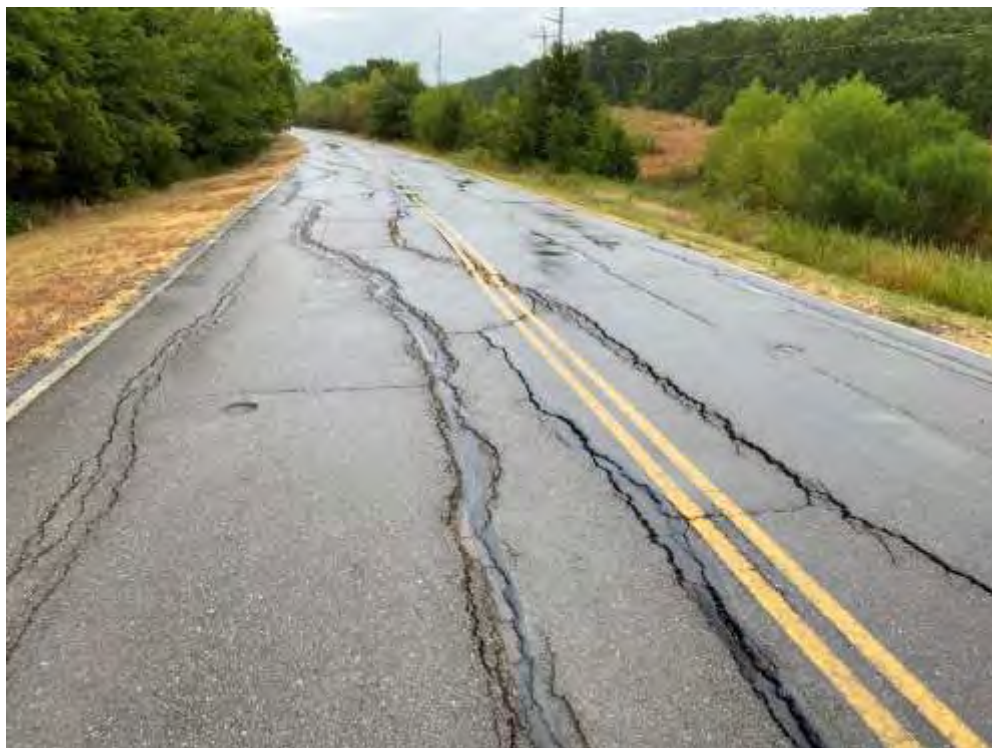
Photo 3 – Pavement condition near approximate location of boring B-7E

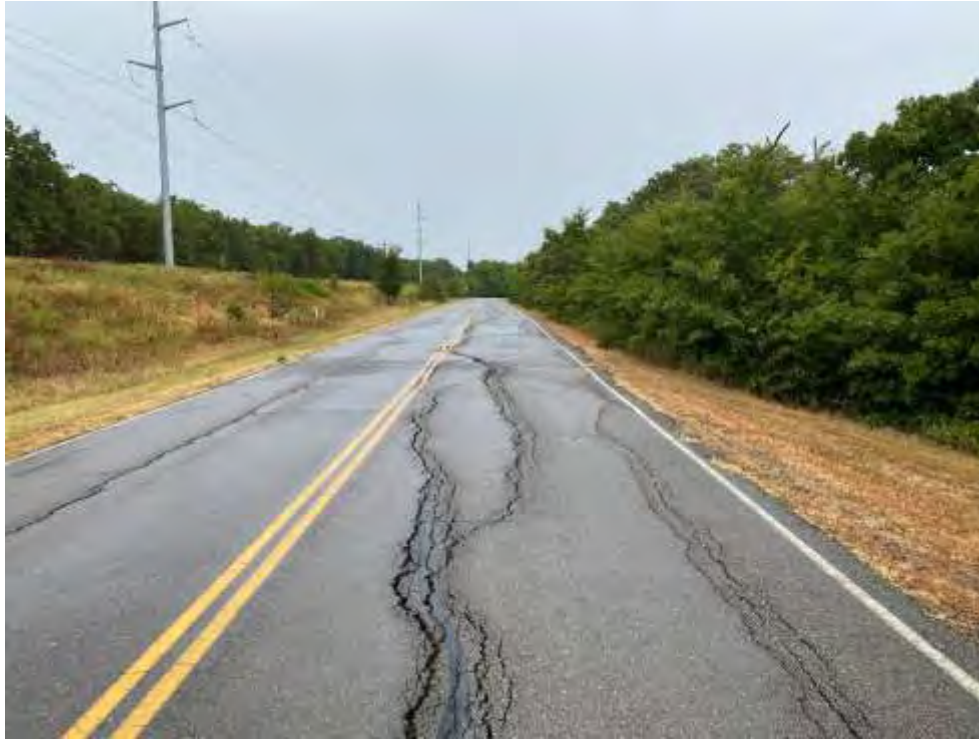
Photo 4 – Pavement condition near approximate location of boring B-5E

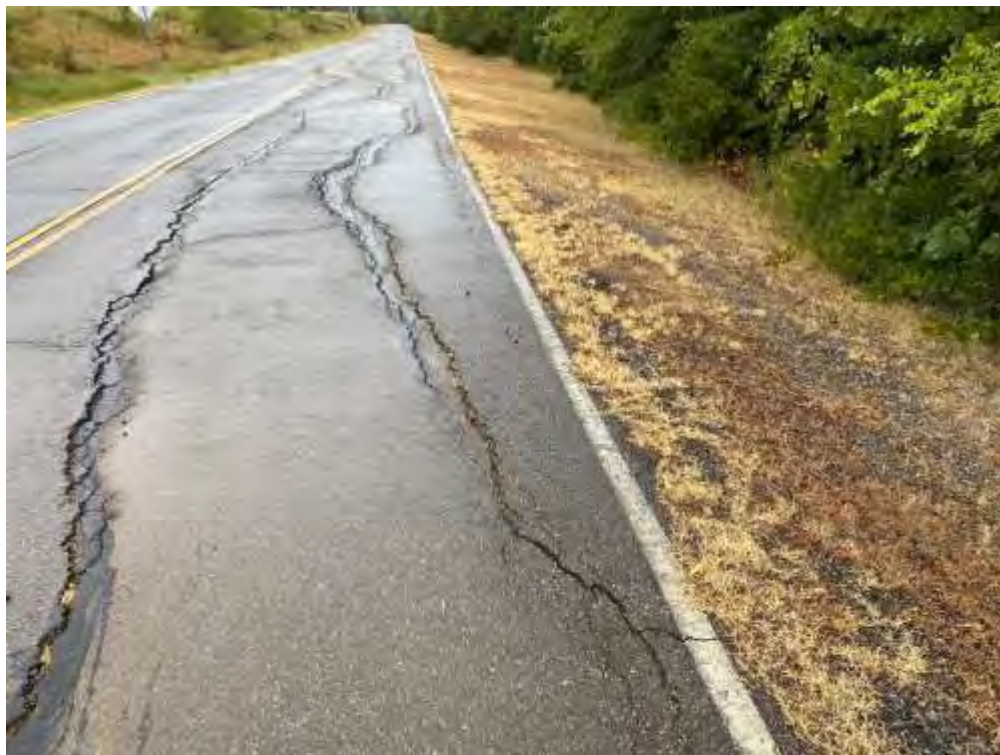
Photo 5 – Pavement condition near approximate location of boring B-7D
