# PRELIMINARY ENGINEERING REPORT

PC-0612 PASEO STREET ENHANCEMENT PROJECT

PC-0649 WALKER NW 23<sup>RD</sup> TO NW 36<sup>TH</sup> STREET ENHANCEMENT  
PROJECT

April 30, 2021

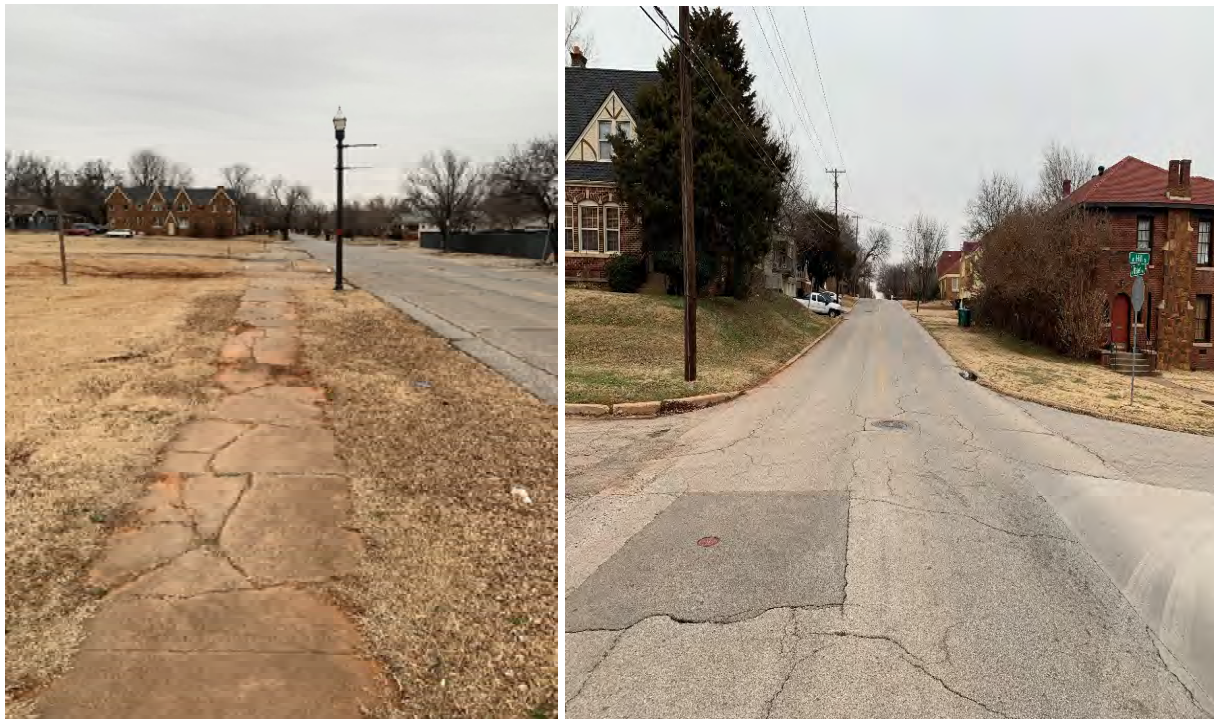
To promote this area, adequate access throughout the site is needed. The existing sidewalk along Walker Avenue is in poor condition, with issues ranging from severe cracking, to ADA compliance problems, and panels being uplifted by roots from existing trees. Further, the existing sidewalk is sporadically placed from NW 28<sup>th</sup> St to NW 36<sup>th</sup> St. Several streets throughout this stretch do not have any existing sidewalk. Examples of this issues can be seen in Figure 3.

Figure 3: Differing Sidewalk Conditions Along Walker Avenue

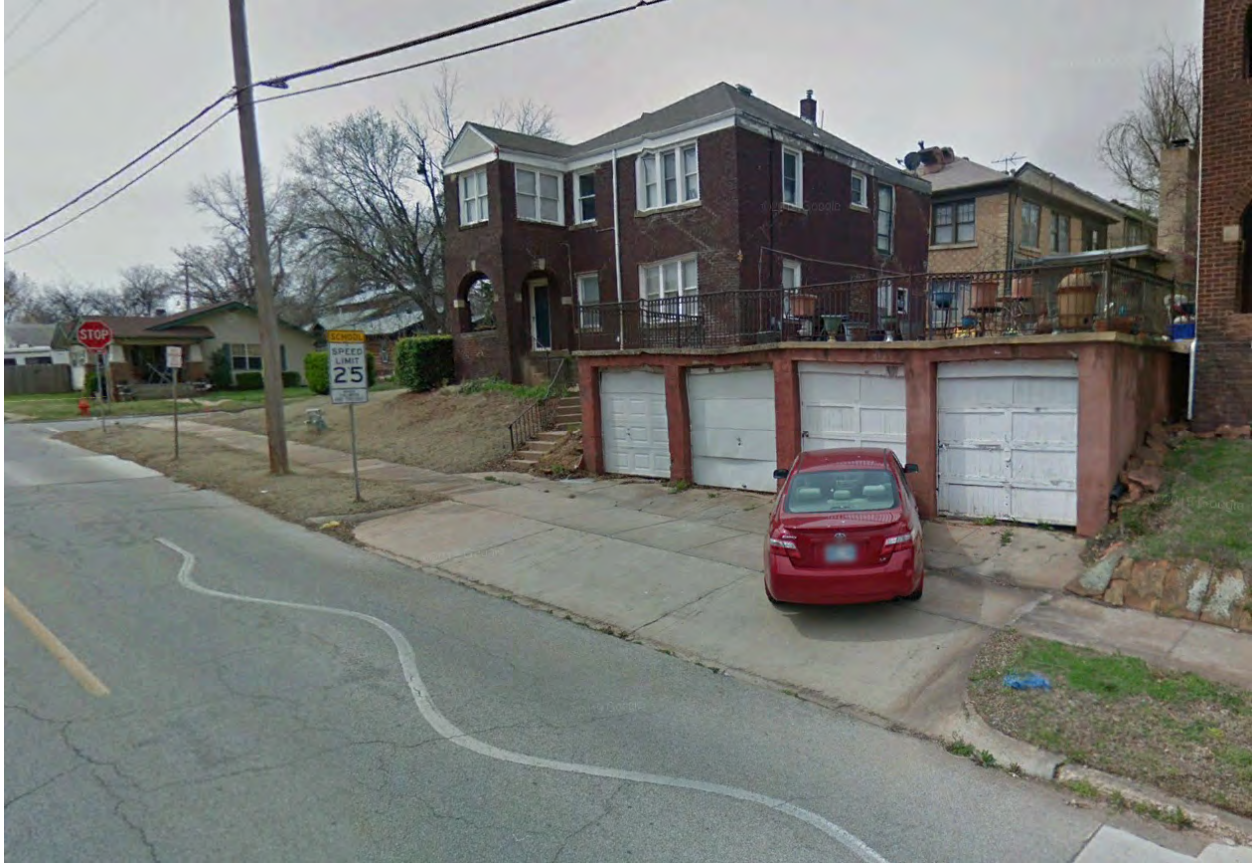
Further complicating the design of this project, several driveways and existing buildings along Walker Avenue are built next to existing property lot lines. With this current situation, homeowners block existing sidewalk paths. An area that highlights this occurs between NW 32<sup>nd</sup> St and W. Hill St, which is shown in Figure 4.

Figure 4 – Existing Sidewalks Blocked by Driveways (Google Earth)

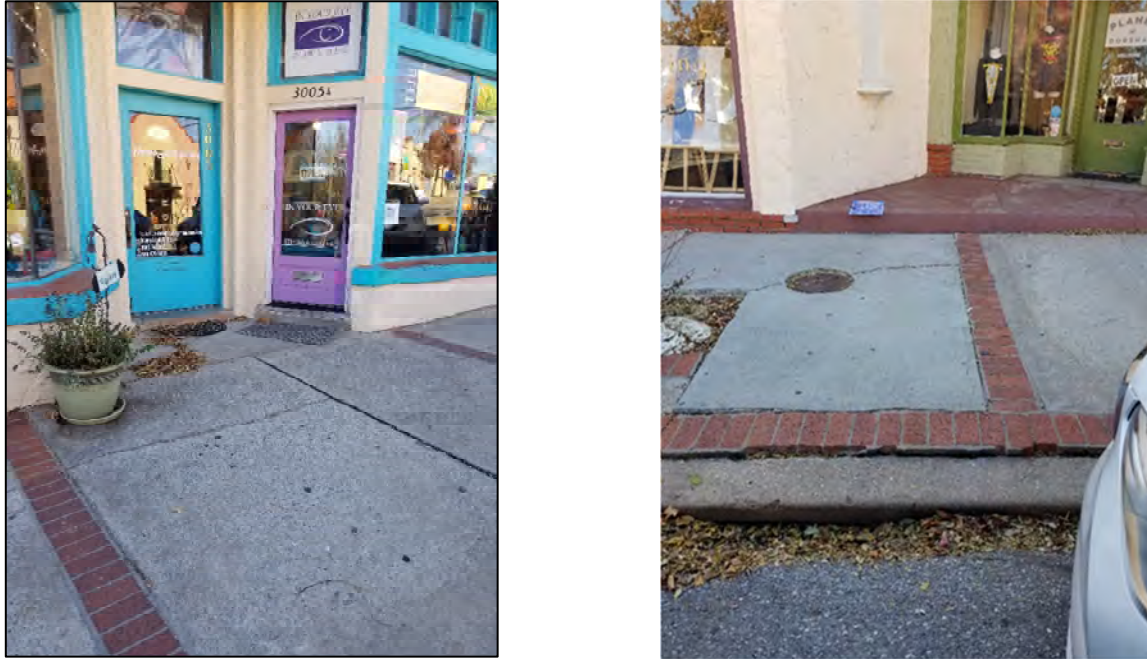
The Paseo Drive Area also has connectivity concerns. The existing sidewalk in front of several storefronts has deteriorated, with cracking and settlement present. Throughout the existing sidewalk, brick paving is integrated into the path. While this does complement the existing architecture, the bricks have also settled, which lead to ADA compliance concerns regarding trip hazards and drainage concerns. Further complicating matters, many of the shops along Paseo Drive have steps that lead from the existing sidewalk up into the storefronts. This makes travel through these establishments challenging for patrons with disabilities. Examples of the existing sidewalk and storefront can be seen in Figure 5.

Figure 5: Sidewalk Deterioration and Existing Storefronts

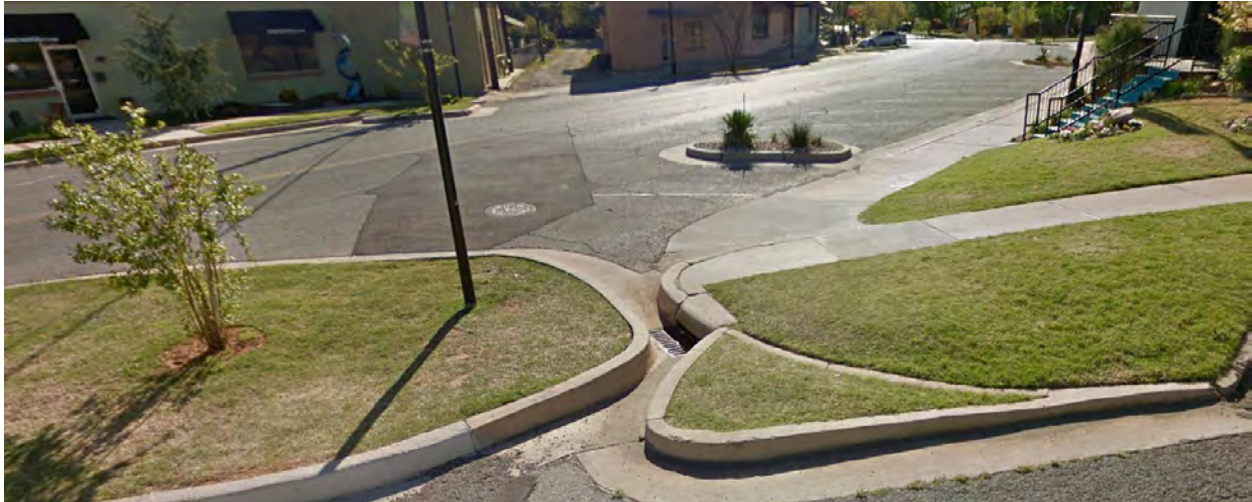
The street crossings Paseo Drive area are also not up to code. Several intersections lack proper tactile warning surfacing at the existing sidewalk ramps, with some intersections lacking ramps entirely. The intersection of Paseo Drive and Dewey Avenue is a clear example of this challenge in using the existing sidewalk as several landscaping islands exist with no existing ramps. This forces pedestrians into roadway to travel to the next existing sidewalk path, which can increase the risk of an accident with vehicular traffic. An example of this lack of connectivity here can be seen in Figure 6.

Figure 6: Paseo Drive Sidewalk Connectivity Concerns at Dewey Avenue (Google Earth)

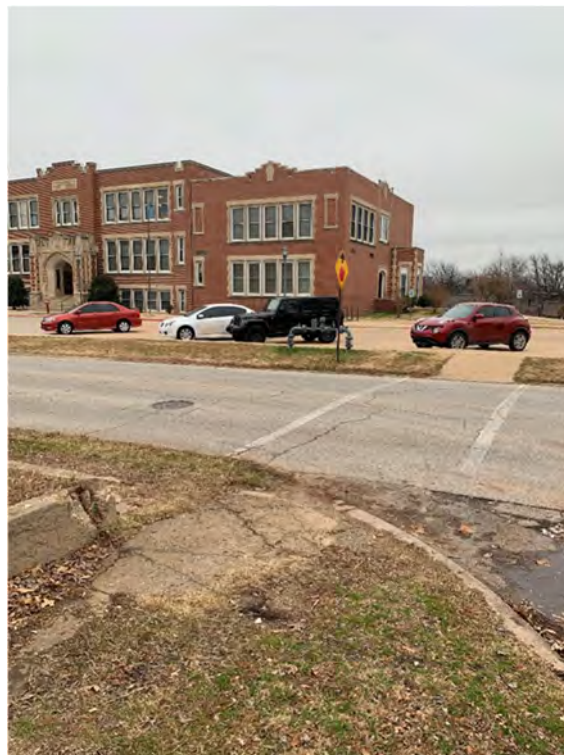
One midblock crossing is currently existing near Edgemere Elementary School, which is located at the intersection of NW 31<sup>st</sup> Street and Walker Avenue. This means that pedestrians can legally cross the road, but vehicle traffic is not directed to stop upon arrival. This crossing leads pedestrians to and from the school on the east side of the road to existing neighborhoods on the west side of the road. This location is not well marked or connected. The current striping is fading, and no signage is present to denote this crossing. Further, there are no ramps present on the west side of the road for ADA connectivity. These combined factors decrease connectivity and increase the risk of an accident at this location. These issues can be seen in Figure 7.

Figure 7: Existing Midblock Crossing to Edgemere Elementary School at NW 31<sup>st</sup> St and Walker Avenue

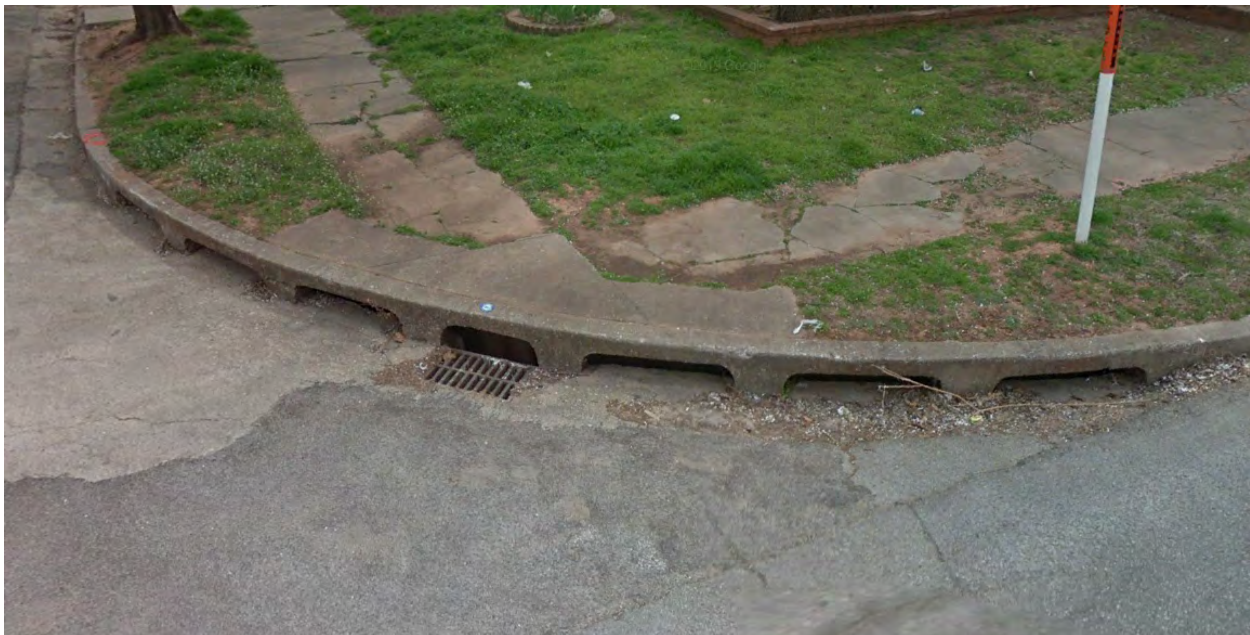
Existing drainage inlets along Walker Avenue also have issues that affect sidewalk connectivity. Several intersections, such as NW 28<sup>th</sup> St and Walker Ave, have inlet concrete hoods that span the length of the turn radius. This can be seen in Figure 8.

Figure 8: Existing Concrete Curb Inlet-NW 28<sup>th</sup> St and Walker Avenue (Google Earth)

These concrete structures are inconsistent with the current OKC standard design and specifications. Further, the grade change between the existing sidewalk and roadway can be as high as 1 ft, which makes ADA compliant ramps difficult to design and install. In some cases, these hoods are broken, with exposed reinforcing steel and large pieces of concrete present at the curb. These deficiencies can present a hazard to pedestrians and vehicles in this area.

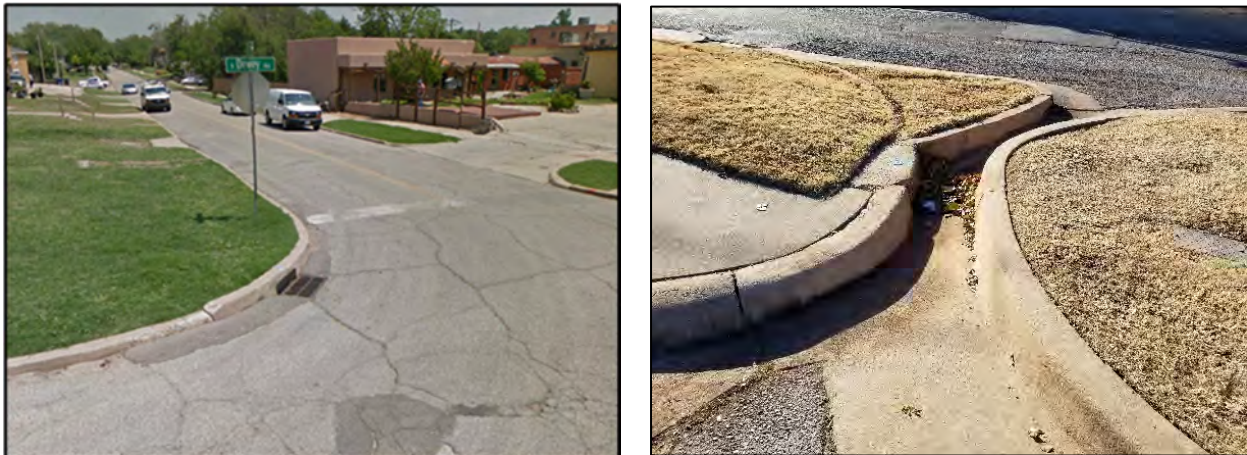
The existing drainage along the Paseo Drive area consists of a combination of channelized flow through the street gutter system and a storm sewer system that does not service the entire area. Inlet locations to this existing storm sewer are located at select locations along NW 29<sup>th</sup> Street, NW 30<sup>th</sup> Street, and Dewey Avenue. At several locations, concrete channels exist between landscaping islands and existing store fronts to direct the runoff. Unfortunately, this overall system is inadequate to handle the existing storm events, as the flow has been reported to flood existing shops on several occasions. Ponding is also an issue at intersections, where water collects in large quantities here during storm events. Examples of the existing drainage infrastructure can be found in Figure 9.

Figure 9: Existing Storm Inlets and Drainage Channels in the Paseo Drive Area

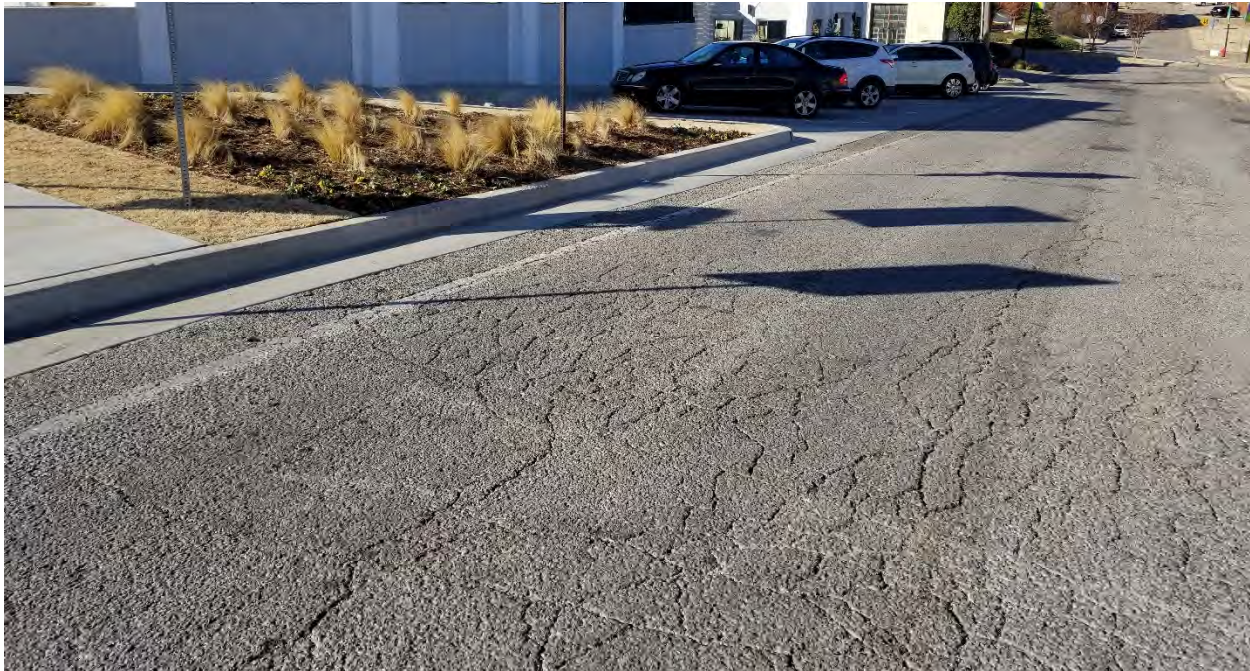
In the Paseo Drive area, the existing pavement consists of a combination of asphalt and concrete pavement. Both are in relatively poor condition. Similar to Walker Avenue, transverse and longitudinal cracking is prevalent throughout the existing roadway, with alligator cracking and rutting developing in the asphalt pavement on the south side of the intersection at Paseo Drive and Dewey Avenue. While patching repairs have been seen in select locations, most of the pavement has not been repaired in any large-scale effort. The paving conditions can be seen in Figure 10.

Figure 10: Cracking in Asphalt Pavement at the NW 28<sup>th</sup> Street & Dewey Avenue Intersection
