HPCA-22-00123

108 NW 15th

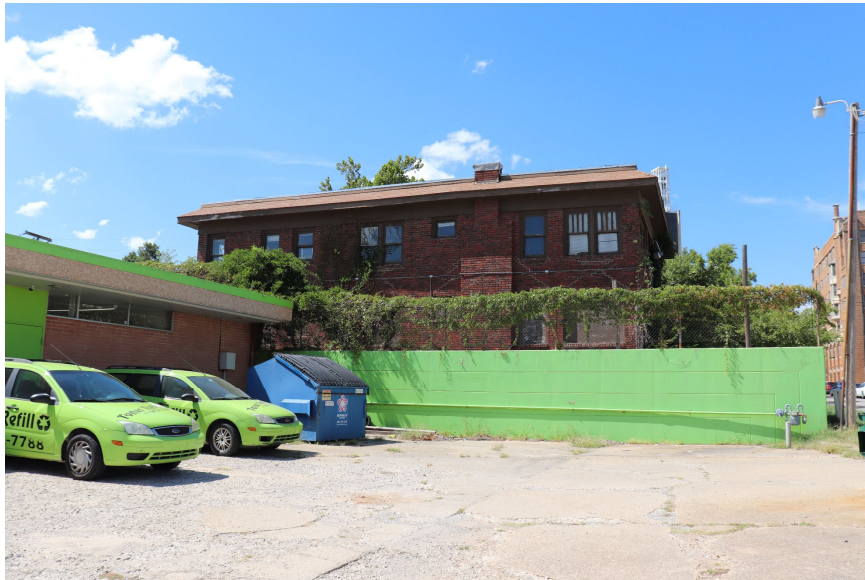
1

East Side of Property

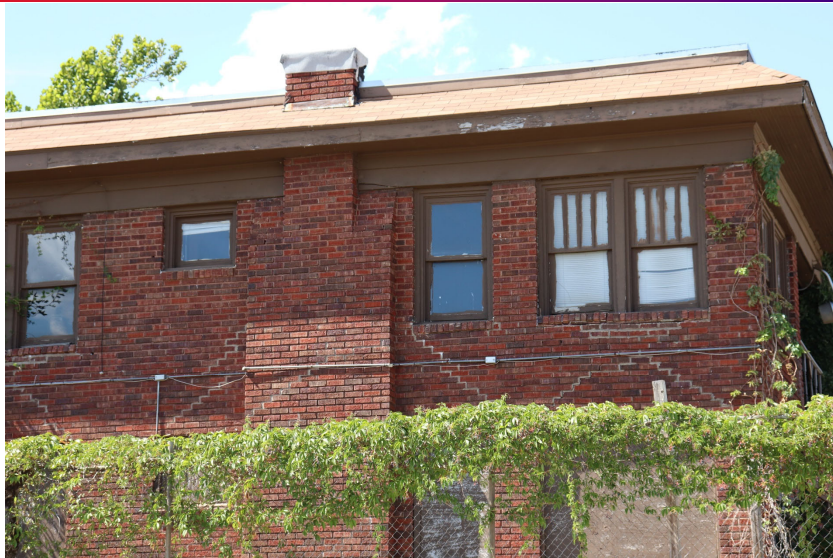
2

NE Corner; Windows of East Elevation

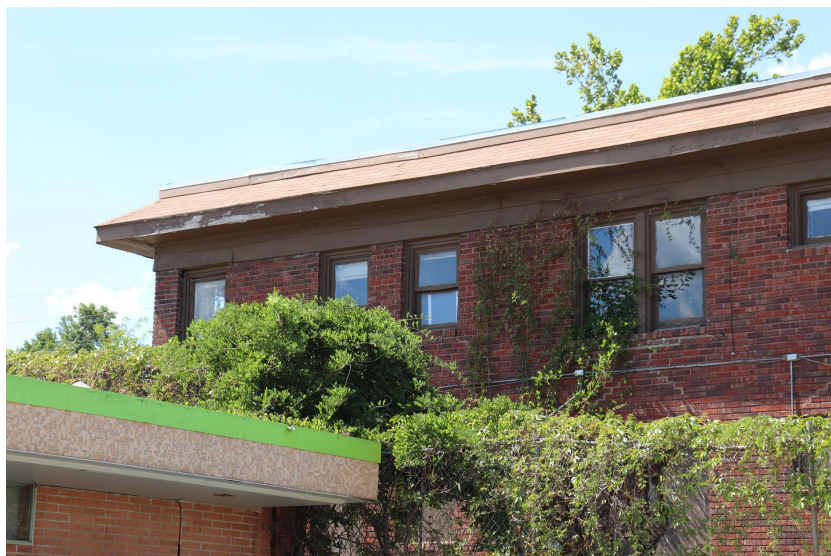
3

SE Corner; Windows of East Elevation

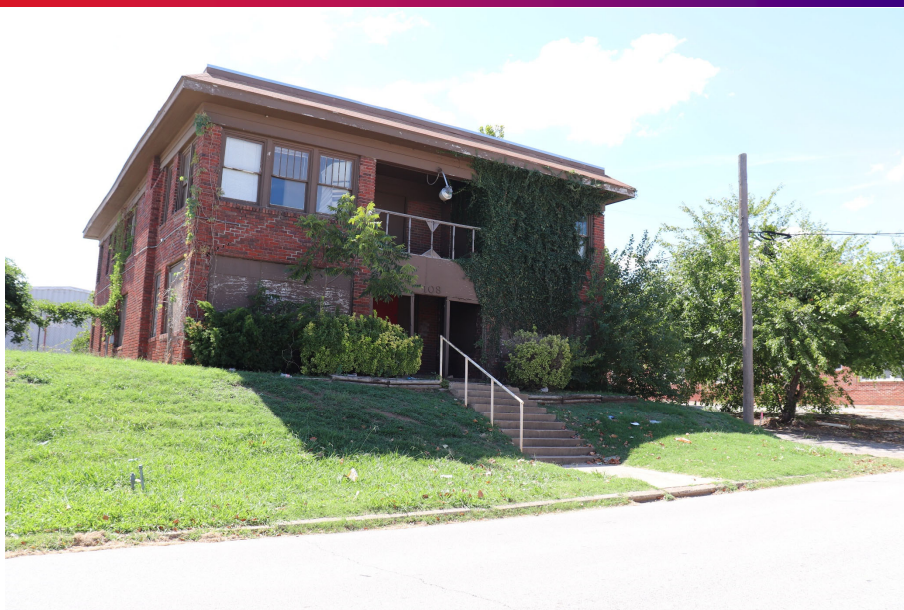
4

NE Corner

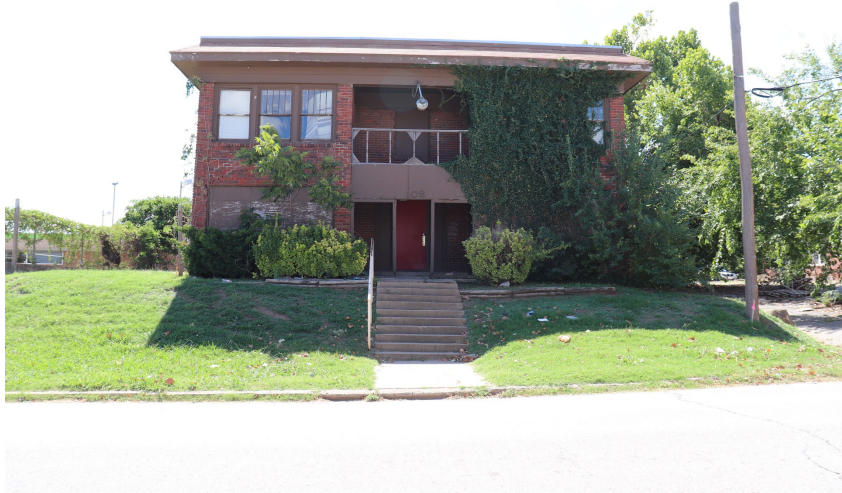
5

North Façade

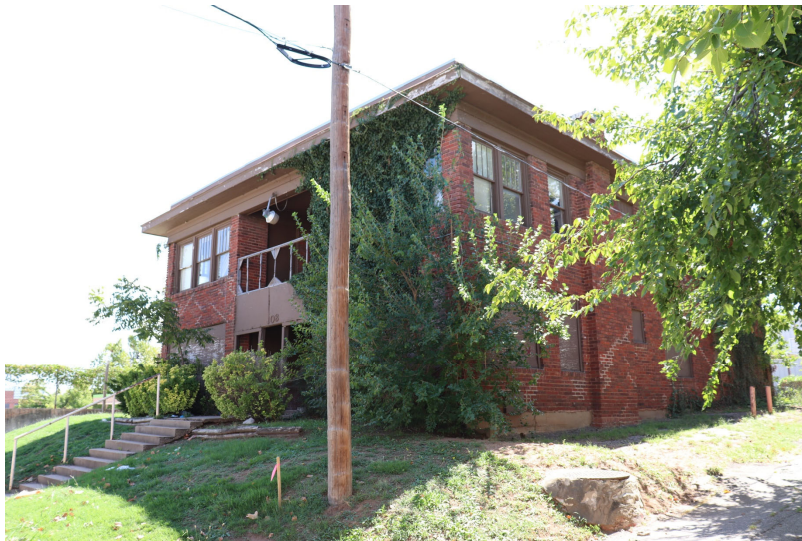
6

NW Corner

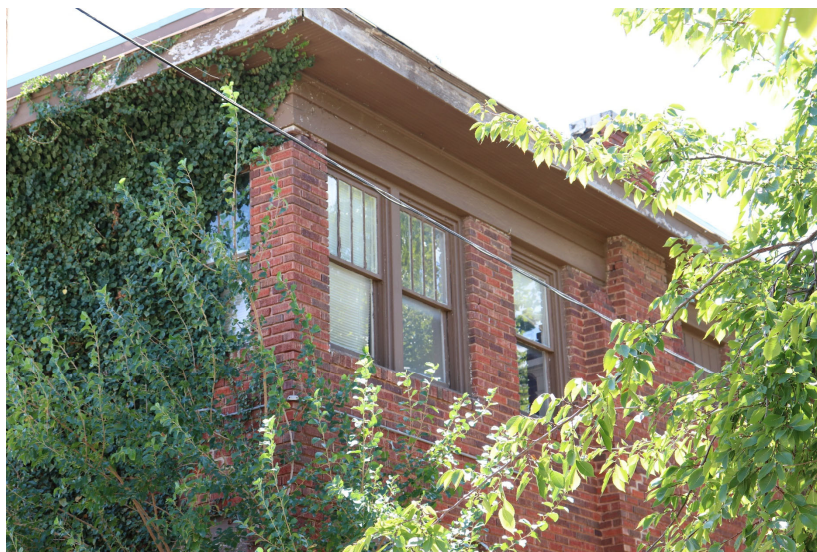
7

NW Corner Second Level; Windows of West Elevation

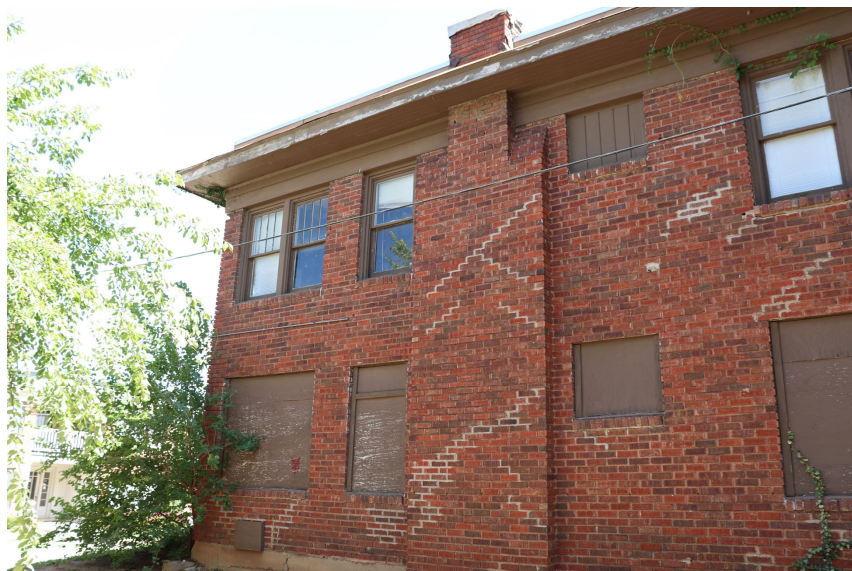
8

West Side Windows

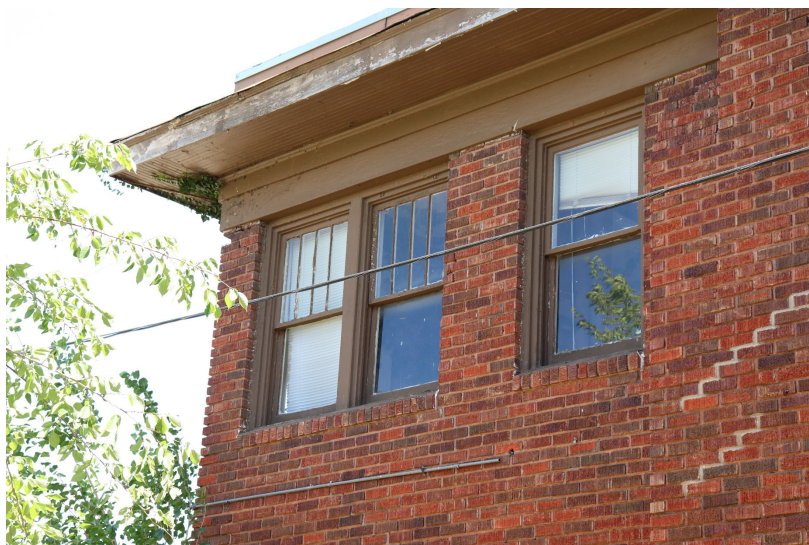
9

NW Corner Second Level

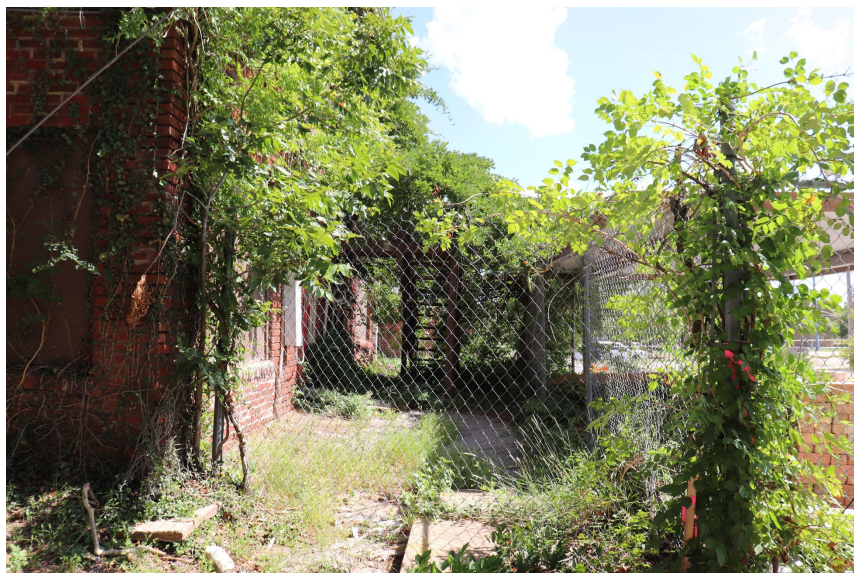
10

South Side (Rear) Looking East

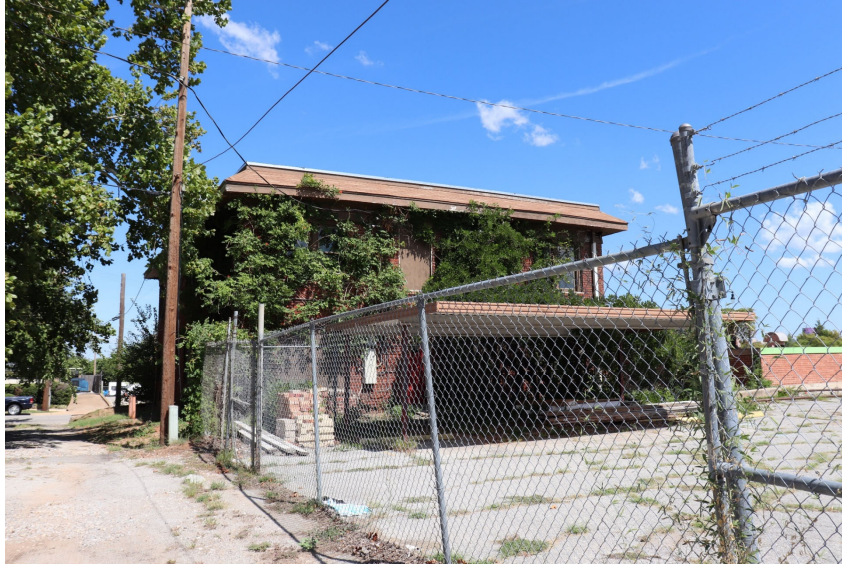
11

SW Corner Looking North

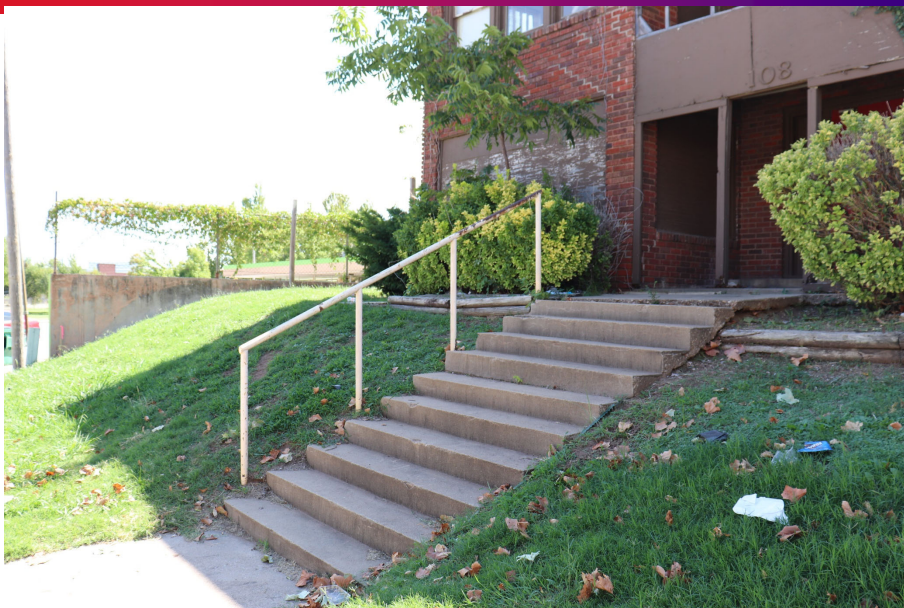
12

Steps Leading to Front Entry at North Elevation; Note Failing Slope or Terrace

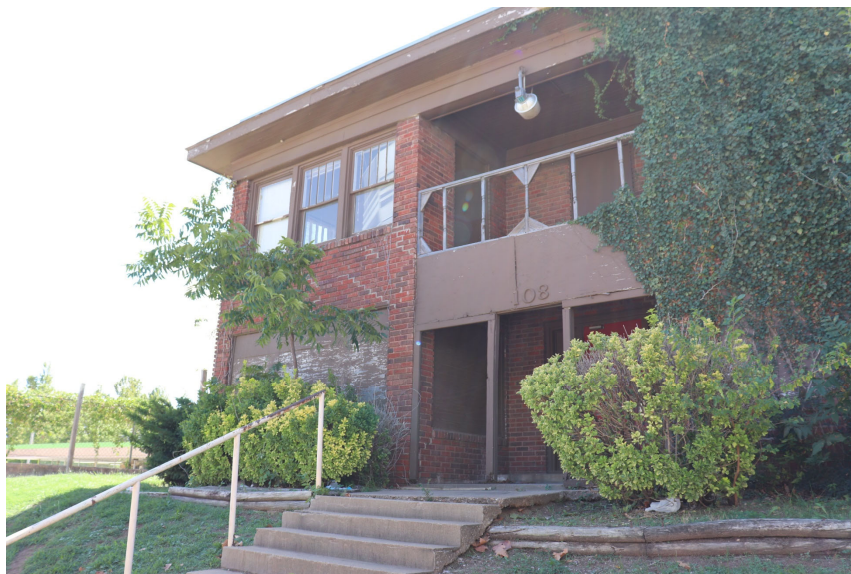
13

Front Entrance with Balcony Above; Looking SE

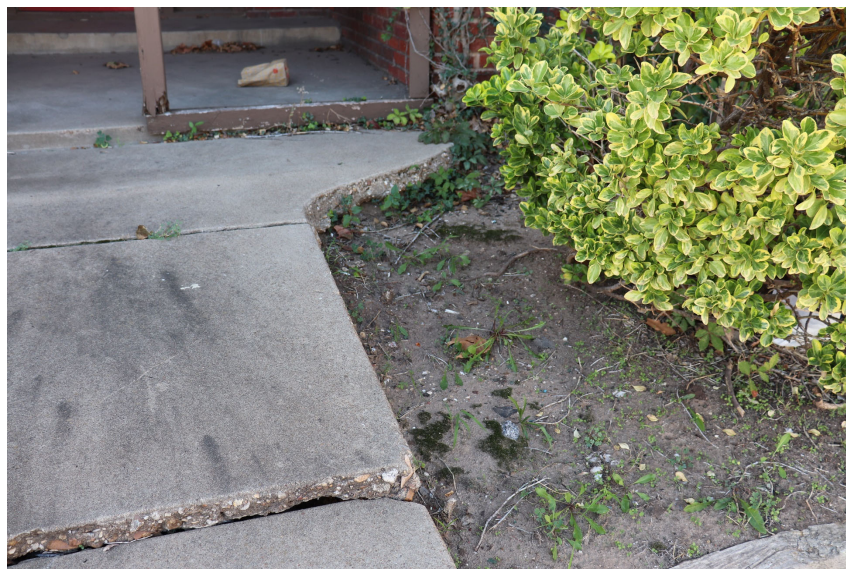
14

Sidewalk Leading to Front Entrance and Erosion

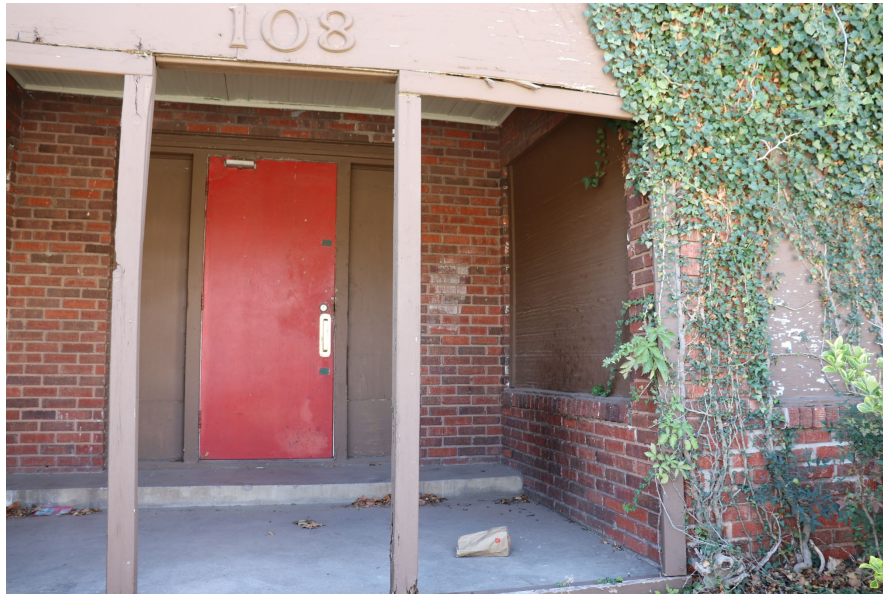
15

Front Entrance First Floor, North Elevation; Boarded Windows and Sidelights

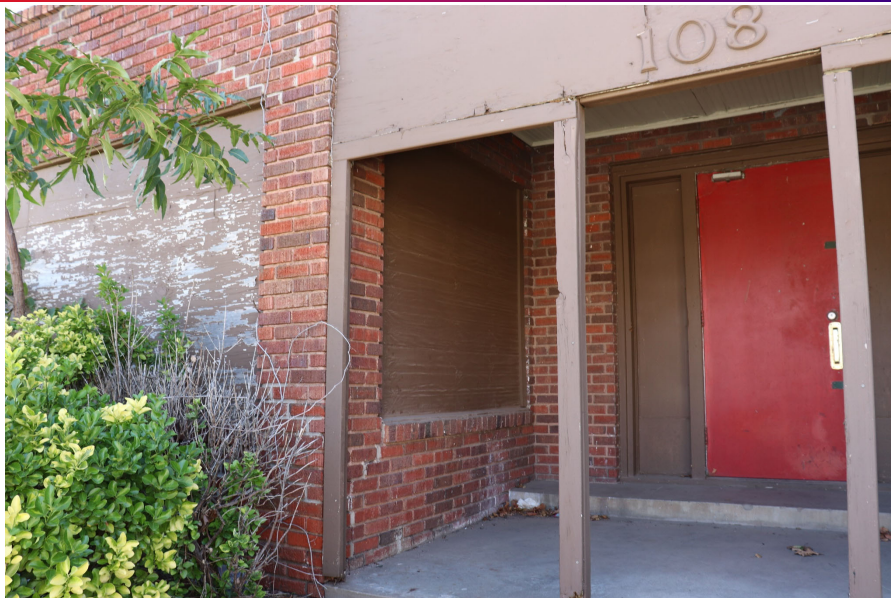
16

East Side of Front Entrance with Boarded Windows and Sidelights

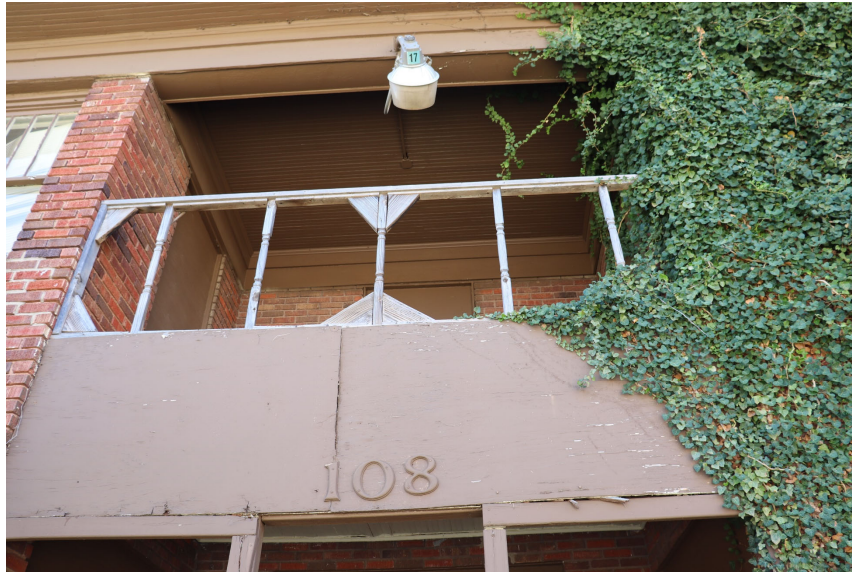
17

Second Level Balcony with Doors and Windows Boarded

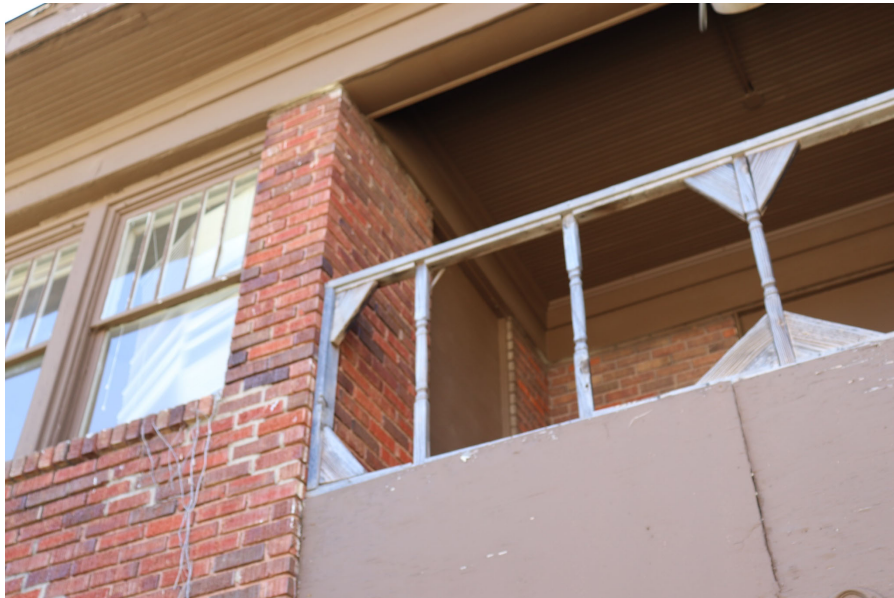
18

Second Level Entrance East Side Railing Detail

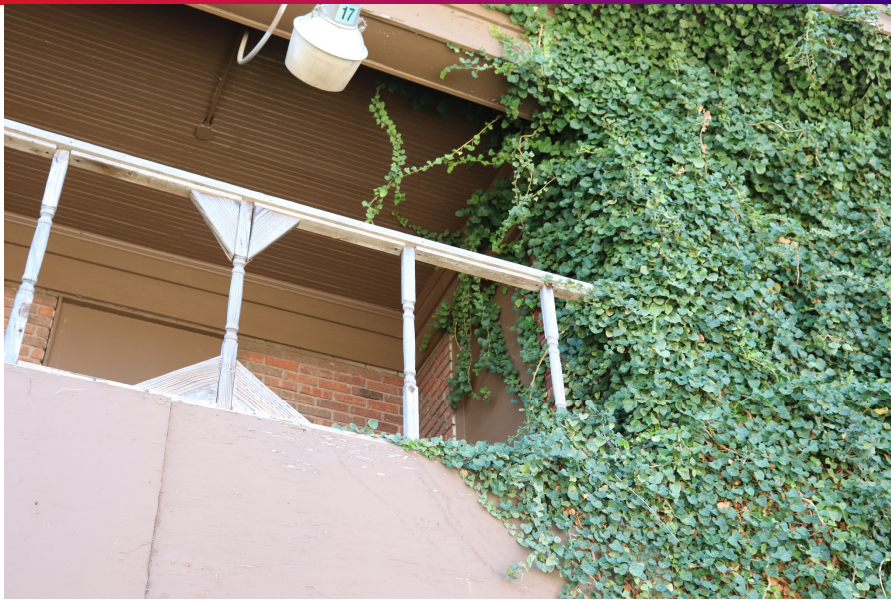
19

Second Level Entrance West Side Soffit Detail

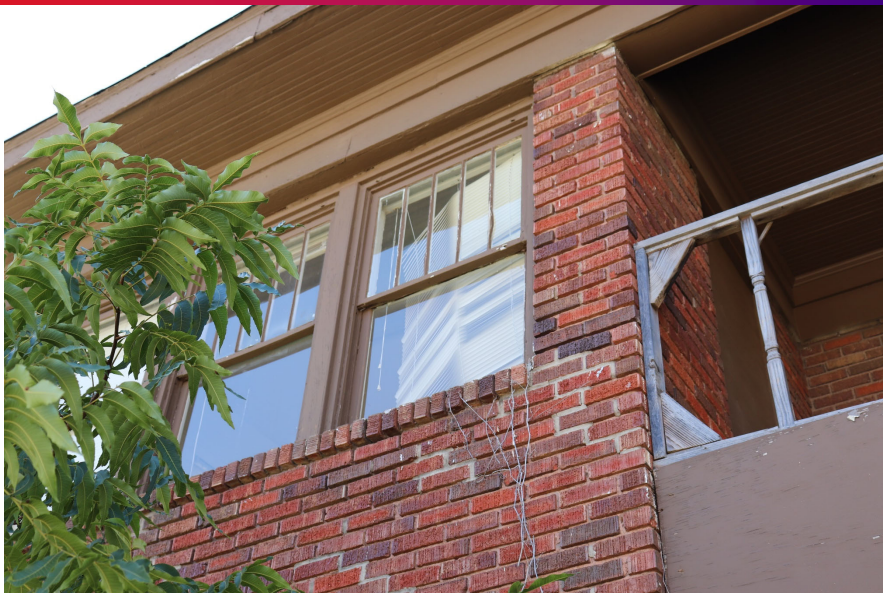
20

Second Level North Side Window Detail

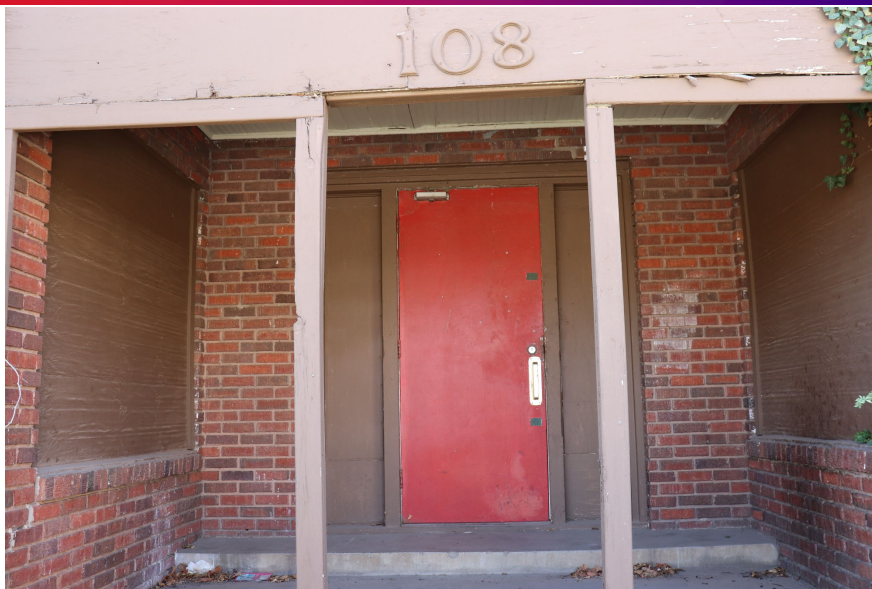
21

Front Entrance

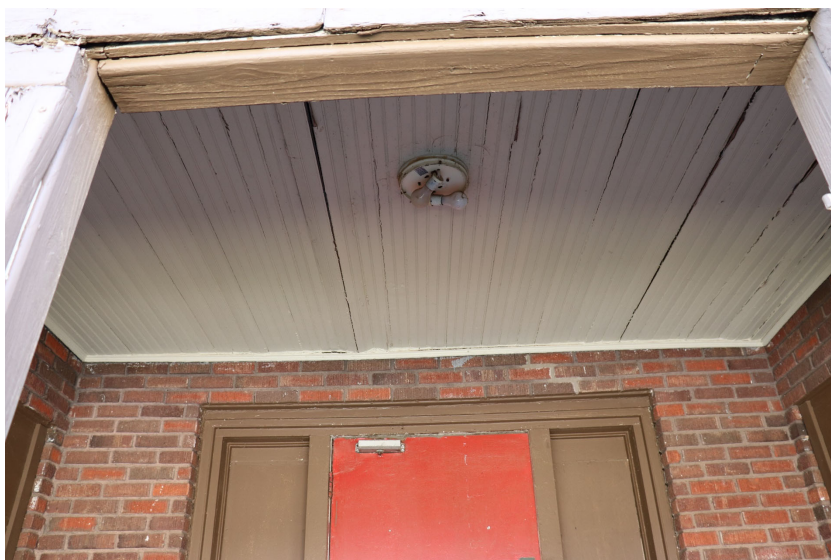
22

Front Entrance Ceiling

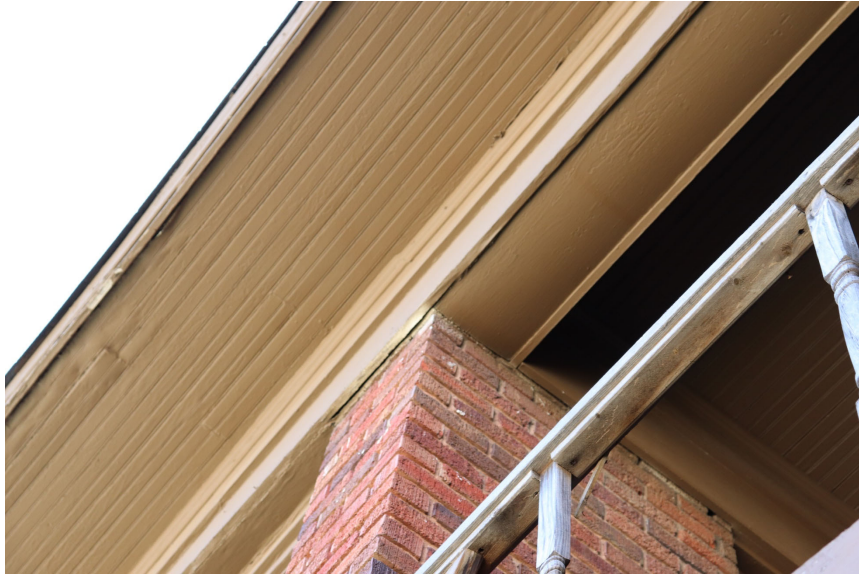
North Side Eaves
