APPLICATION FOR CERTIFICATE OF APPROPRIATENESS

Location of Proposed Work (Address): 101 Northwest 19th Street, Oklahoma City, OK 73103

SCOPE OF WORK

SECTION B: DOCUMENTATION OF EXISTING CONDITIONS

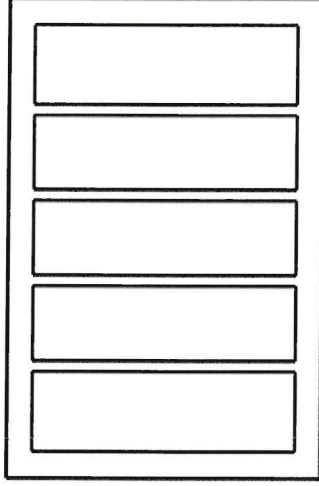
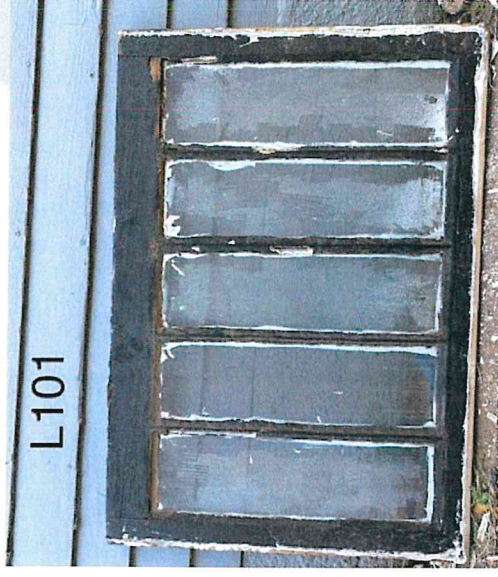
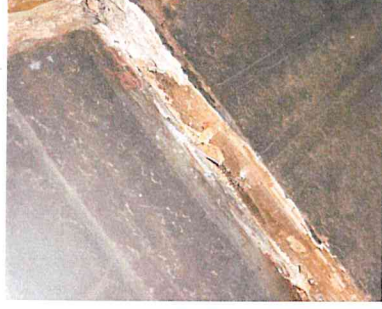
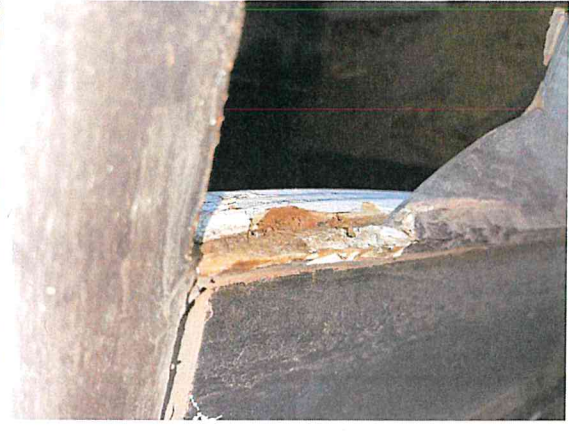
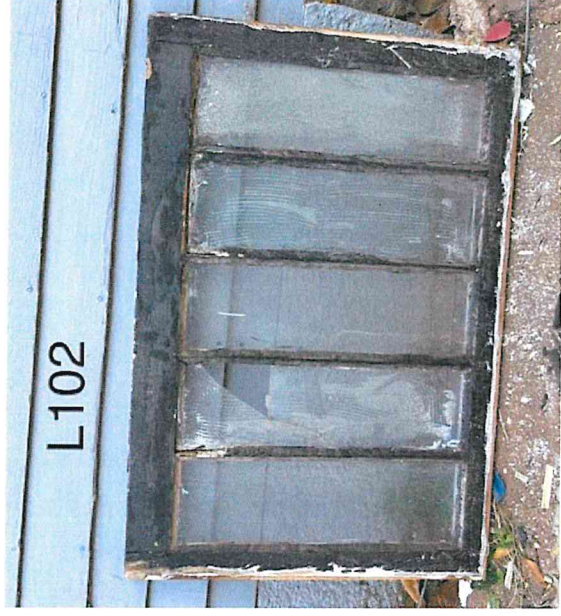
Left Side Window 1 & 2 (L101 & L102)

- Old Window:
- L101: Sturdy / Muntins Deteriorating from Rot
 - L102: Muntins Deteriorating from Rot

- Total Height: 23 3/8"
- Total Width: 35 7/8"
- Upper Rail Height: 2 1/8"
- Lower Rail: 3 1/8"
- Stiles: 2 1/8"
- Muntins 3/4"
- Glass Panels
 - Height: 18 1/8"
 - Width: 7 3/16"

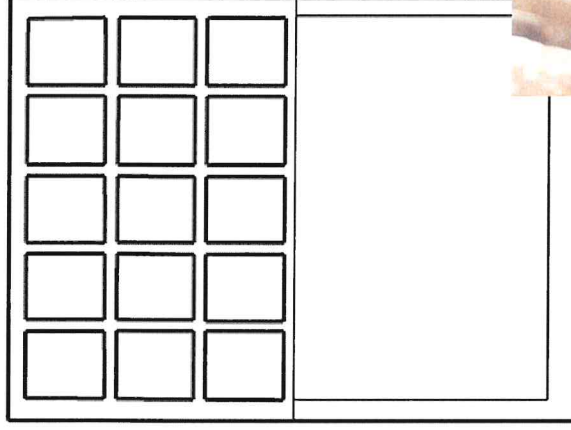
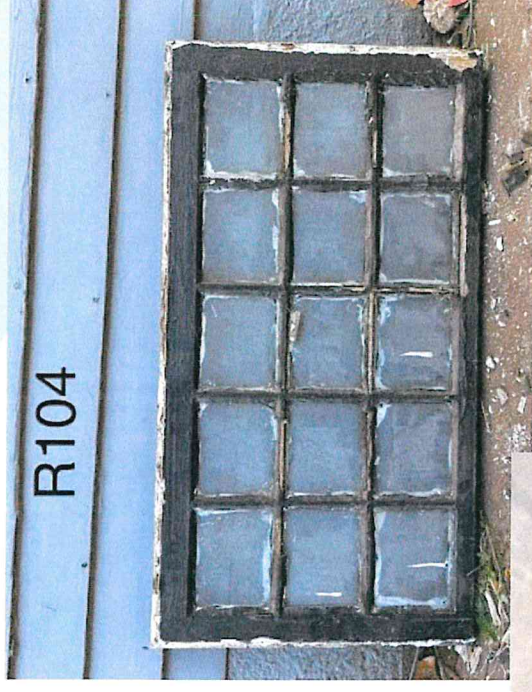
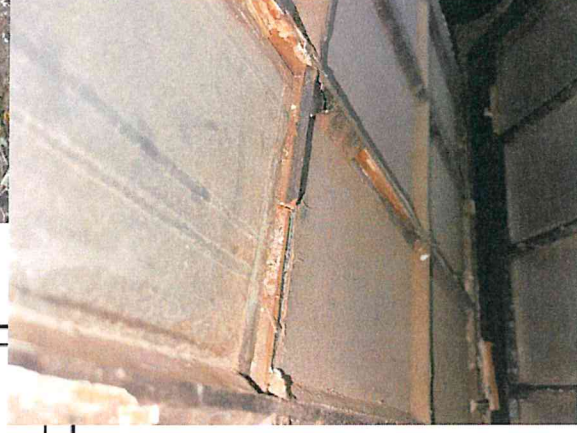
Right Window 4 (R104)

- R103: Muntins broken and deteriorated. Rails and stiles wobbly.
- R105: Muntins falling apart when removing glazing putty.
- R108: Muntins rotted. Can wiggle and pull off interior muntins with little force.

- R104: Muntins deteriorating when removing glazing putty.

- Total Height: 37 $\frac{3}{4}$ "
- Total Width: 36"
- Upper Rail Height: 2 $\frac{1}{8}$ "
- Lower (meeting) Rail Height: 1 $\frac{1}{4}$ "
- Lower Sash Rail: 3 $\frac{1}{8}$ "
- Upper and Lower Sash Stiles: 2 $\frac{1}{8}$ "
- Muntins $\frac{3}{4}$ "
- Glass Panels
 - Height: 6 $\frac{7}{8}$ "
 - Width: 7 $\frac{3}{16}$ "

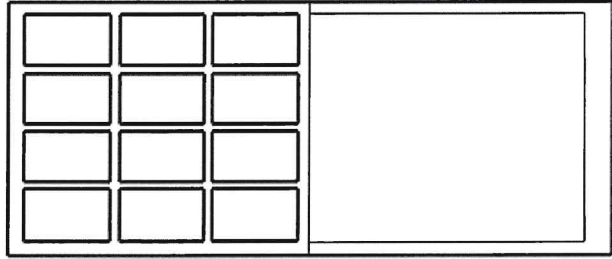
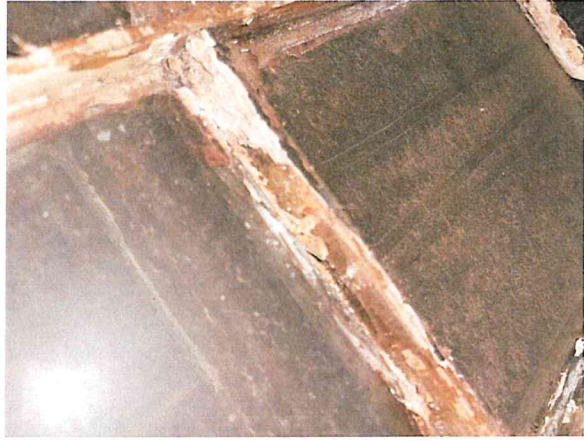
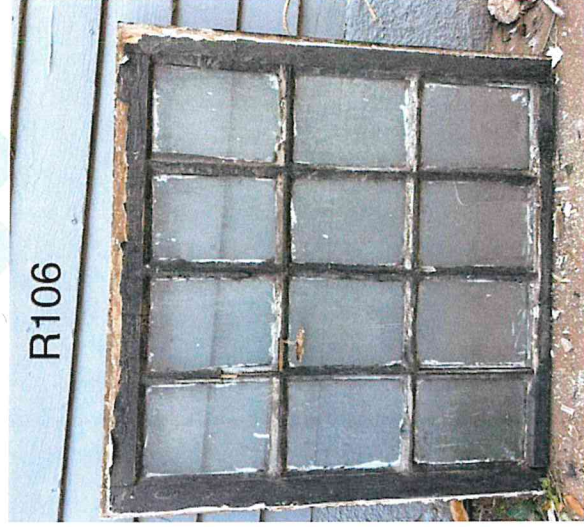
Right Side Window 6 & 7 (R106, R107)
New Window

- R106: All muntins deteriorated beyond repair
- R107: Previously Aluminum

- Total Height: 57 3/4"
- Total Width: 30 1/8"
- Upper Rail Height: 2 1/8"
- Lower (meeting) Rail Height: 1 1/4"
- Lower Sash Rail: 3 1/8"
- Upper and Lower Sash Stiles: 2 1/8"
- Muntins 3/4"

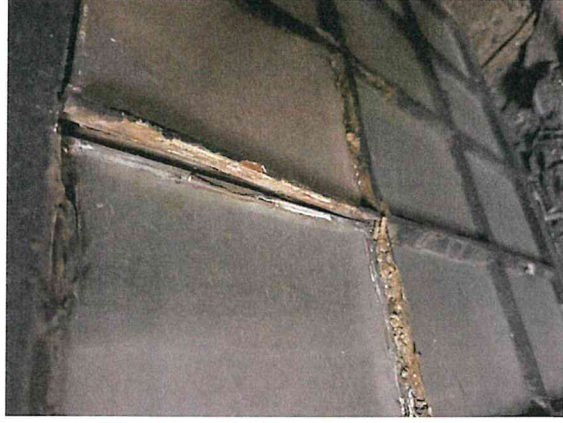
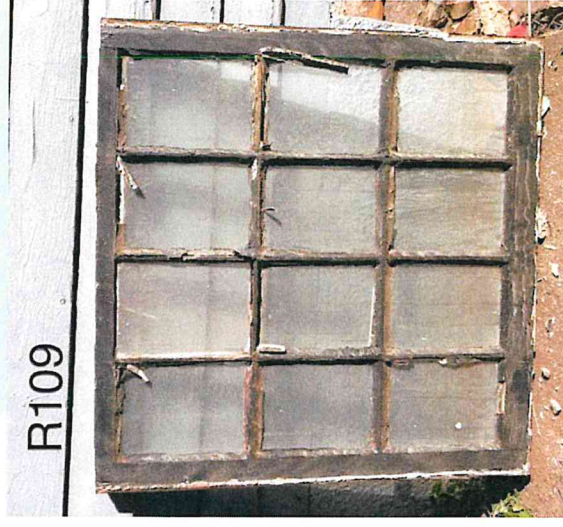
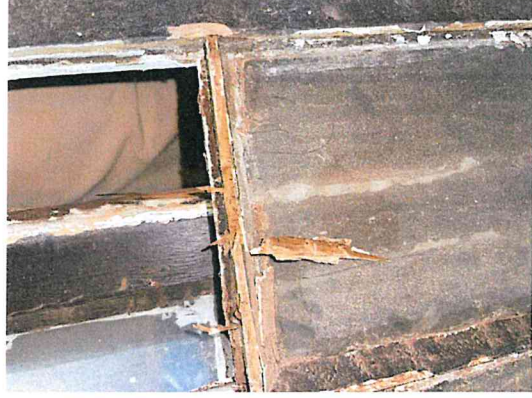
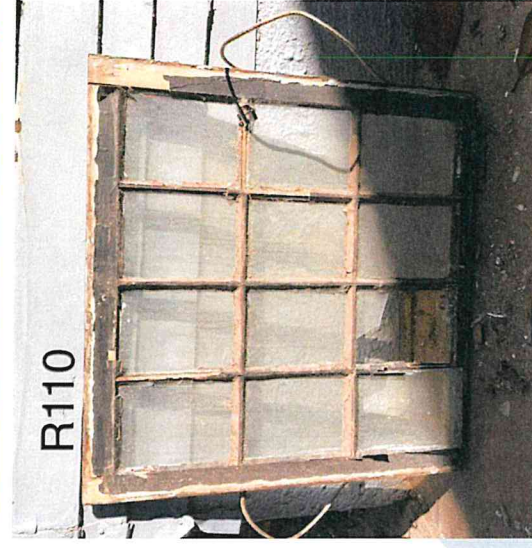
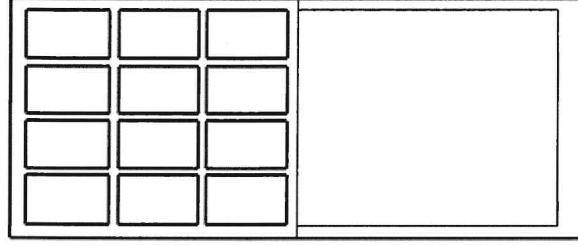
Right Side Window 9 & 10 (R109, R110)

- R109: Muntins and stiles deteriorating when trying to remove any paint.
- R110: Sash extremely unstable with rotted, disintegrating muntins.

- Total Height: 57 $\frac{3}{4}$ "
- Total Width: 30"
- Upper Rail Height: 2 $\frac{1}{8}$ "
- Lower (meeting) Rail Height: 1 $\frac{1}{4}$ "
- Lower Sash Rail: 3 $\frac{1}{8}$ "
- Upper and Lower Sash Stiles: 2 $\frac{1}{8}$ "
- Muntins $\frac{3}{4}$ "

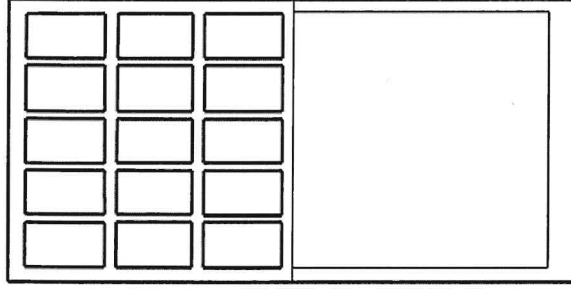
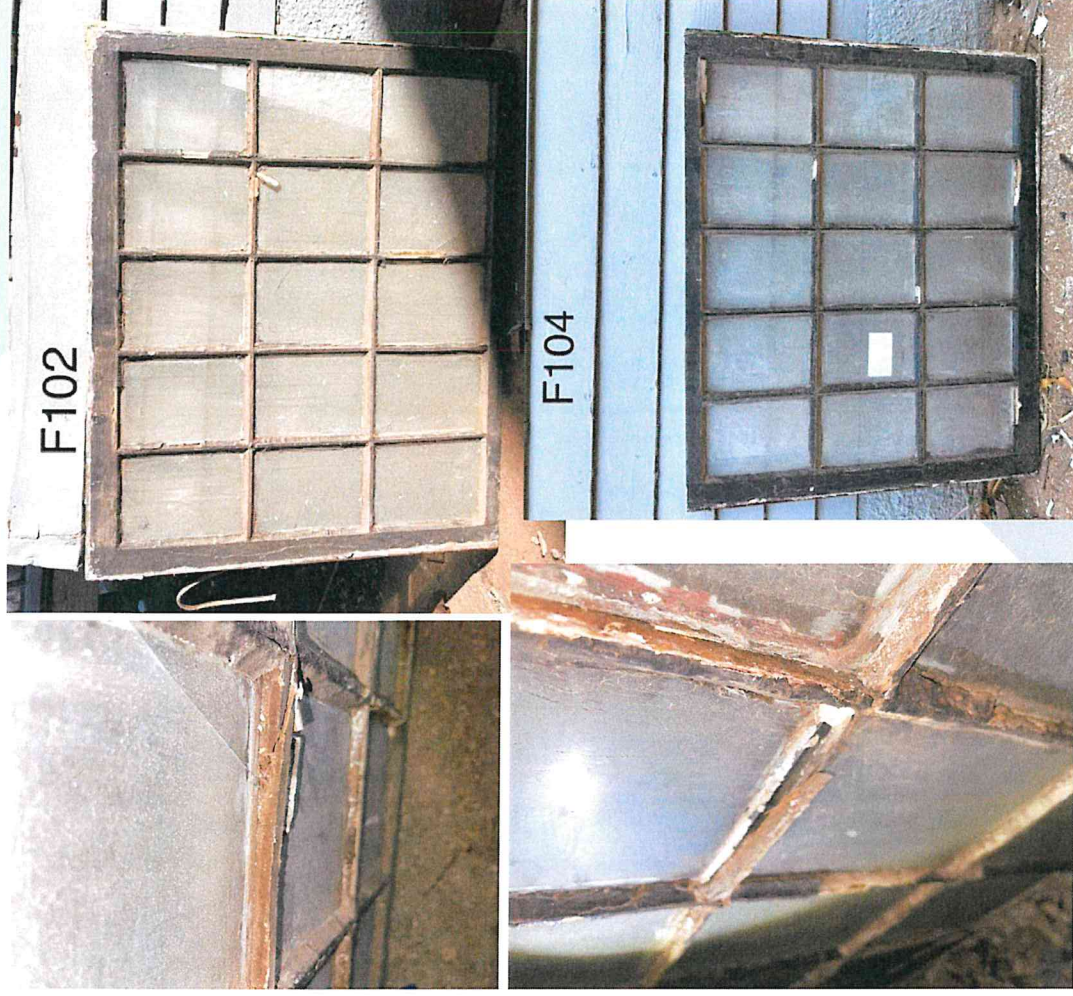
Front Window 2 & 4 (F 102 & 104)

- F102: All muntins deteriorated from rot. Attempting to remove glazing putty, removes muntin.
- F104: Solid feeling window, but was able to remove rotted wood from stile with pointer finger and thumb. Muntins deteriorated from rot.

- Total Height: 57³/₄"
- Total Width: 36"
- Upper Rail Height: 2 1/8"
- Lower (meeting) Rail Height: 1 1/4"
- Lower Sash Rail: 3 1/8"
- Upper and Lower Sash Stiles: 2 1/8"
- Muntins 3/4"

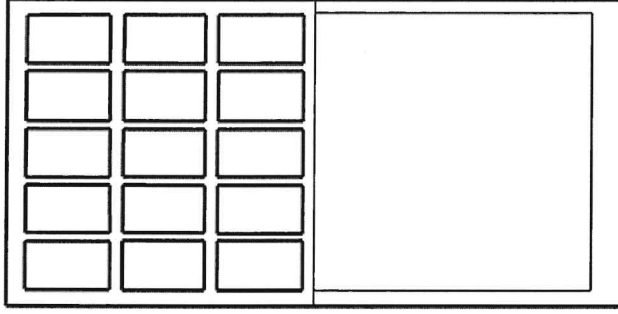
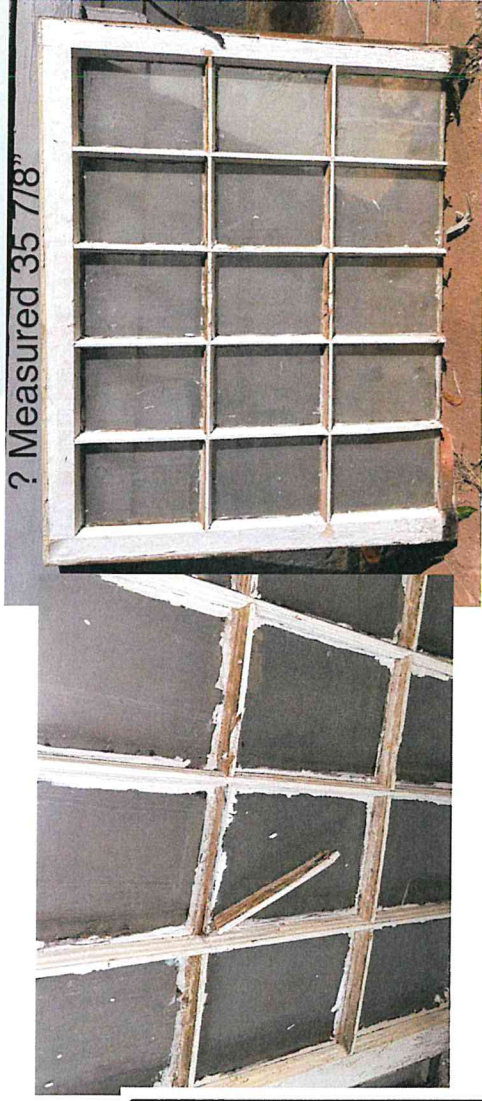
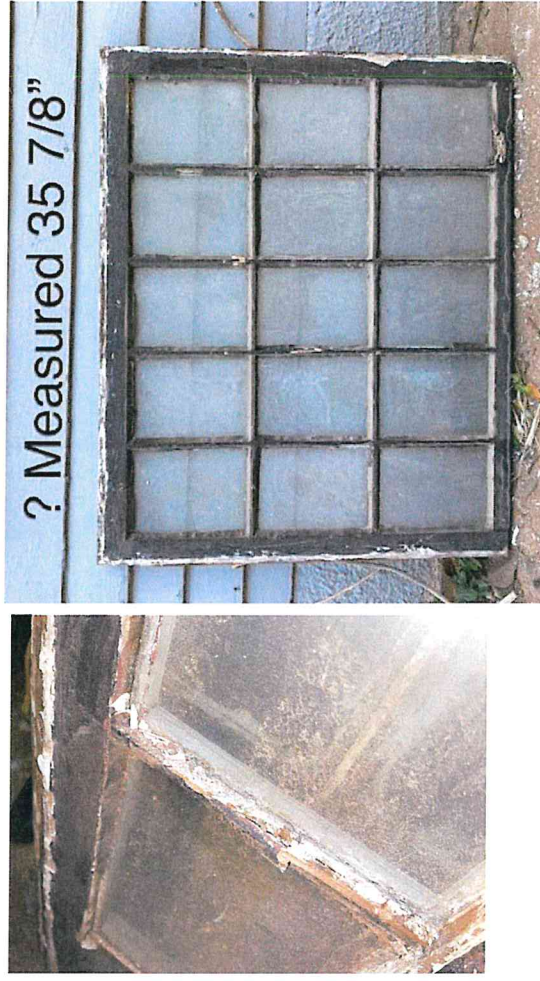
Front Window 1 & 3 / Back Window 3 (F 101, 103, B103)

- F101: We are unsure if this is for F101, but likely. Muntins deteriorate to the touch. Meeting rail gone.
- F103: We are unsure if this is F103, but likely. Muntins deteriorate to the touch
- B103 Previously Aluminum

- Total Height: 57³/₄"
- Total Width: 36¹/₄"
- Upper Rail Height: 2 1/8"
- Lower (meeting) Rail Height: 1 1/4"
- Lower Sash Rail: 3 1/8"
- Upper and Lower Sash Stiles: 2 1/8"
- Muntins 3/4"
- Glass Panels
 - Height: 11 7/8"
 - Width: 7 1/4"

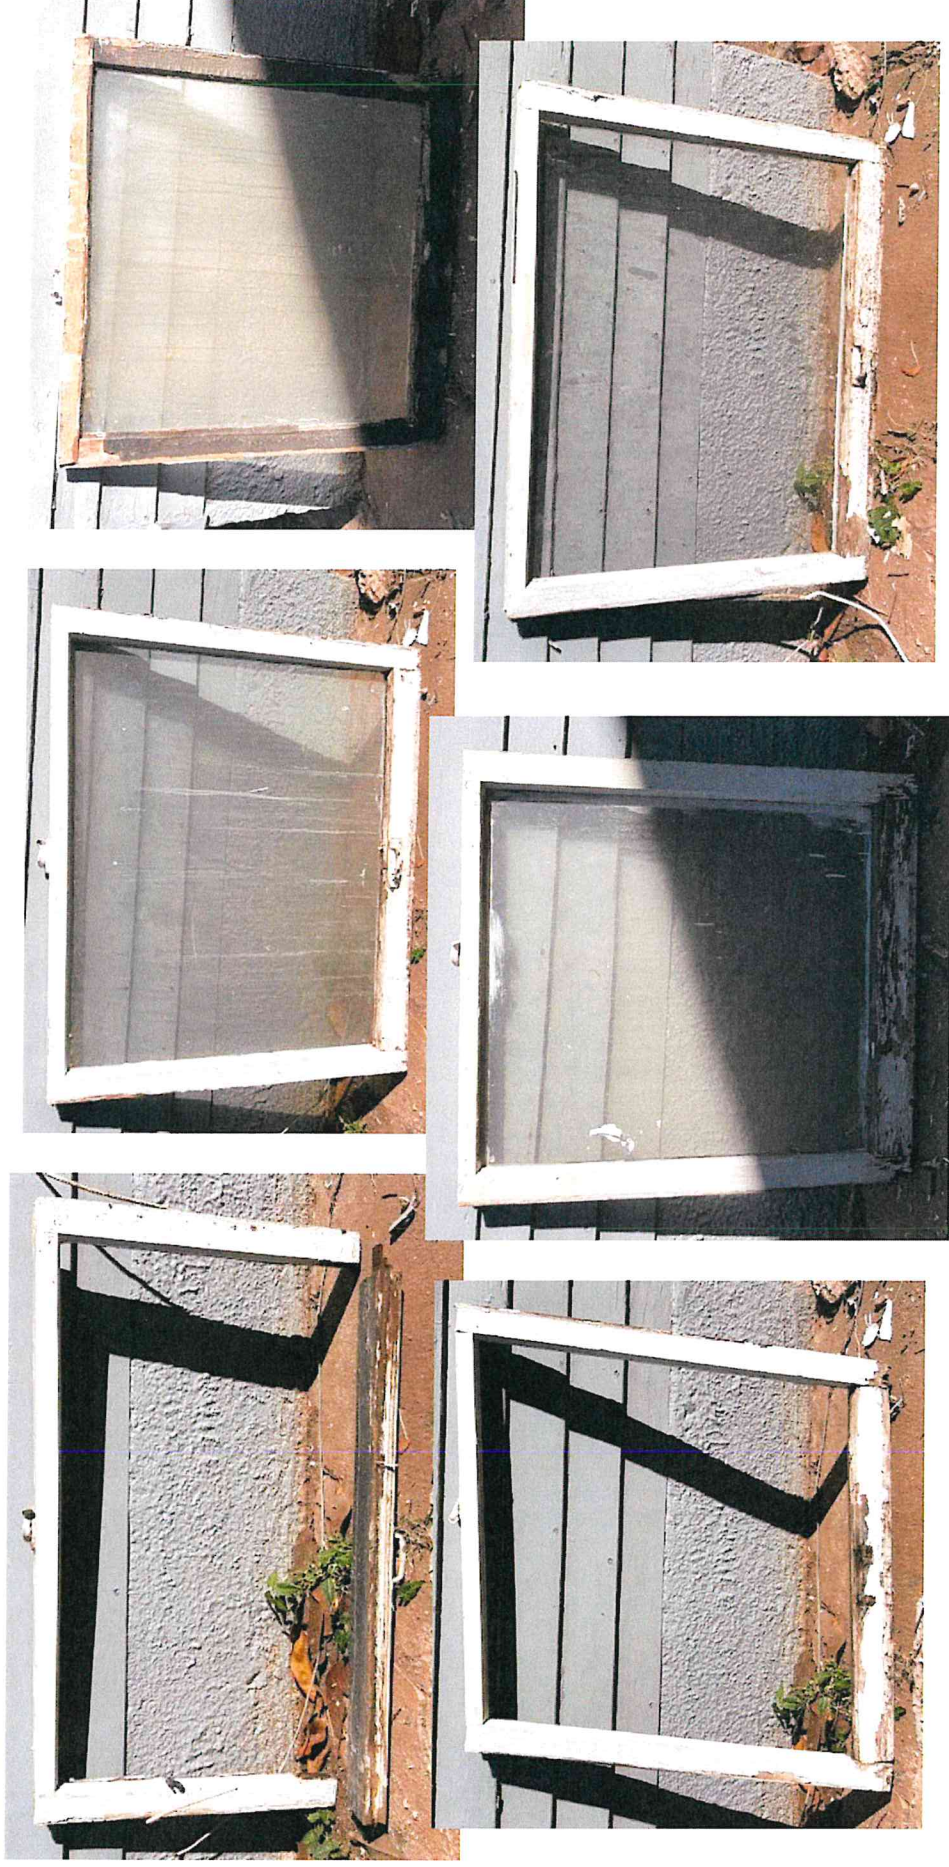
Documented bottom sashes that are not linked to an upper sash.

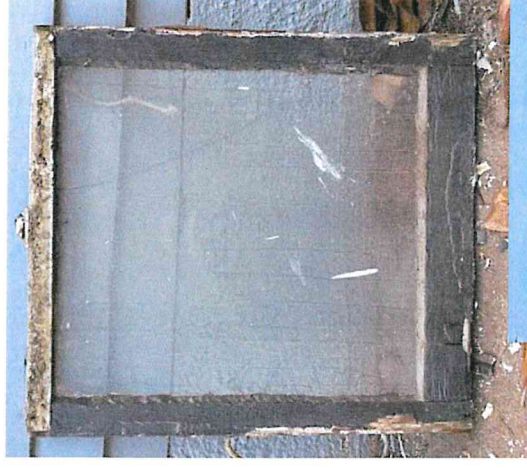
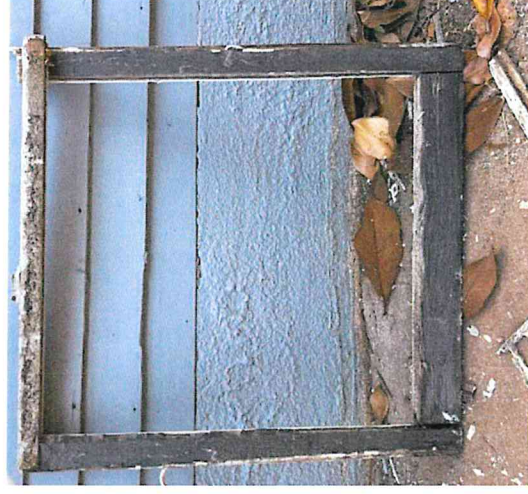
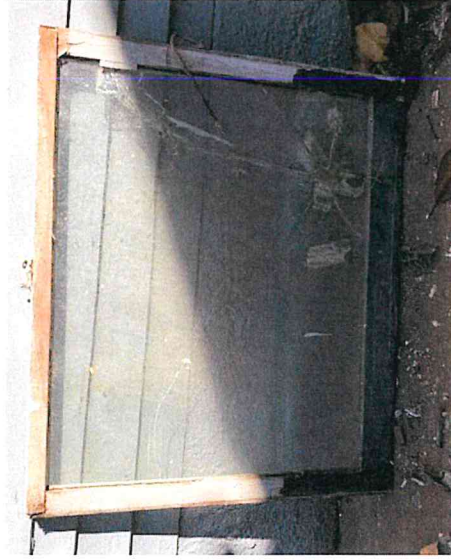
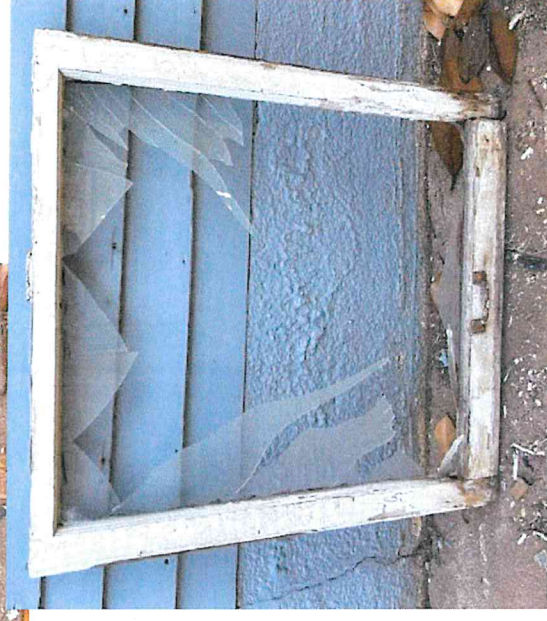
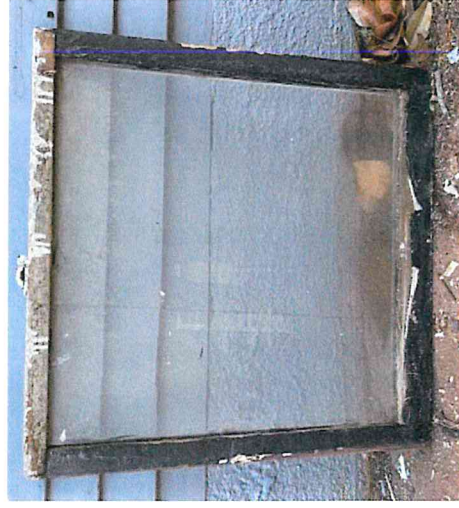
Documented bottom sashes that are not linked to an upper sash.

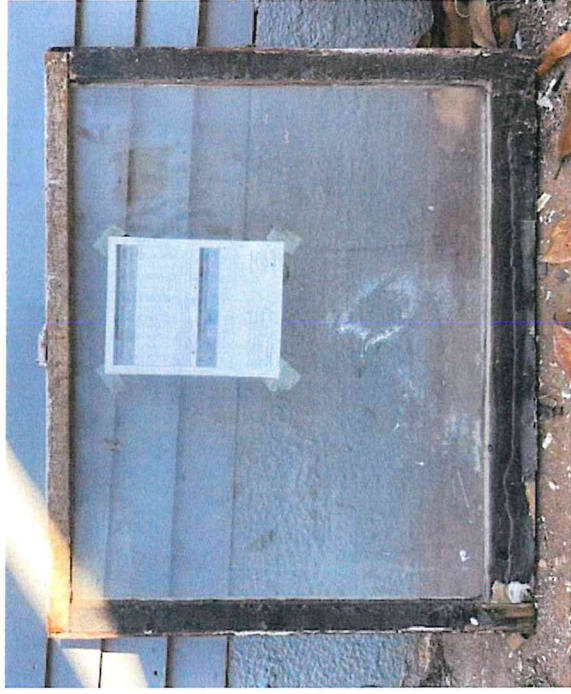
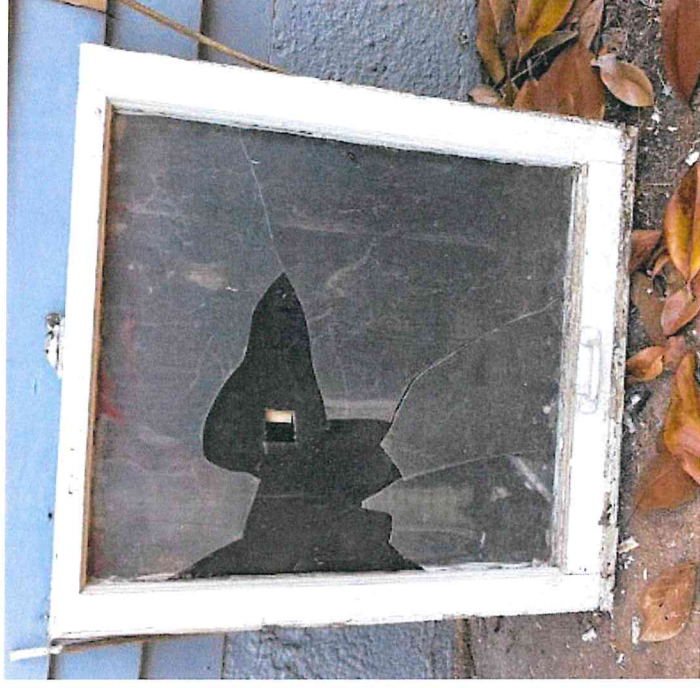
Documented bottom sashes that are not linked to an upper sash.

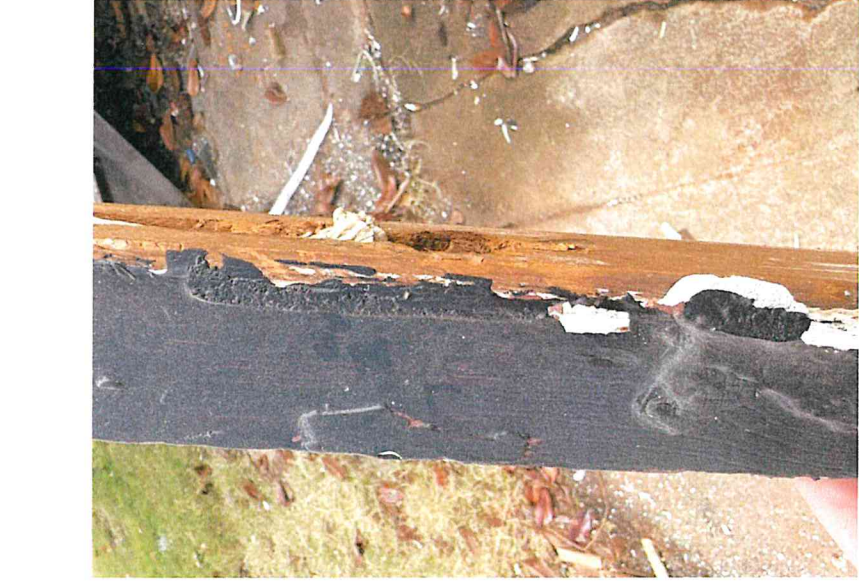
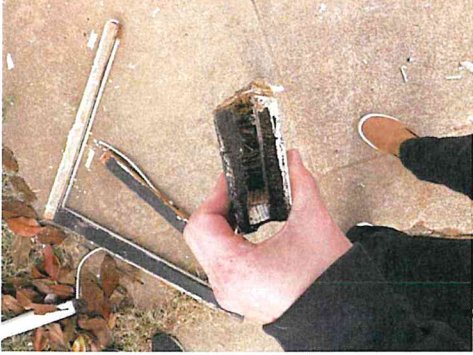
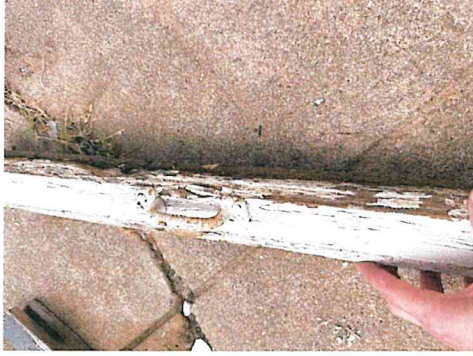
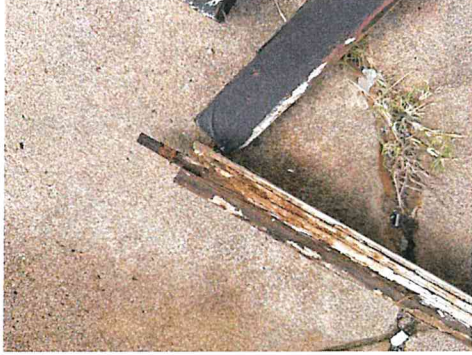
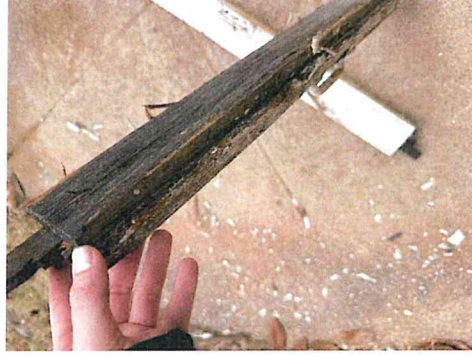
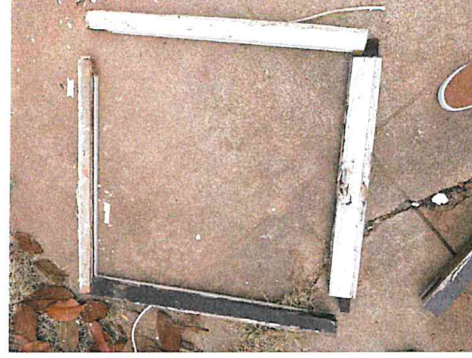
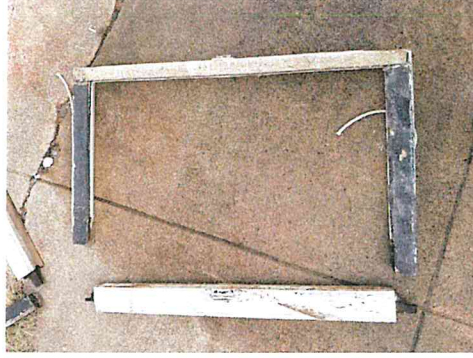
Additional photos of condition of bottom sashes. Significant rot and decay.
