**HPCA-21-00005**

**530 NW 20<sup>th</sup> Street**

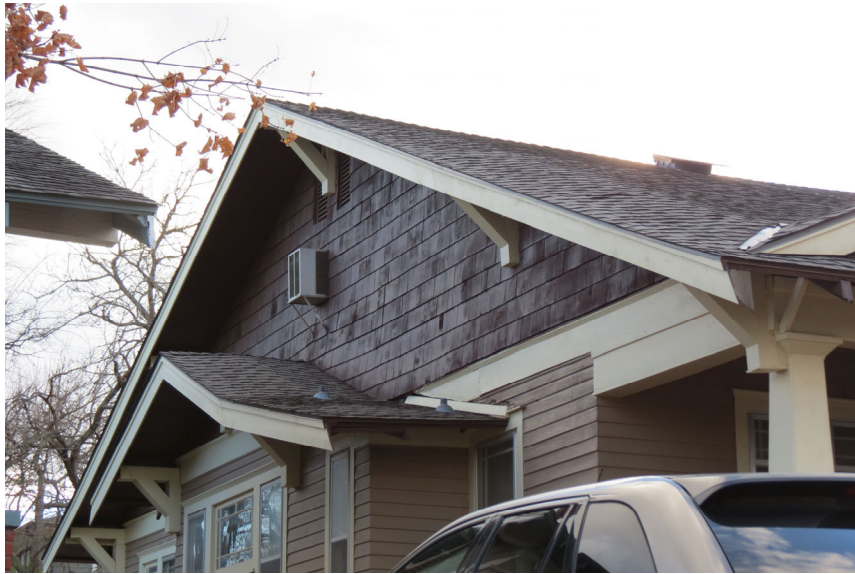
7

**Small AC Unit to be Replaced with Window**

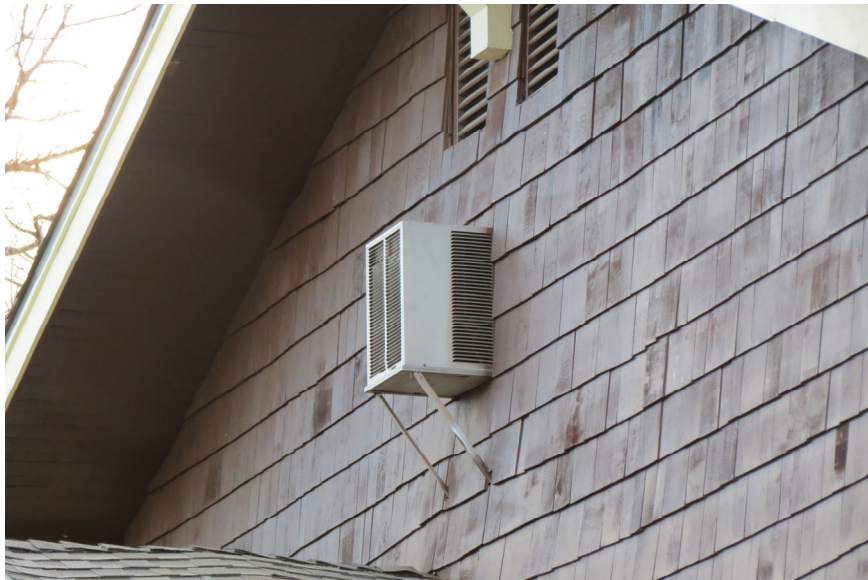
8

**Detail AC Unit**

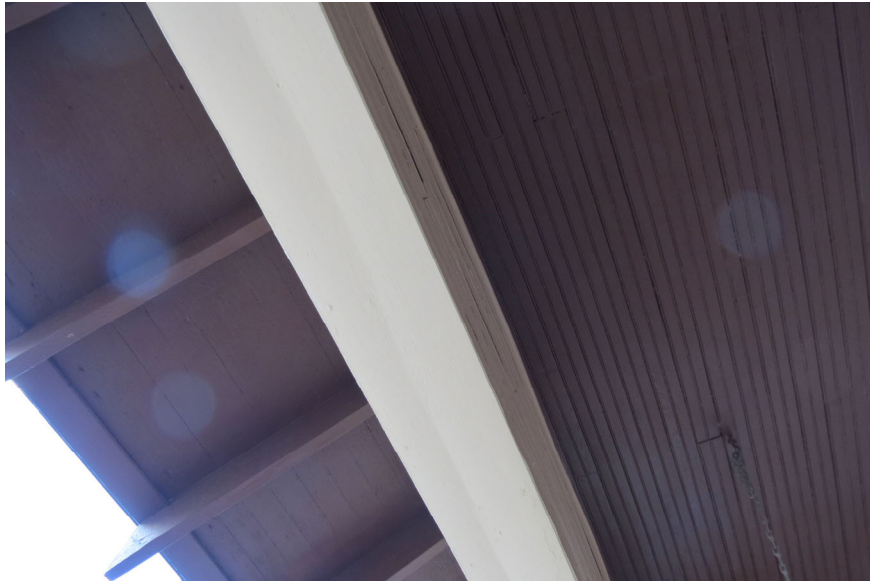
11

**Porch Beam Above East Pier Offers No Evidence of Previously Existing Column**

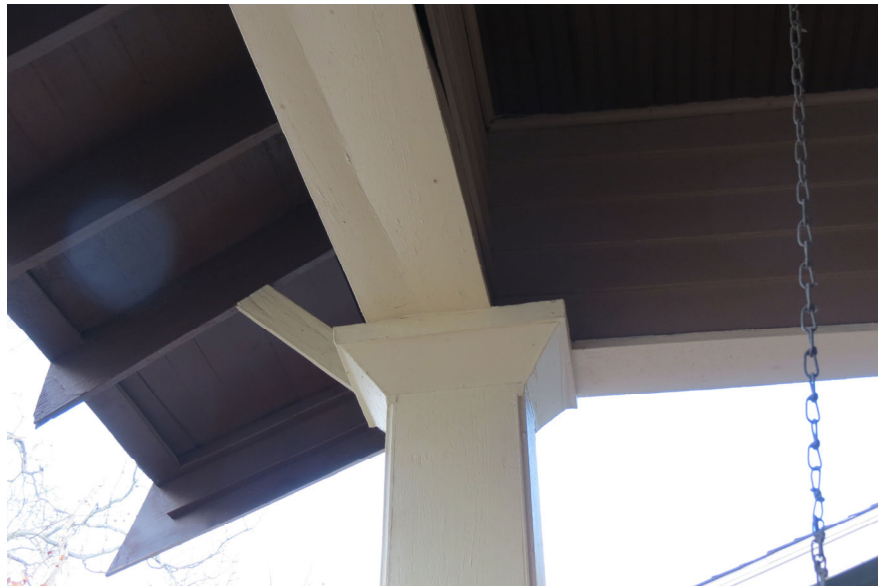
12

**Interaction of Easternmost Porch Column**

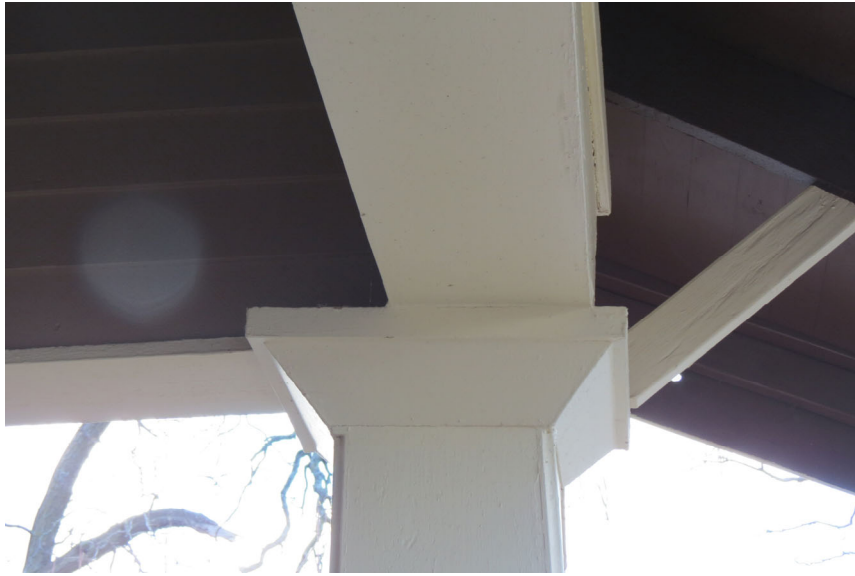
15

**Interaction of West Column with Beam of Front Porch**

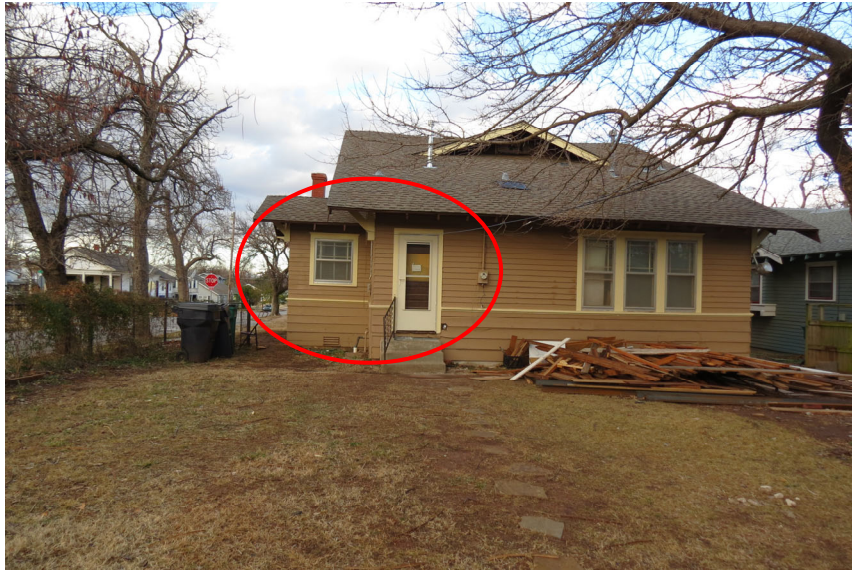
17

**Window and Door to Exchange Locations**
