The City of  
**OKLAHOMA CITY**

**APPLICATION FOR CERTIFICATE OF APPROPRIATENESS**

Location of Proposed Work (Address): 217 NW 31st Street, Oklahoma City, OK 73118

☒ **Work not specified above** Installation of handrail to front porch steps.

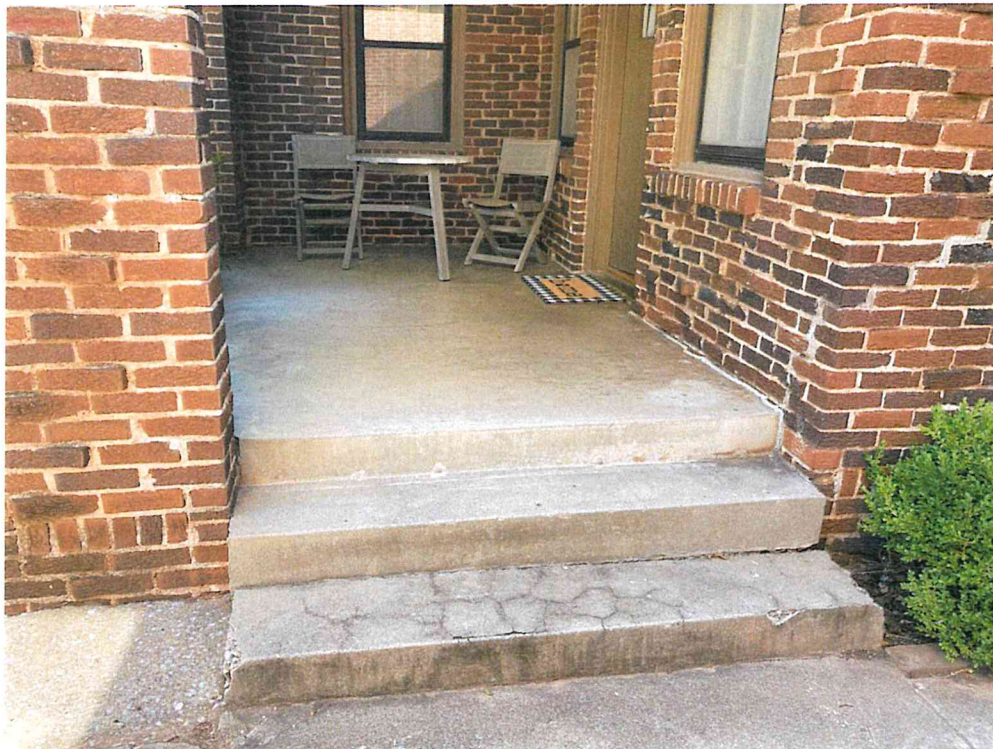
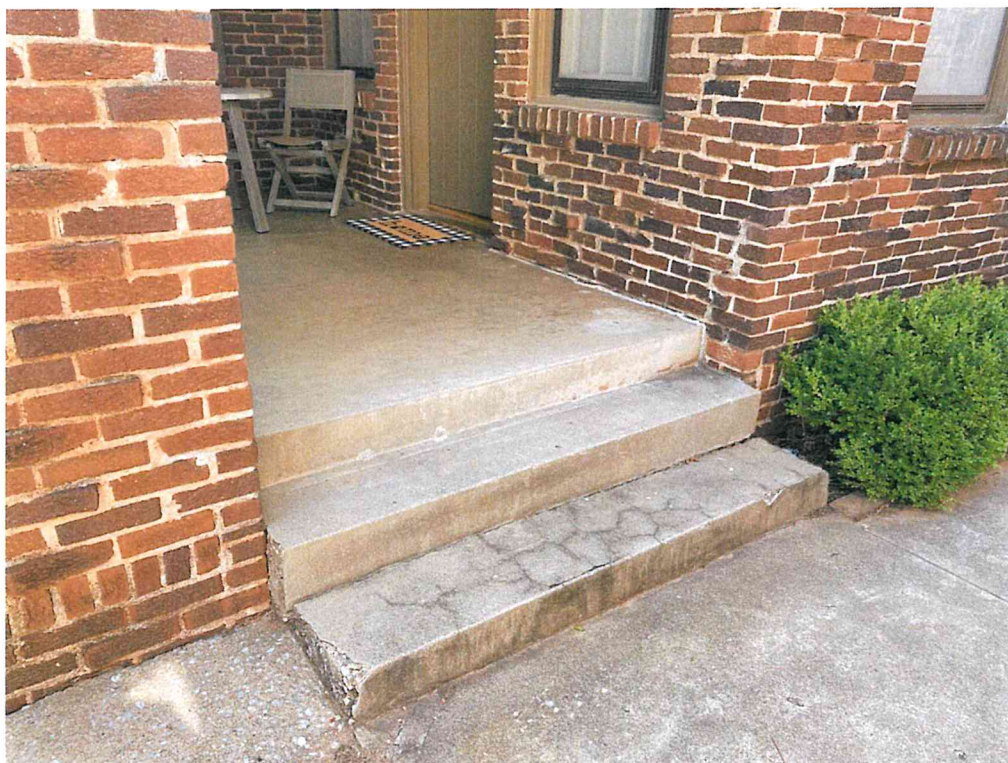
Documentation of Current Condition:

- A. Scope of work: Add wrought iron handrails to steps leading to front porch of the home.
- B. Document of existing conditions: No handrails on front porch steps.
- C. Site plans: Front porch steps
- D. Elevations, floor, and roof plans: See attached
- E. Construction materials and methods: Black wrought iron, attached to concrete of steps and porch
- F. Products: wrought iron
