APPLICATION FOR CERTIFICATE OF APPROPRIATENESS

Location of Proposed Work (Address): 301 NW 18th St, OKC 73103

FENCE REPLACEMENT AT THE WIGGIN RESIDENCE

301 NW 18th Street

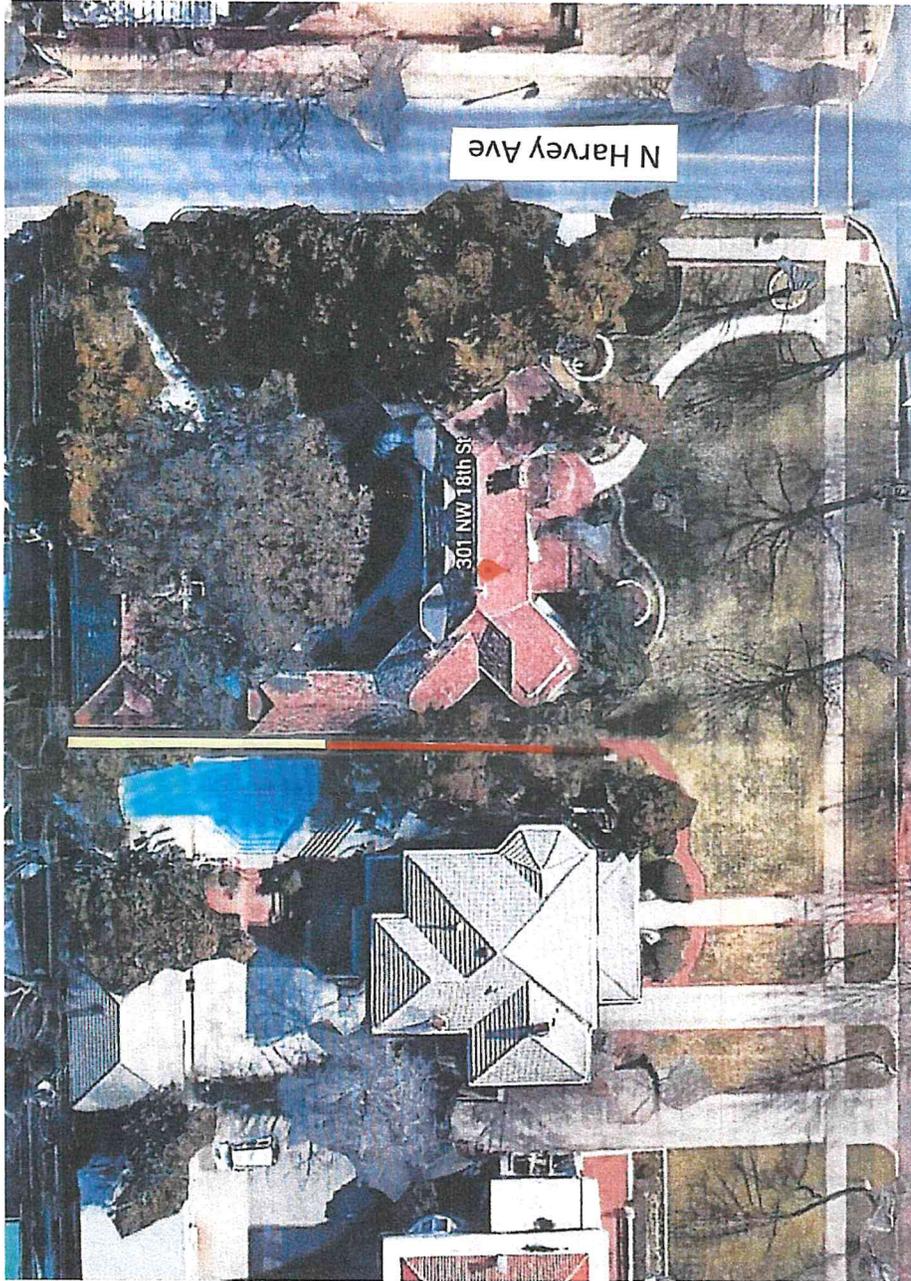
1. **Scale:** The aerial photo shows a scale of approximately 38 feet to the inch. According to the County Assessor's records, the property includes 100 feet along NW 18th Street and approximately 143 feet from 18th Street to the centerline of the alley.

2. **North arrow:** See the aerial.
3. **Property lines:** NW 18th Street on the south, N Harvey Ave on the east, the centerline of the alley to the north, and the west side of the fence on the west.

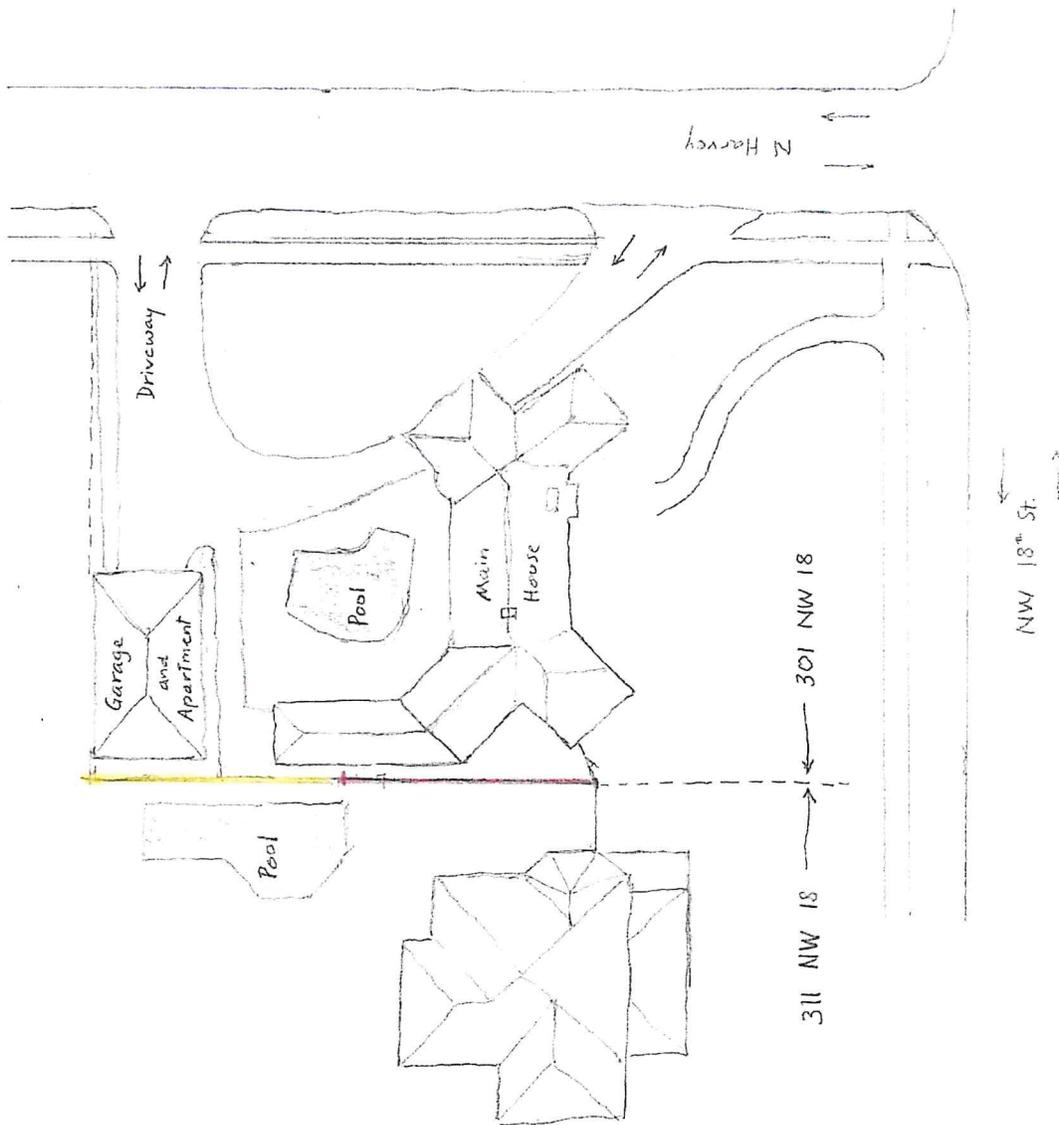
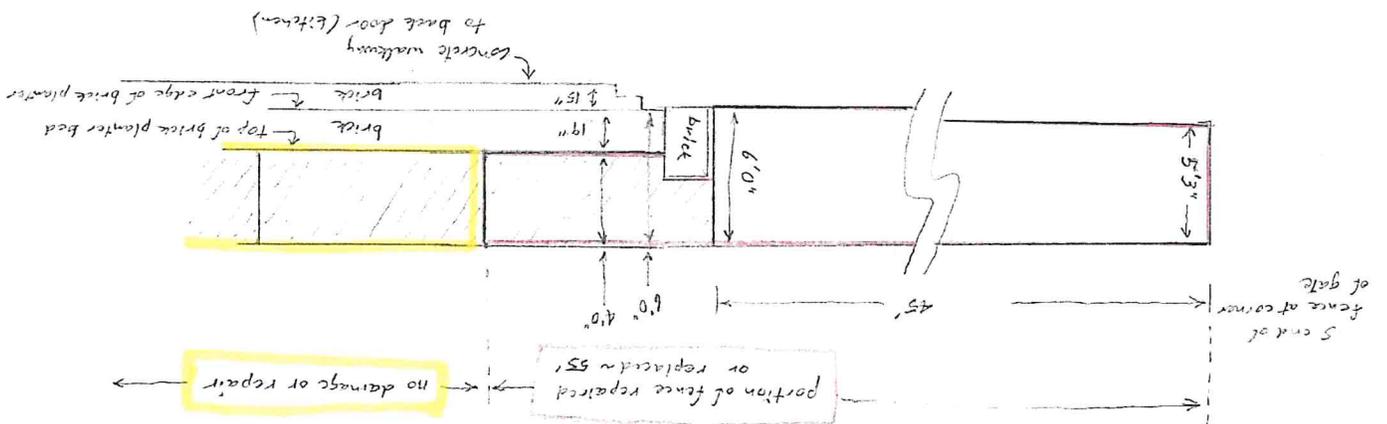
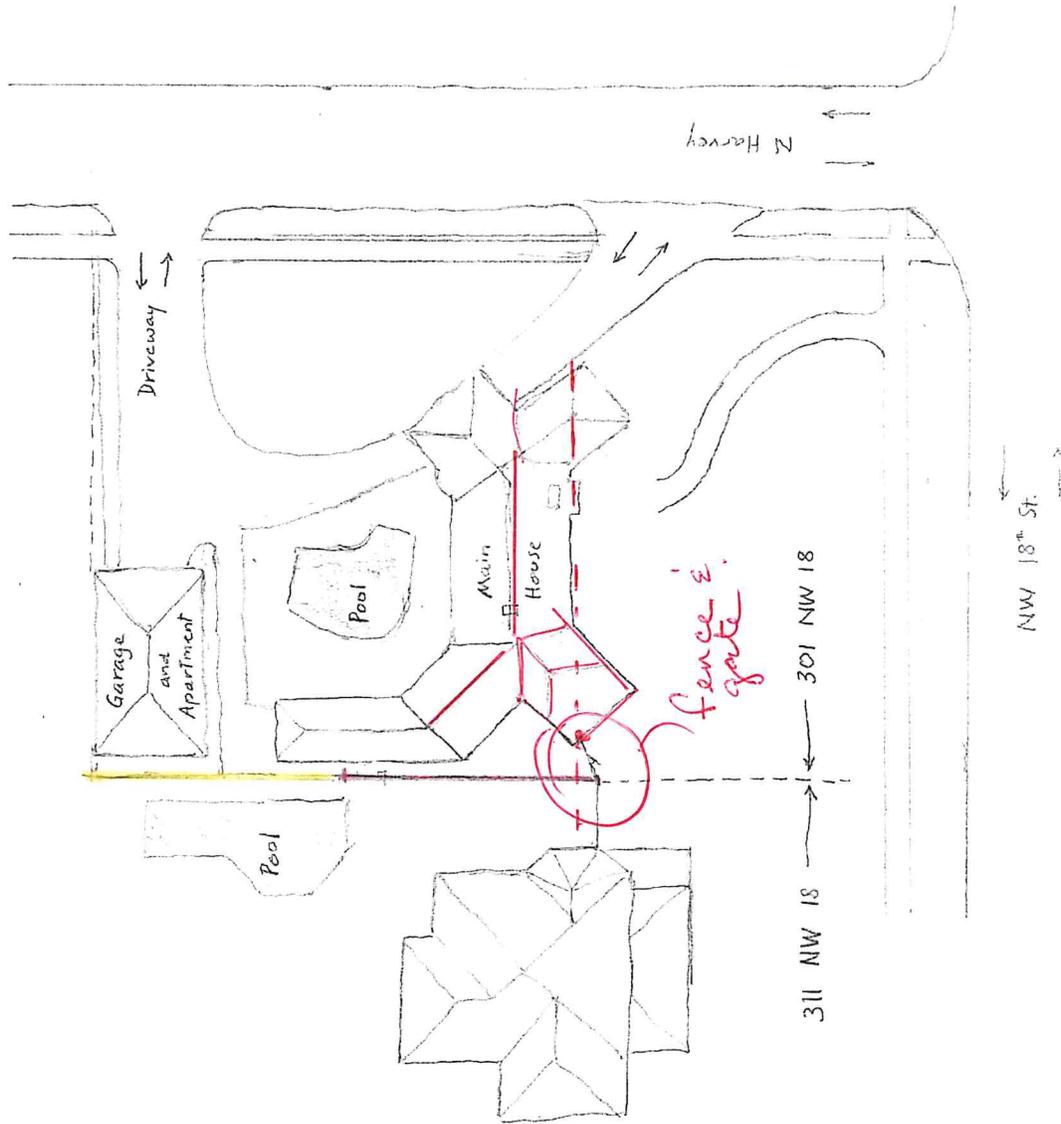
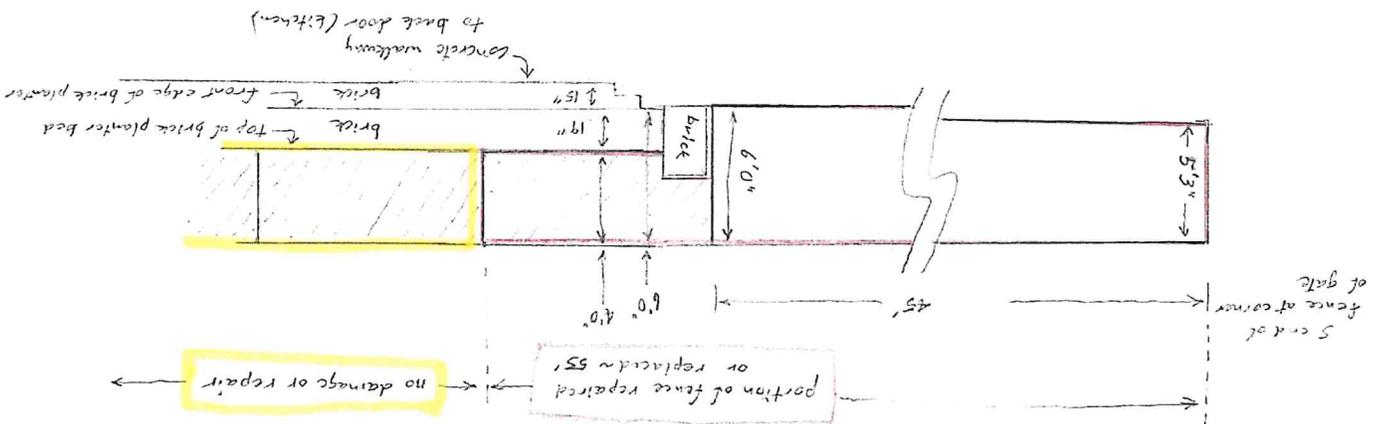
Revised
1-3-2021

5. **Dimensions:** From the front gate corner to the brick planter bed (45 feet) the fence will be 6 feet tall. The lattice fence along the planter bed (10 feet knocked over) will be 4 feet tall to match the fence on both sides. The remaining 20 feet of lattice fence and 33 feet of regular cedar fence to our side of the alley was not damaged and will remain as-is.

A ~ 27'
 B ~ 8'
 C ~ 19'
 D ~ 51'
 E ~ 26'

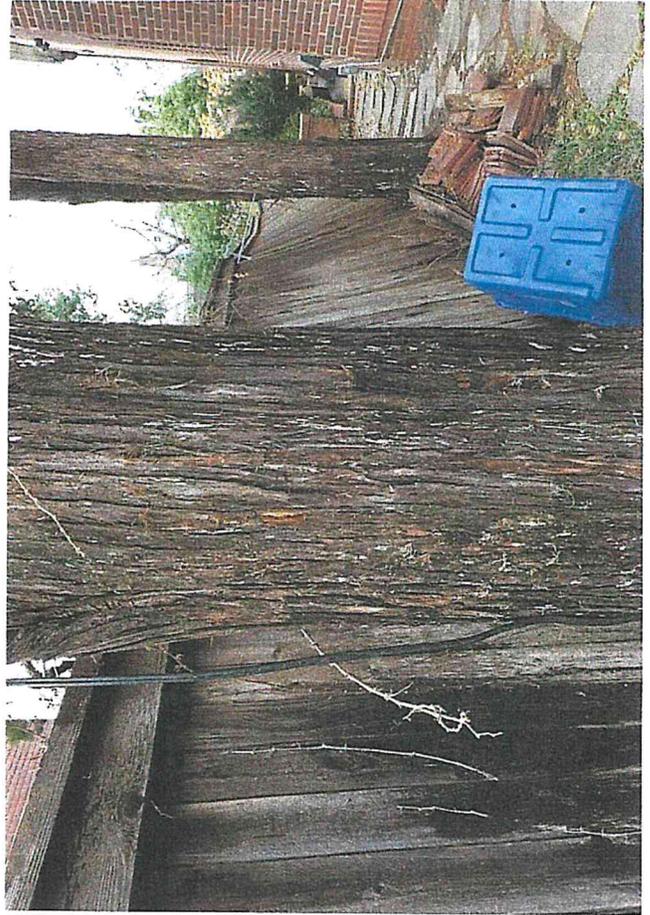
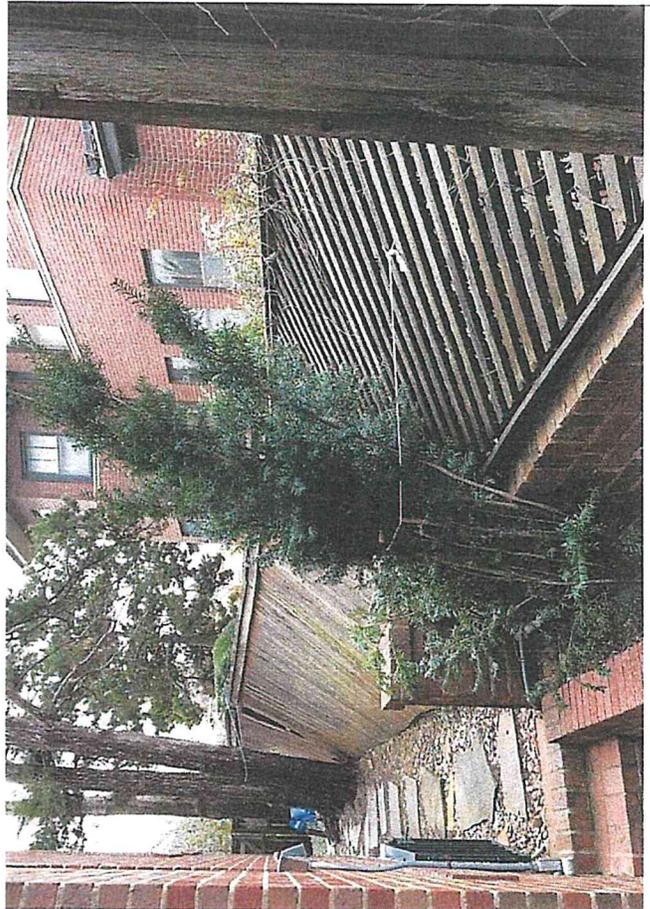
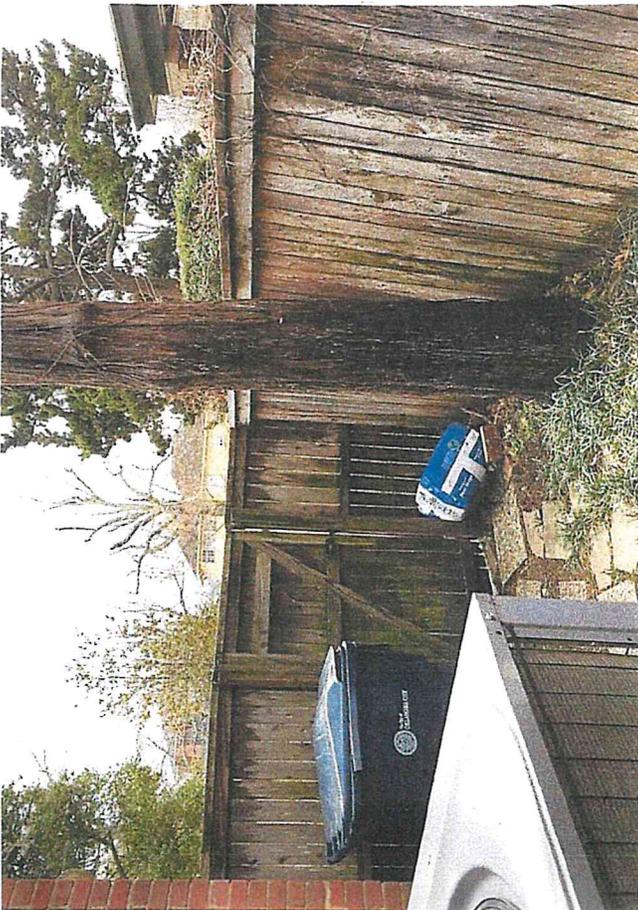
Counterclockwise from top left:

1. Looking south toward 18th Street at the inside of the gate, which will remain. The new fence will start at the corner of the existing fence and the gate.
2. Looking south from the planter bed toward the gate. Note that both the main fence and the latticework have been knocked over by tree limbs that fell in the ice storm, breaking the fence posts. This is approximately half of the length of the existing fence. The rest of the fence is not damaged and will not be replaced at this time.
3. Looking north from the gate. The planter beds are visible in the background framed in brick.

- A. **Scope of work.** The south half of the existing fence was badly damaged by falling tree branches in the Oct. 27 ice storm. Our intention is to replace the damaged fence, which was there before we bought the house in 1990. The new fence will be built to match the existing fence in all respects, according to the dimensions shown above and the photos attached.

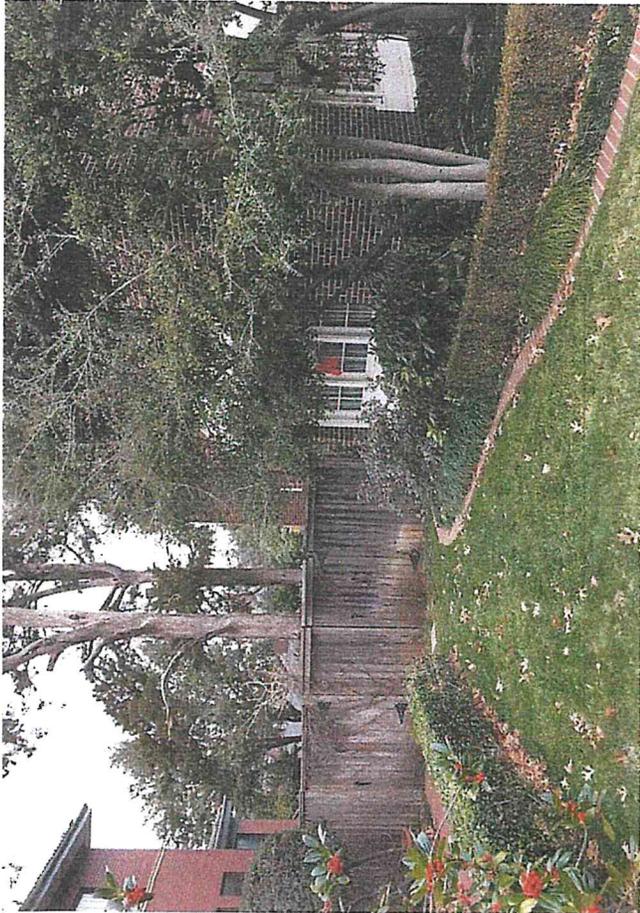
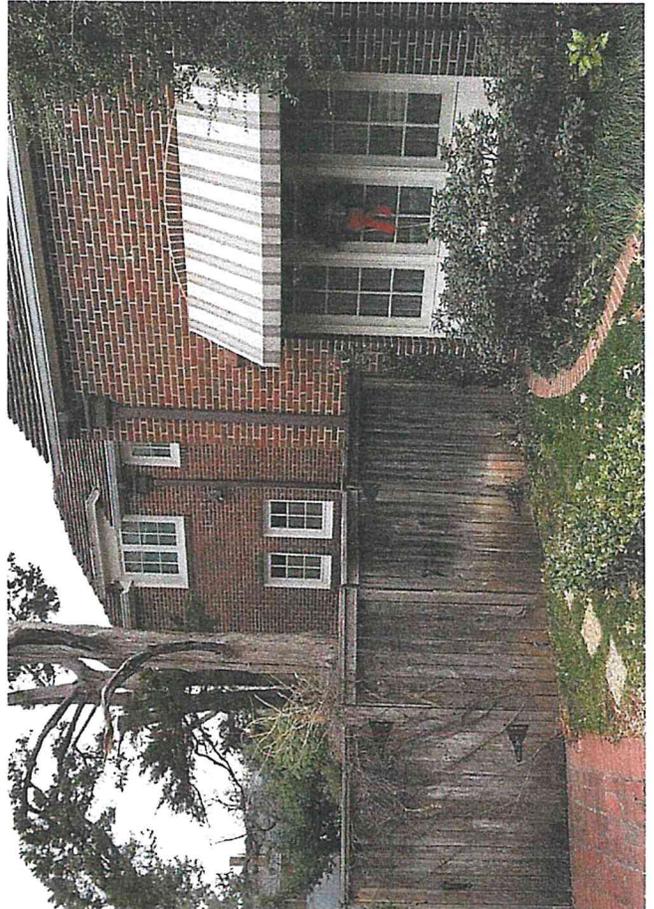
Top to bottom:

4. Looking north from the front yard at 301 NW 18th St at the existing cedar fence and gate. The existing fence to be replaced is entirely hidden on the other side of the gate.
5. The property line between 311 and 301 NW 18th St is on the right edge of the brick walkway. The stepping stones lead to the gate to 301. The existing fence to be replaced is just to the left of the big tree inside the gate. Fence heights here are from 5'3" near the tree to 5'6" near the house.

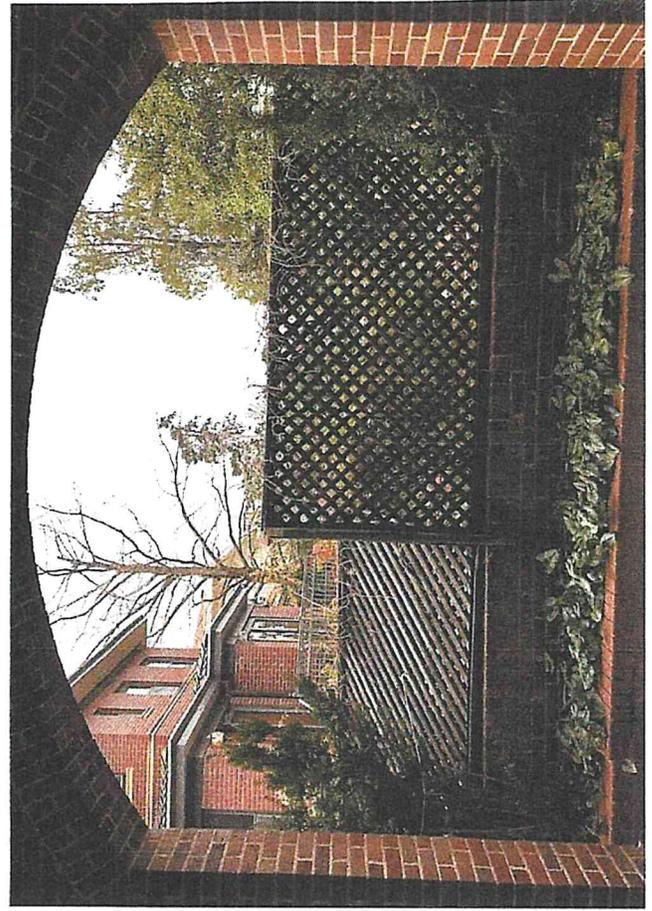
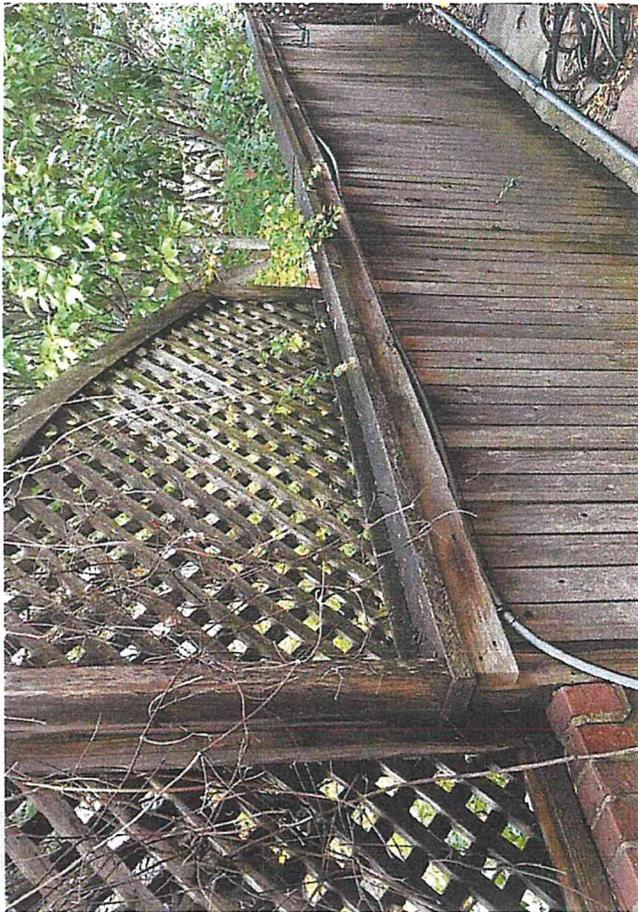
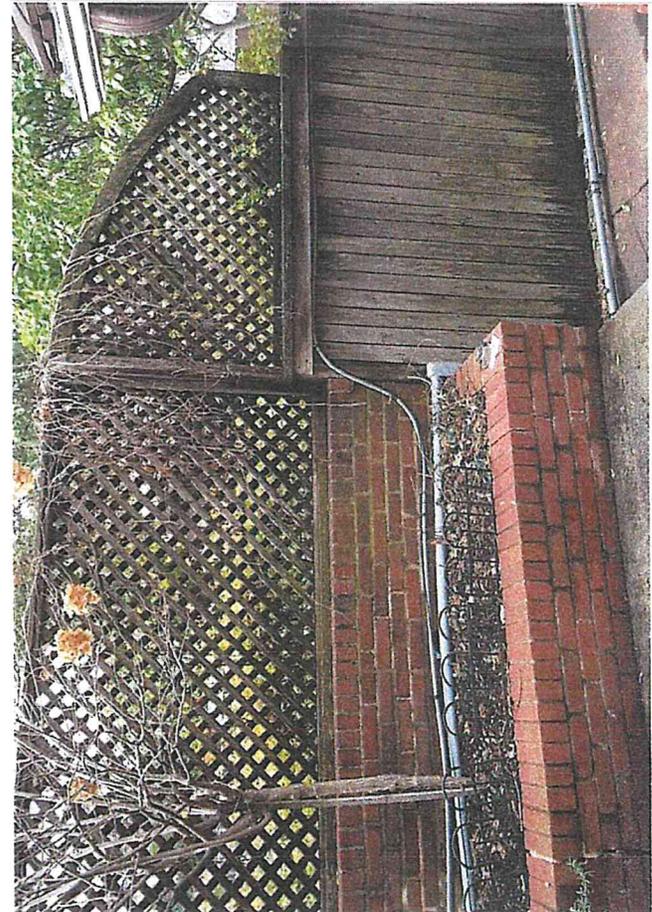
Clockwise from lower right:

4. The first 10 foot section of latticework was broken and knocked over. This is also visible in photo #2.
5. The north end of the latticework, terminating just past the brick planter bed.
6. The final 33 feet of fence, terminating on our side of the alley. It varies in height from 5 to 6 feet, as the grade falls off to the north. Our neighbor's pool and deck are on the other side of the fence.
