APPLICATION FOR CERTIFICATE OF APPROPRIATENESS

Location of Proposed Work (Address): 301 NW 18th St, OKC, OK 73103

**HISTORIC DISTRICT AND HISTORIC LANDMARK
CERTIFICATE OF APPROPRIATENESS
HPCA-13-00044**

2. Why are we replacing historic wood windows?

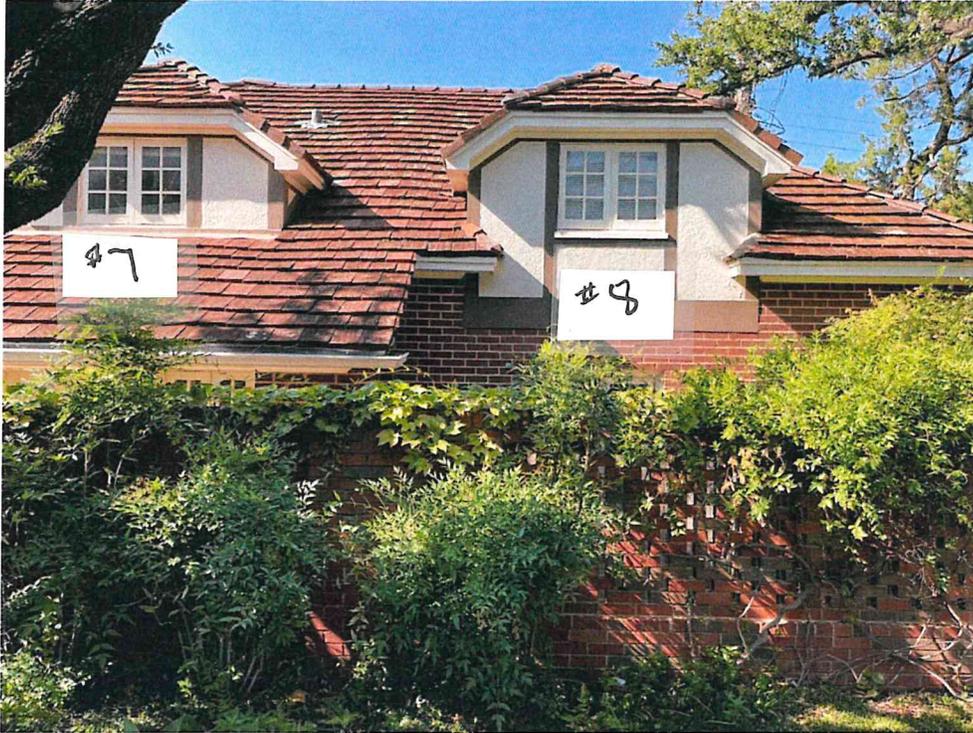
South Elevation

2nd floor dormer windows, #7 on the left (west) and #8 on the right (east):

Dimensions of both windows are:

36" wide x 29" high

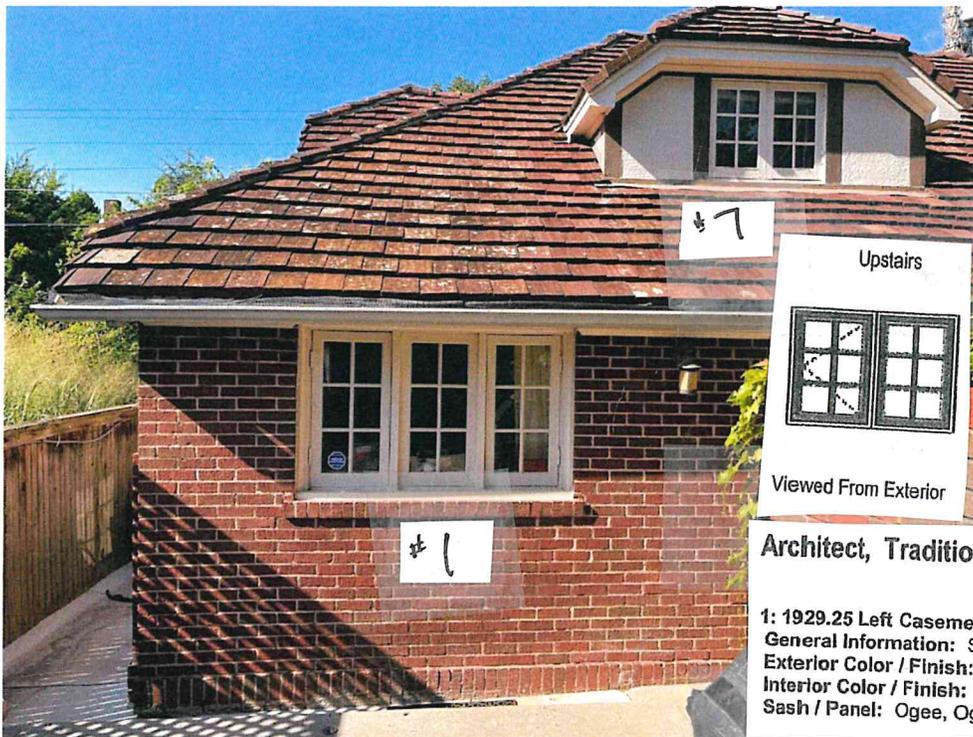
South Elevation

2nd floor dormer window, #7 measures:

36" wide x 29" high

1st floor window (#1) measures:

59" wide x 36" high

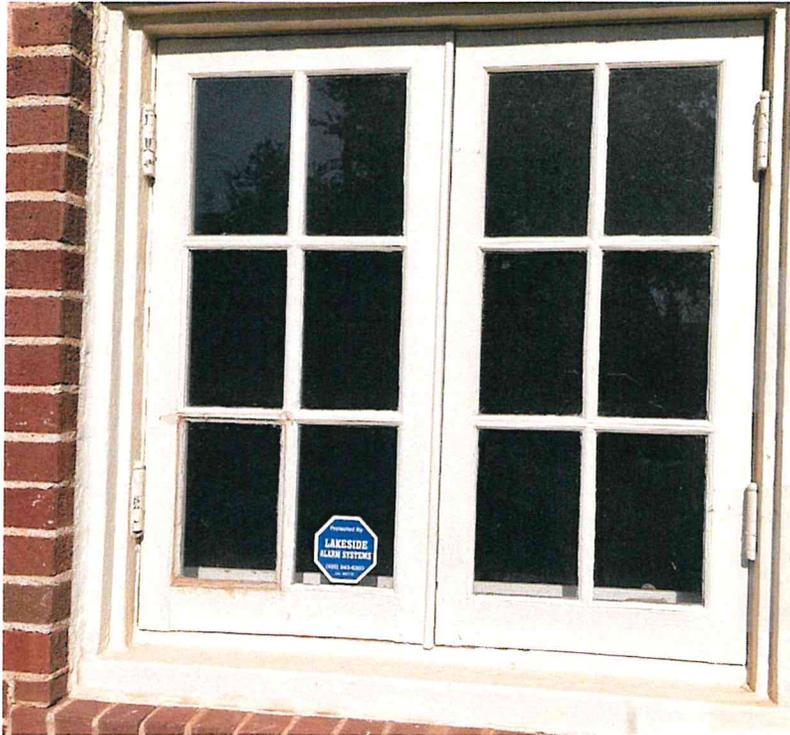
West Elevation

Dimensions of window 5 shown here are:

36" wide x 36" high

This matches window 4 to the left (north) and 3 on the north elevation.

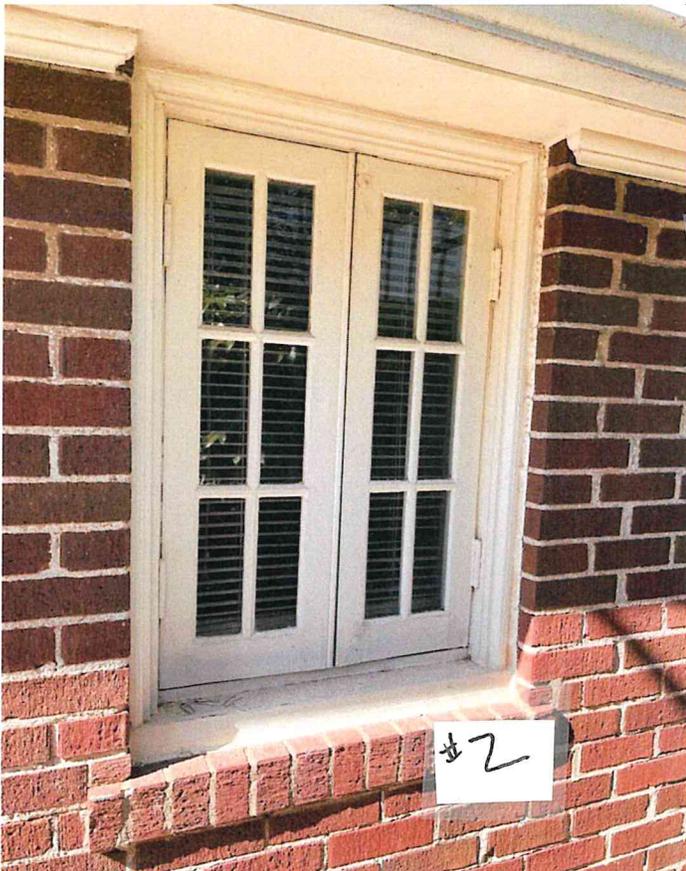
South Elevation

Window 2 on 1st floor.

Dimensions are:

24" wide x 36" high

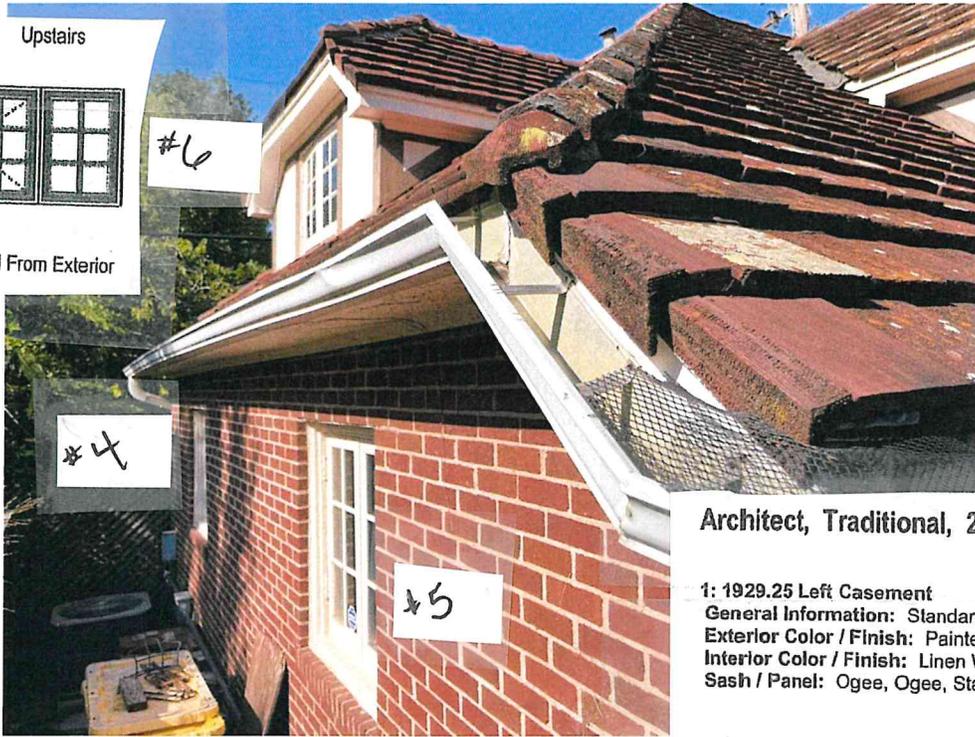
West Elevation

Windows 5 (closest) and 4 (distant, 1st floor), and 6 (dormer, 2nd floor).

Dimensions are:

Windows 4 and 5:

36" wide x 36" high

Window 6:

36" wide x 29" high

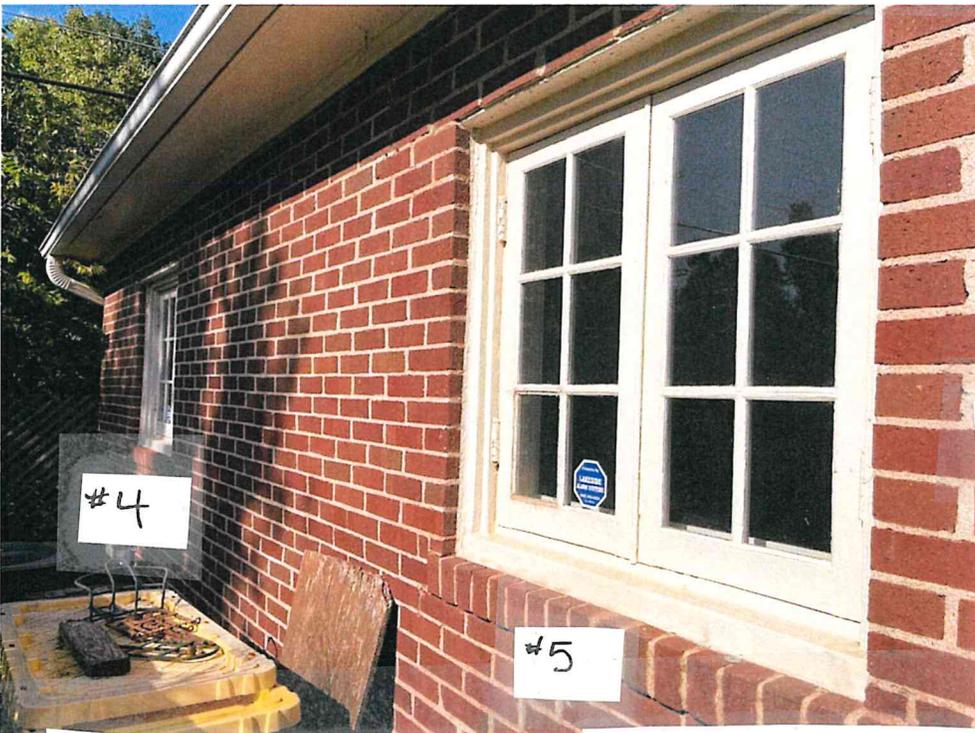
West Elevation

Windows 5 (closest) and 4 (distant) on west elevation.

Dimensions of both windows are:

36" wide x 36" high

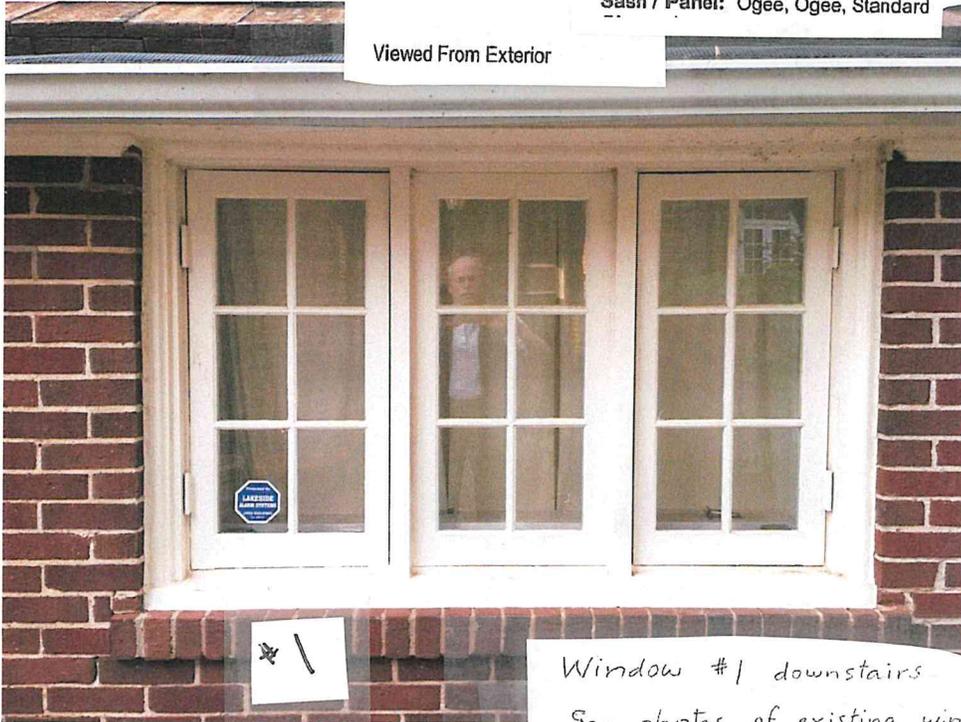
South Elevation

Window #1, ground floor:

59" wide x 36" high

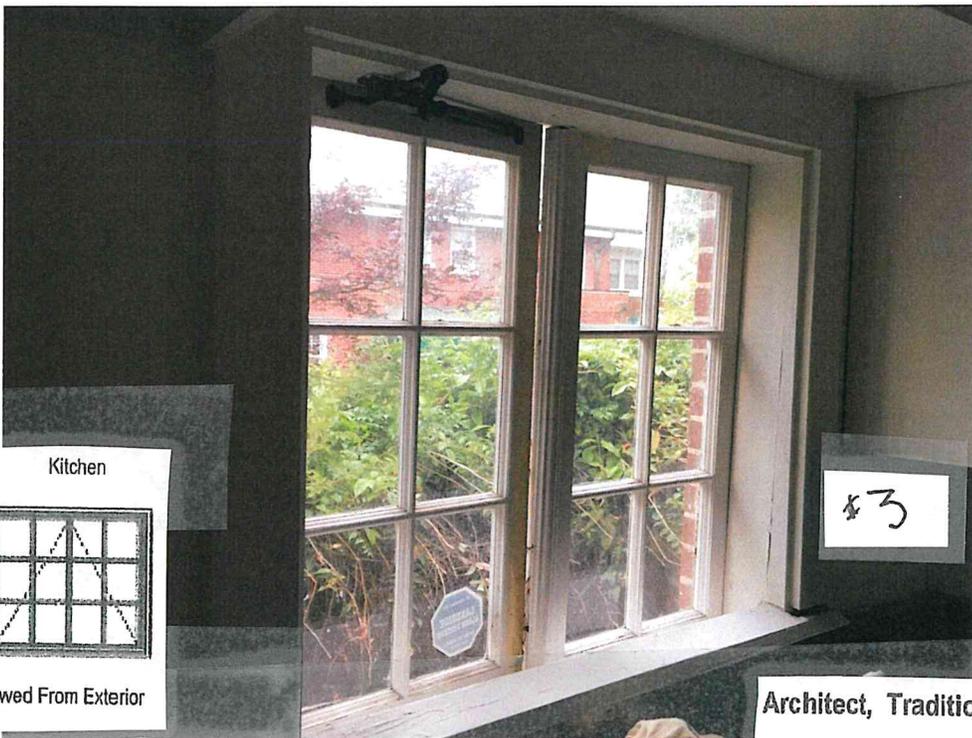
North Side of Garage

Window #3 is on the north elevation, overlooking the alley. It is not readily accessible to be photographed. Dimensions are the same as windows 4 and 5:

36" wide x 36" high
