APPLICATION FOR CERTIFICATE OF APPROPRIATENESS

Location of Proposed Work (Address): 101 Northwest 19th Street, Oklahoma City, OK 73103

SCOPE OF WORK

SECTION B: DOCUMENTATION OF EXISTING CONDITIONS

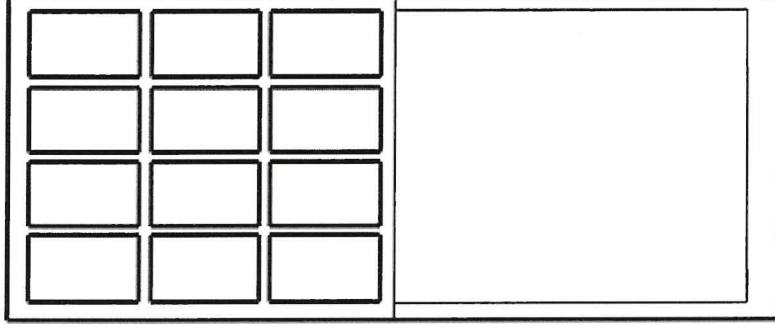
Left Side Windows 3 & 5 (L103 & L105)

- L103: No photo documentation. Original window was 9 over 1. We installed 12 over 1
- L105: No photo documentation. Original window was 9 over 1. We installed 12 over 1

- Total Height: 49 3/4"
- Total Width: 24"
- Upper Rail Height: 2 1/8"
- Lower (meeting) Rail Height: 1 1/4"
- Lower Sash Rail: 3 1/8"
- Upper and Lower Sash Stiles: 2 1/8"
- Muntins 3/4"

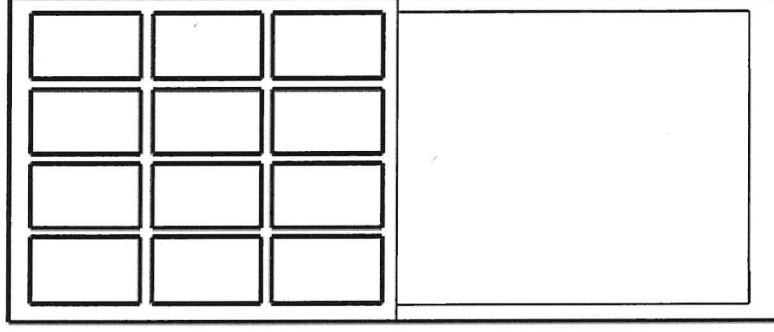
Left Side Window 4 (L104)

- L104: No photo documentation. Original window was 9 over 1. We installed 12 over 1

- Total Height: 49 $\frac{3}{4}$ "
- Total Width: 24 $\frac{1}{8}$ "
- Upper Rail Height: 2 $\frac{1}{8}$ "
- Lower (meeting) Rail Height: 1 $\frac{1}{4}$ "
- Lower Sash Rail: 3 $\frac{1}{8}$ "
- Upper and Lower Sash Stiles: 2 $\frac{1}{8}$ "
- Muntins $\frac{3}{4}$ "

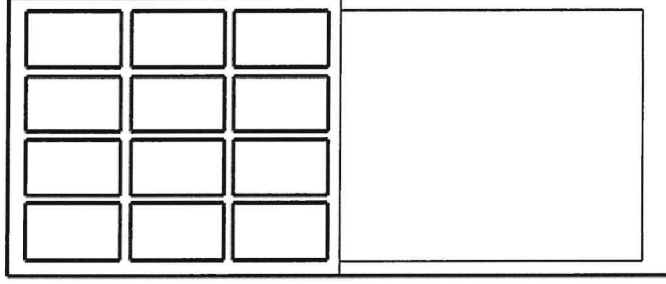
Right Side Window 1 & 2 (R101 & R102)

- R101: Previously Aluminum
- R102: Previously Aluminum

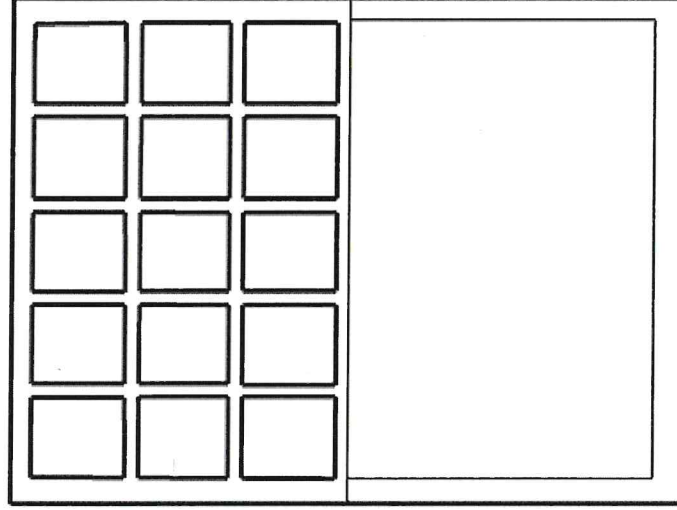
- B101: Previously Aluminum
- B102: Previously Aluminum

Documented bottom sashes that are not linked to an upper sash.
