WM-0342 & WM-0343 Lake Atoka Road Rehabilitation Preliminary Engineering Report

April 2023

OCWUT Project Nos. WM-0342 & WM-0343
Atoka Lake Road Rehabilitation
Lake Atoka

Poe and Associates, Inc.
Certificate of Authorization No. 541
1601 Northwest Expressway, Suite 400
Oklahoma City, OK 73118
Telephone: (405) 949-1962

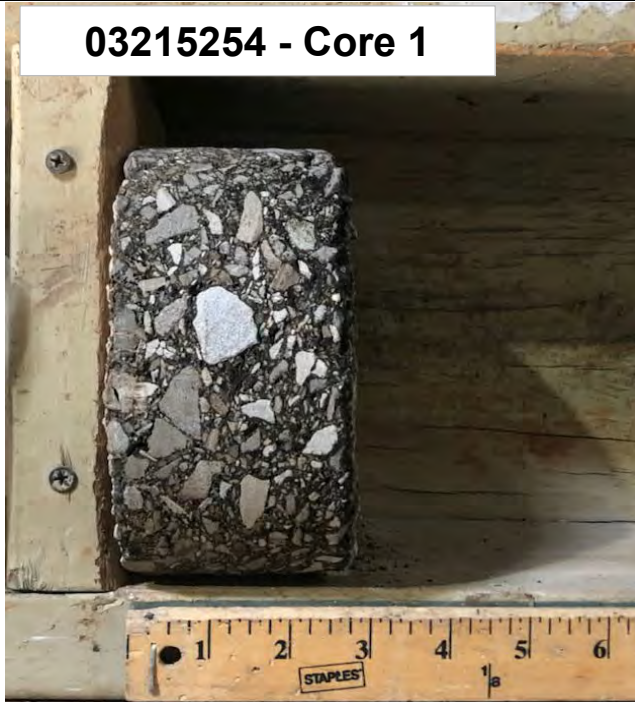
03215254 - Core 1

CORE NUMBER C-1
 DATE CORED 2/18/2022
 LOCATION Atoka Lake Access Road- South Section
 Pavement Evaluation
 Access Road East side of Atoka Lake
 Stringtown, Oklahoma

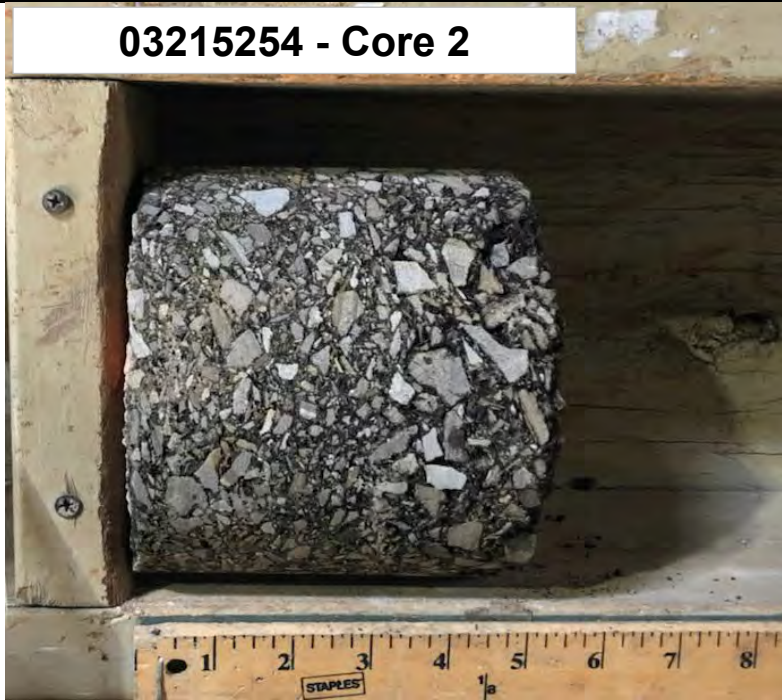
03215254 - Core 2

CORE NUMBER C-2
 DATE CORED 2/18/2022
 LOCATION Atoka Lake Access Road- South Section
 Pavement Evaluation
 Access Road East side of Atoka Lake
 Stringtown, Oklahoma

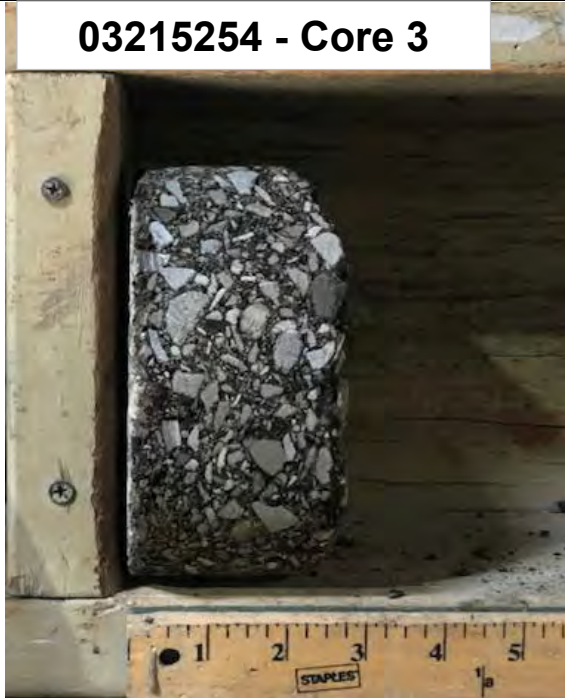
03215254 - Core 3

CORE NUMBER C-3
 DATE CORED 2/18/2022
 LOCATION Atoka Lake Access Road- South Section
 Pavement Evaluation
 Access Road East side of Atoka Lake
 Stringtown, Oklahoma

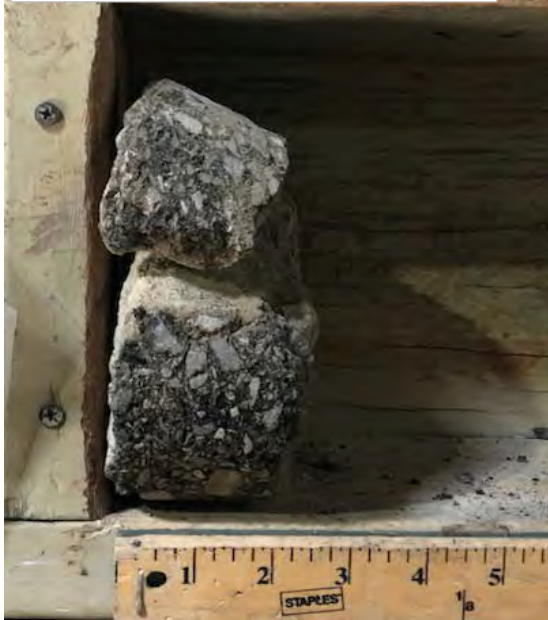
03215254 - Core 4

CORE NUMBER C-4
 DATE CORED 2/18/2022
 LOCATION Atoka Lake Access Road- South Section
 Pavement Evaluation
 Access Road East side of Atoka Lake
 Stringtown, Oklahoma

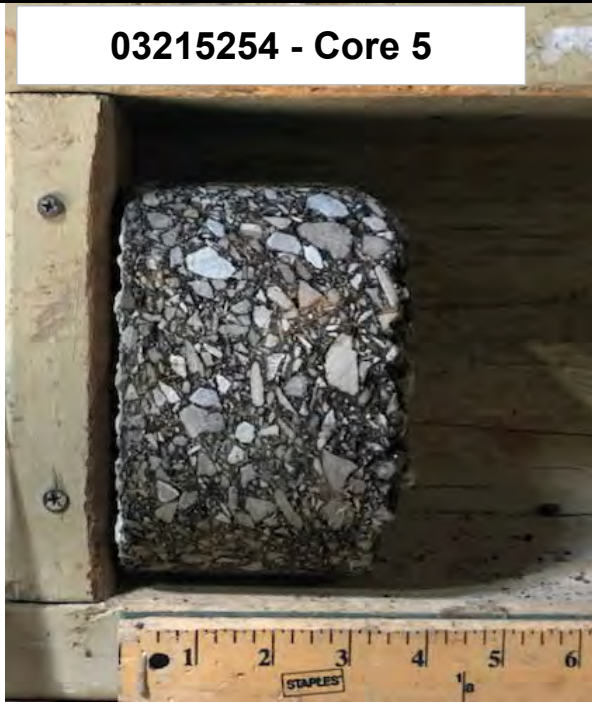
03215254 - Core 5

CORE NUMBER C-5
 DATE CORED 2/18/2022
 LOCATION Atoka Lake Access Road- South Section
 Pavement Evaluation
 Access Road East side of Atoka Lake
 Stringtown, Oklahoma

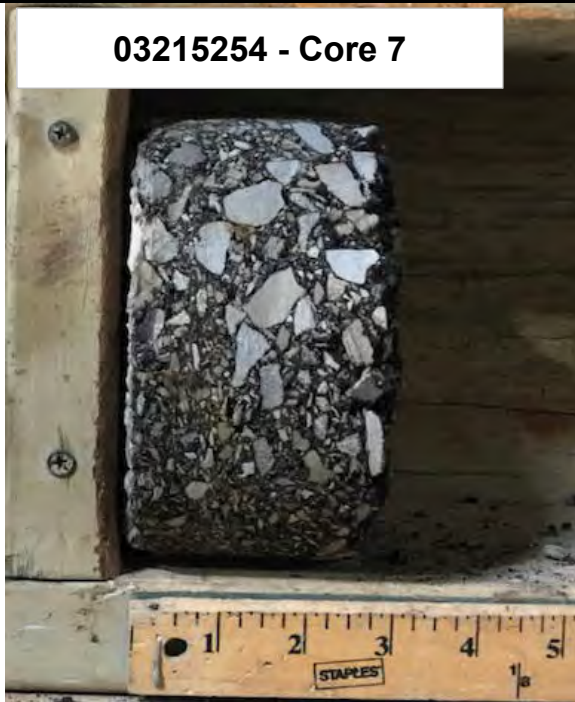
03215254 - Core 7

CORE NUMBER C-7
 DATE CORED 2/18/2022
 LOCATION Atoka Lake Access Road- South Section
 Pavement Evaluation
 Access Road East side of Atoka Lake
 Stringtown, Oklahoma

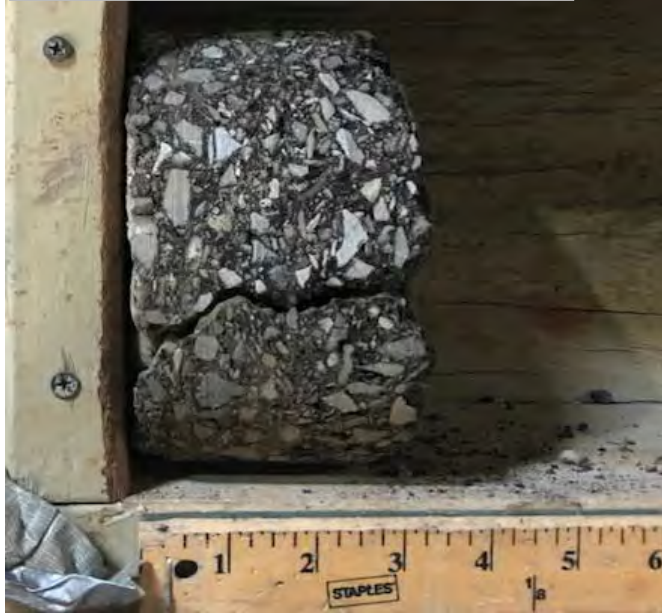
03215254 - Core 8

CORE NUMBER C-8
 DATE CORED 2/18/2022
 LOCATION Atoka Lake Access Road- South Section
 Pavement Evaluation
 Access Road East side of Atoka Lake
 Stringtown, Oklahoma

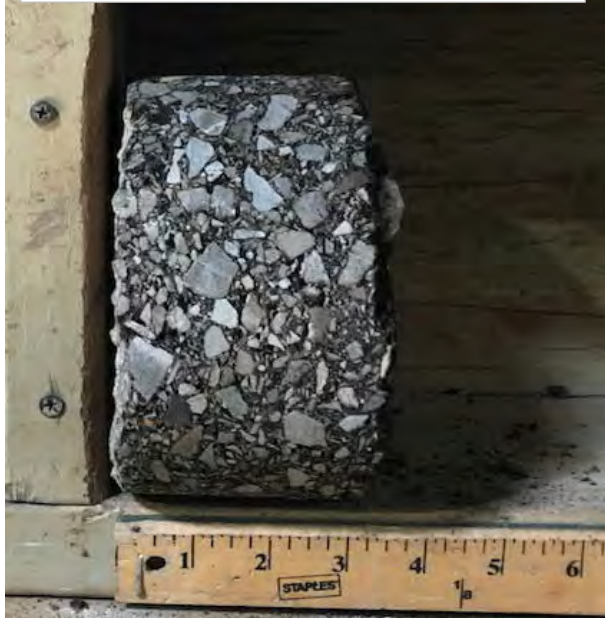
03215254 - Core 9

CORE NUMBER C-9
 DATE CORED 2/18/2022
 LOCATION Atoka Lake Access Road- South Section
 Pavement Evaluation
 Access Road East side of Atoka Lake
 Stringtown, Oklahoma

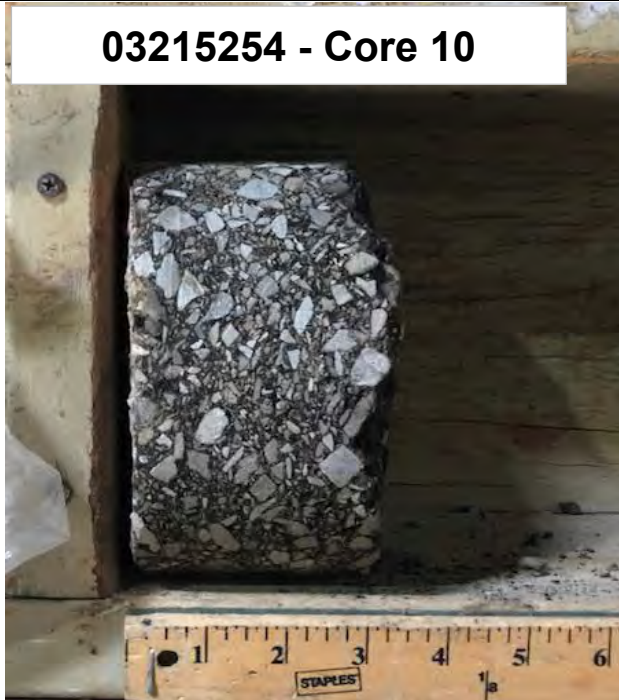
03215254 - Core 10

CORE NUMBER C-10
 DATE CORED 2/18/2022
 LOCATION Atoka Lake Access Road- South Section
 Pavement Evaluation
 Access Road East side of Atoka Lake
 Stringtown, Oklahoma

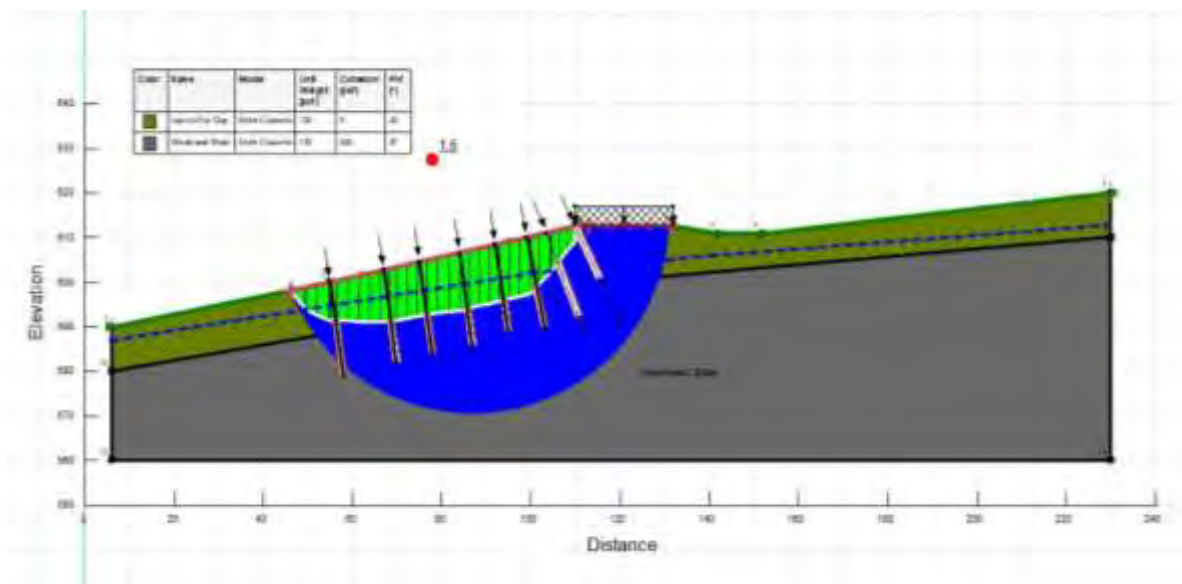
Another slope reinforcement option is available that does not require the extensive reconstruction described in the previous approach. This option uses soil nails or soil anchors to stabilize the slope in place. The advantage of this approach is that it can be achieved without closing the road for extensive periods of time and may possibly be conducted with one lane of traffic open during operations. In this reinforcement method, soil nails or anchors composed of high strength steel rods or tubes are either driven or drilled to a specified depth beyond the slippage plane into stable strata within the slope. They are placed along the slope in a grid pattern with spacing typical ranging from 3 to 6 feet. A reinforcing mesh of steel wire or cable is also placed along the slope and fastened to the anchors to reinforce the soil between the soil nails or anchor rods. This approach has the advantage of saving considerable time and the expense over other methods requiring extensive earthwork operations. This option was analyzed for feasibility at each of the two slide locations where borings were drilled. They are illustrated in Figures 3 and 4 below.

Figure 3. Slide near borings B-5, B-5A, & B-5B reinforced with soil nails into the existing slope.
Approximate Station 547+20

Figures 3 and 4 indicate that soil nails and/or soil anchors can be used to successfully stabilize the slopes, in place, without the requirement of extensive earthwork. **The final designs for this option should be developed by a contractor which specializes in this type of stabilization approach.** That design will be based upon the information detailed in our boring logs, the slope

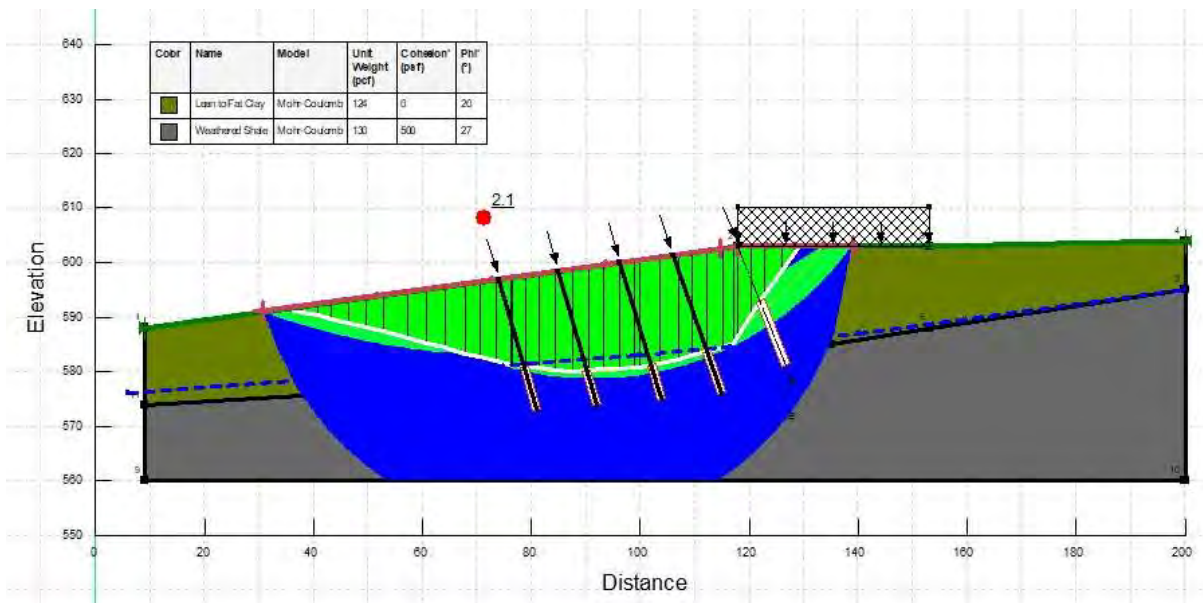
Figure 4. Soil nail reinforced slide near borings B-7, B-7A, & B-7B.
Approximate Station 556+20
