# APPLICATION FOR CERTIFICATE OF APPROPRIATENESS

Location of Proposed Work (Address): 224 NW 18th Street

☐ New Construction ☒ Addition ☐ Fence ☐ Demolition (specify structure) \_\_\_\_\_  
☒ Paving (specify) Driveway ☒ Renovation (specify) Structural repair of west exterior of home  
☒ Work not specified above Basement expansion  
Included with addition details

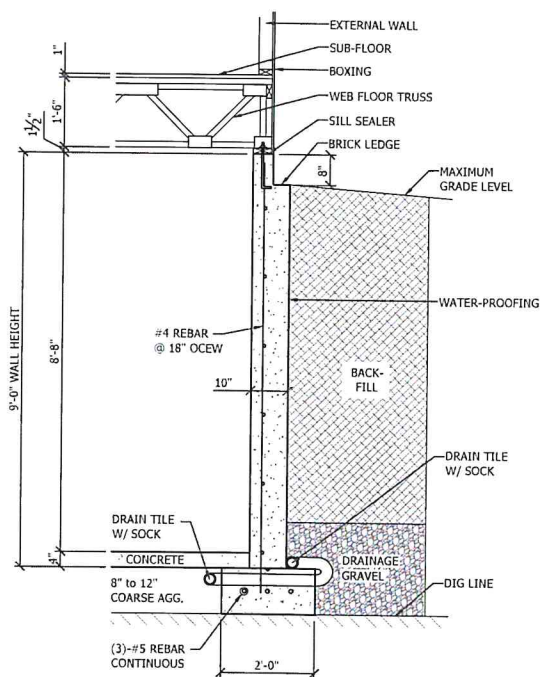
① BASEMENT WALL DETAIL  
SCALE: 1/2"=1'-0"

- 1.) 3500 PSI CONCRETE MIX 28 DAY COMPRESSIVE STRENGTH
- 2.) REBAR TO BE GRADE 60
- 3.) COMPACTION TO BE 98% STANDARD PROCTER DENSITY
- 4.) ALL VEGETATION, INCLUDING TREE STUMPS MUST BE REMOVED
- 5.) PIERS REQUIRED IN FILL MATERIAL OR SOIL <1500 PSI BEARING CAPACITY. PLACE PIER AT CORNER AND AT 8' CENTER SPACING.
- 6.) SOIL BEARING CAPACITY TO BE >1500 PSF MIN.
- 7.) FOOTINGS MUST BE PLACED ON UNDISTURBED SOIL.
- 8.) FOLLOW ALL DETAILS OF IRC 2015
- 9.) CUT FRAMING STUDS TO MATCH WALL HEIGHT IN BASEMENT (TO IRC 2015)

E4. construction methods and materials basement wall

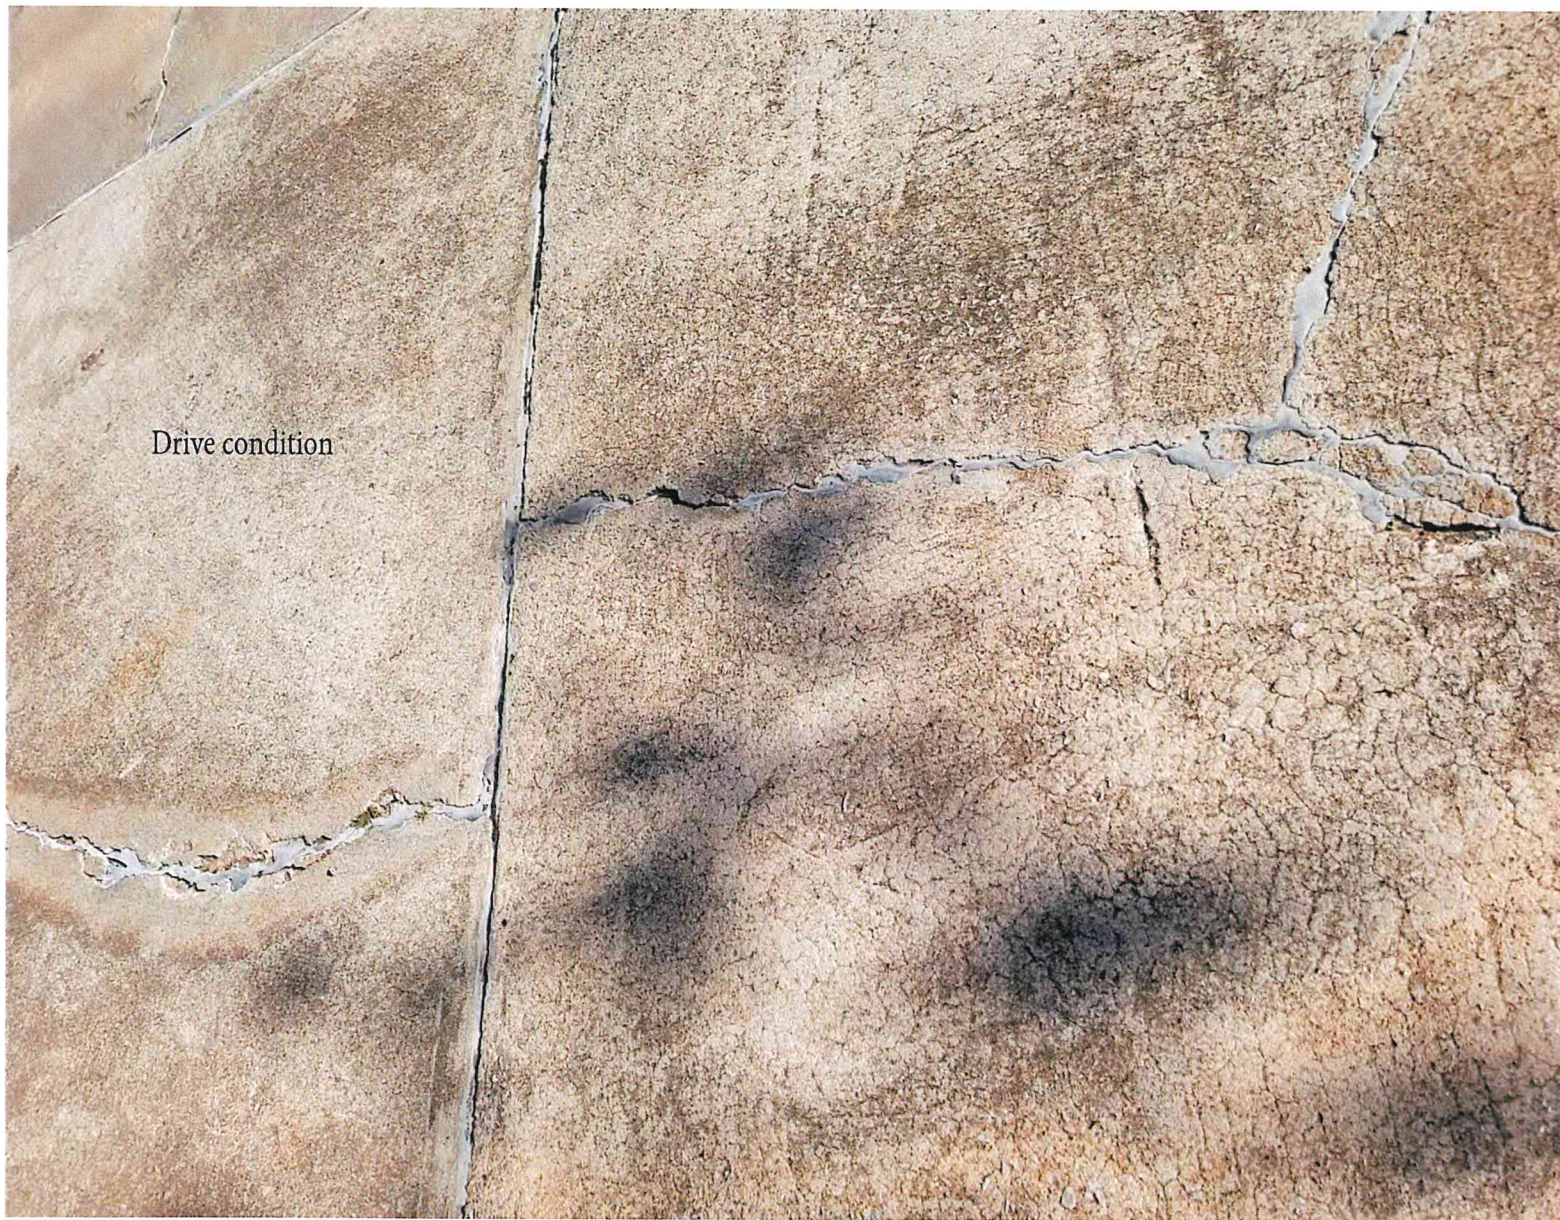
B1. driveway condition, slope  
towards house

Drive condition

Photo 2: condition of driveway
