APPLICATION FOR CERTIFICATE OF APPROPRIATENESS

Location of Proposed Work (Address): 424 NW 17th Street

FIELD INSPECTION REPORT

Project Name 427 NW 27th, Block 13 Lot 19 of
Jefferson Park Addition Project Number 5681
Date 12-21-2023 Type of Work Property condition assessment
Report Number 1 Reported By: Tim Meltabarger, RCI

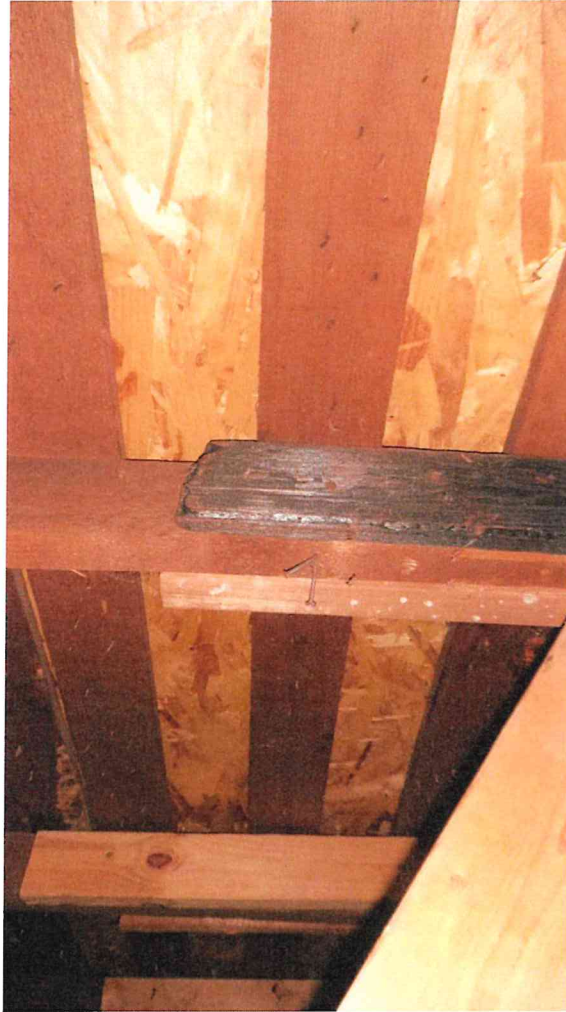
Rafters commonly scabbed together throughout.

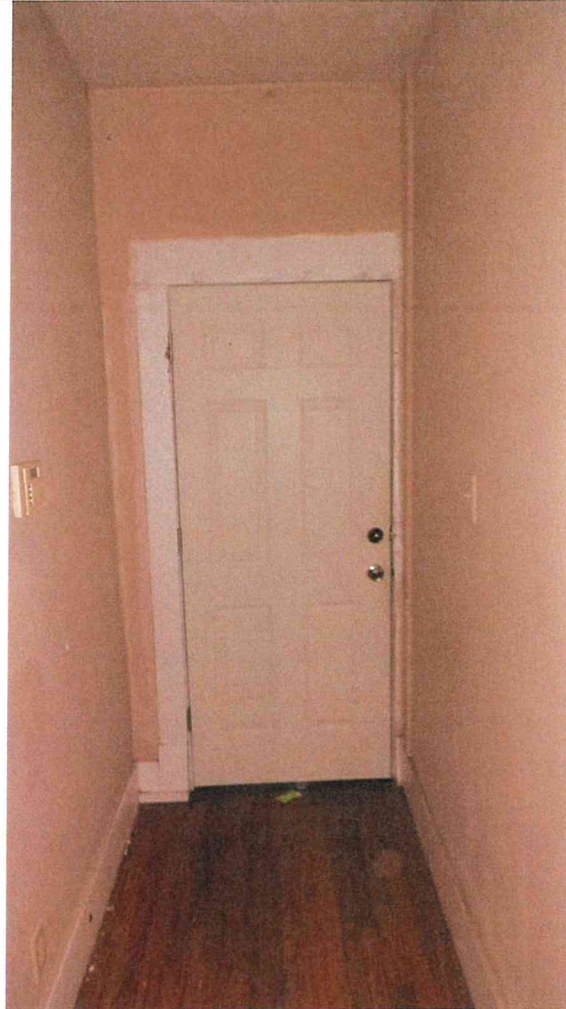
Front door installation.

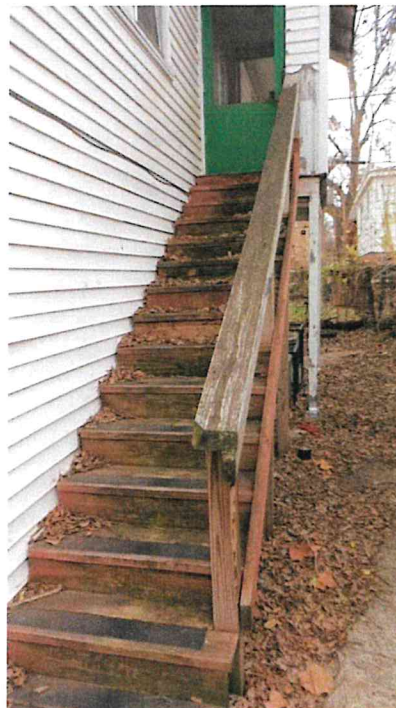
Stairs to upper Apartment.

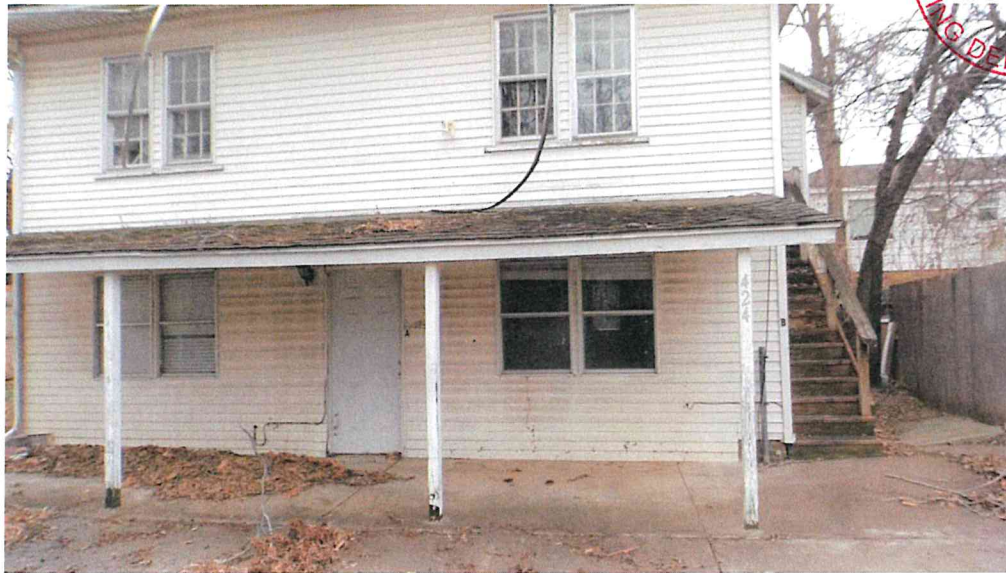
Front of Apartments

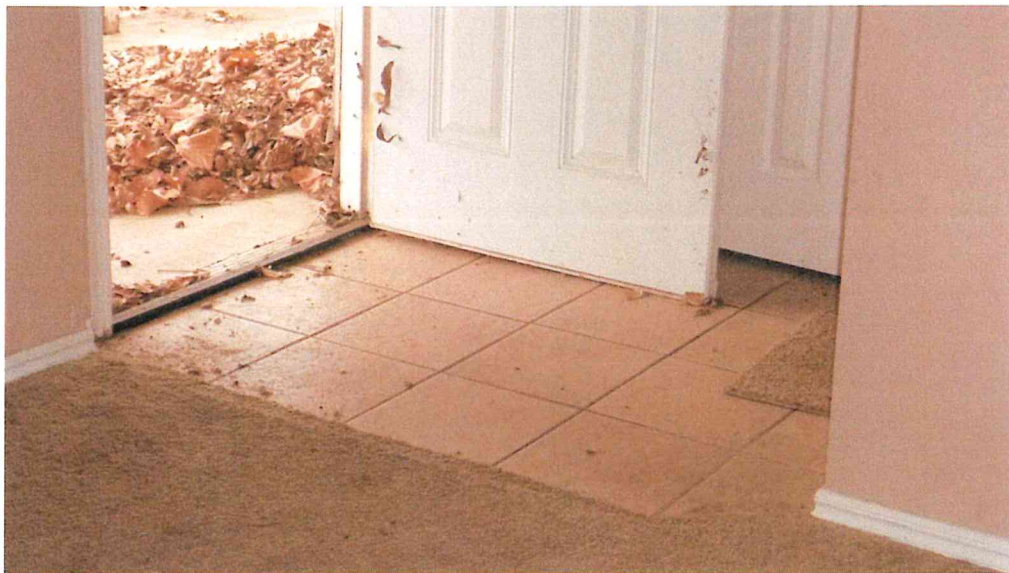
The finished floor elevation of apartment and exterior grade is only slightly higher.

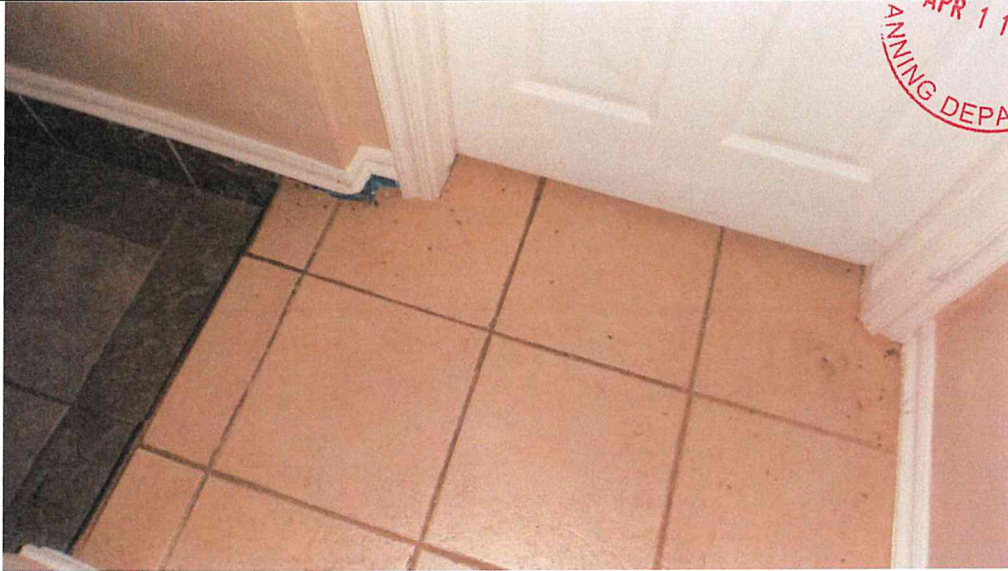
Appearance of water on first floor.

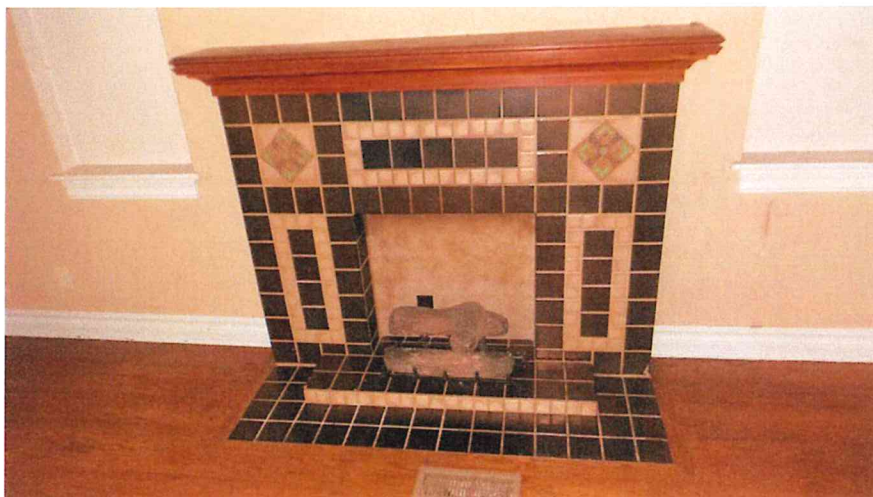
In the main room of the apartment is an unvented open gas fireplace. There is a gas line connected, so it is possible it was used. Ceilings and walls are cracking significantly and bear signs of water and stress damage. There is no sign of insulation in any of the walls in the entire building.

Functional gas log heater extends outside fire box.

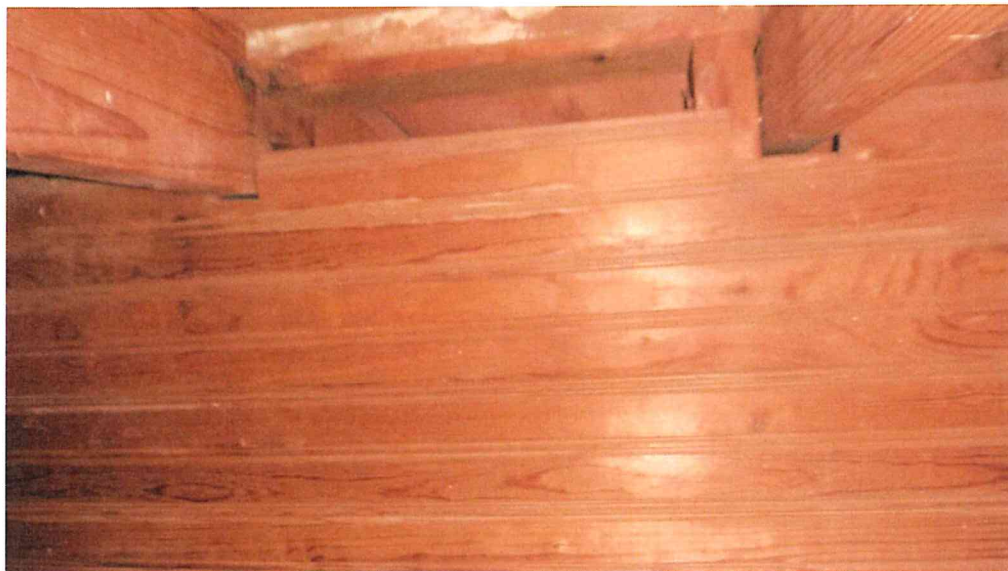
Exposed exterior sheathing above bead board under window seat.
